Buick Creek Arena (Rural)

Asset:
Clearview Arena (Rural)

Asset:
Fort St. John Curling Club

Asset:
North Peace Arena

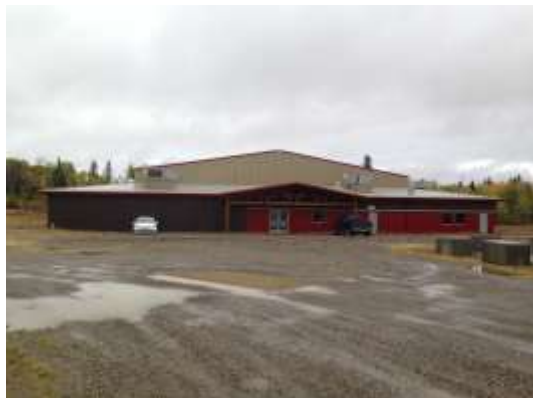
Exterior

Corrugated metal exterior siding to foundation may show premature damage and corrosion.

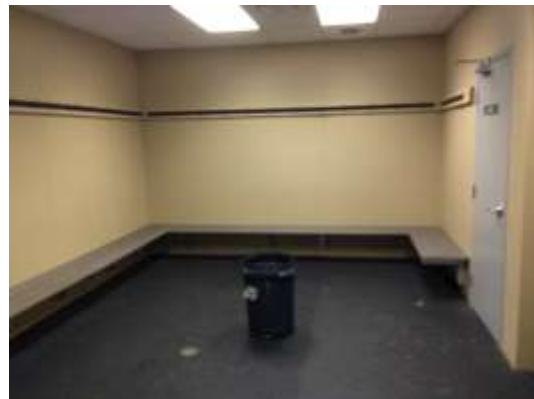
Dressing Room

Team rooms have t-bar ceiling and unprotected light fixtures vulnerable to stick damage.

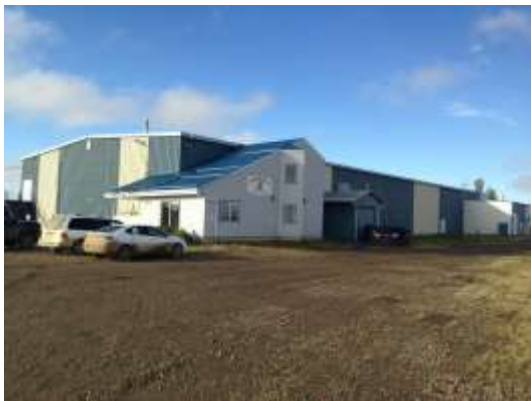
Exterior

Corrugated metal exterior siding to foundation showing damage and corrosion in sections.

Full building replacement will likely be required within 10-15 years. Building has already out-performed expectations for pre-engineered low-cost structure.

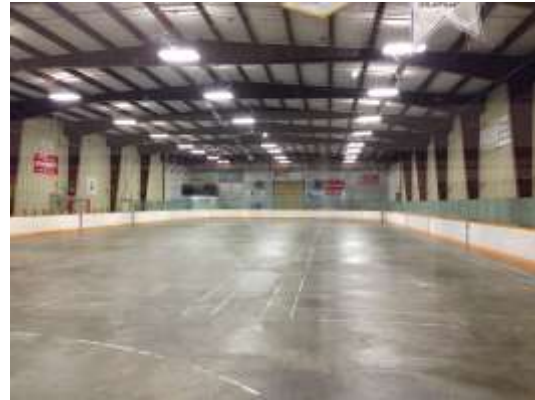
Interior

Interior: Uninsulated walls, exposed structure. Fair.

Dasherboards and glass are scratched and damaged and approaching end of service life.

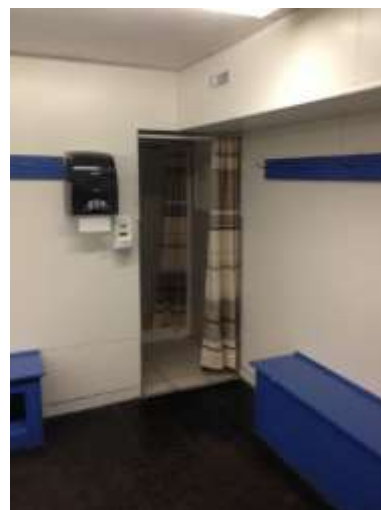
Dressing Room

Team rooms are small for 20 adults.

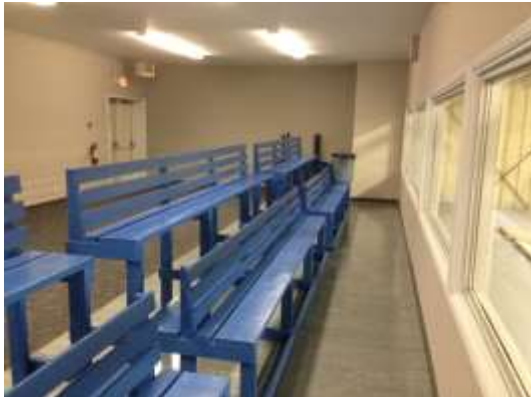
Mezzanine seating

Functionality: Medium (obsolete; spectator viewing from end-zone only inadequate). Fair.

Code compliance: Conforming; non-combustible, non-sprinklered; multiple exits. Wooden bleachers are non-conforming. Good.

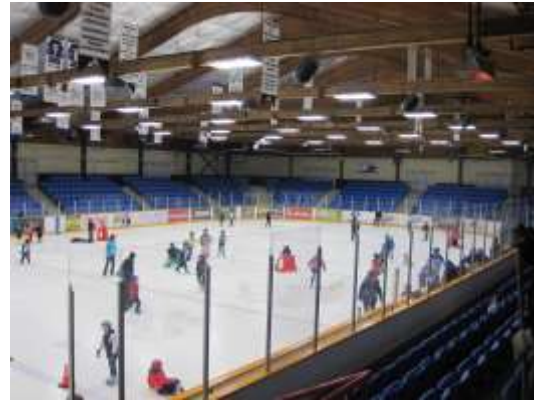
Ice and seating bowl

Functionality: Adaptable and usable for all types of events including dry-floor. Acoustics poor for concerts.

Appearance: Fair (maintained but obsolete and aging). Spectator seating is relatively new and appears to be in excellent condition. Good.

Lighting system marginally adequate (not for TV broadcast though), electrical system maximized and major upgrade will be required. Acoustics are poor (hard surfaces) and addition of acoustic panels would improve sound for concerts and events.

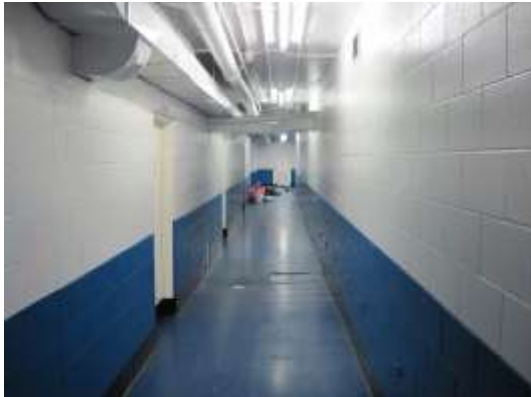
Dressing Room Corridor

Only four team rooms, plus refs room. Ideally an oversized anchor tenant team room and one or two additional rooms for mixed-gender team opposite sex players. There is no contiguous space available for this purpose without taking over public skate change area (not recommended).

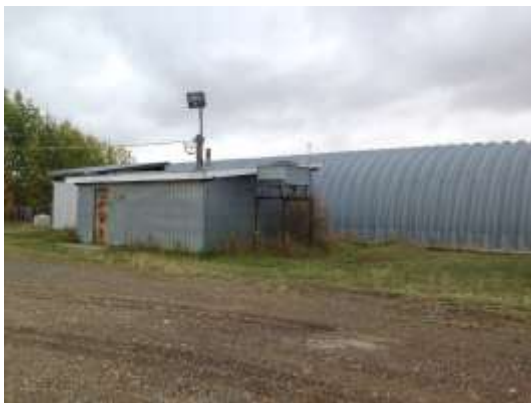
Exterior

Envelope: Corrugated metal, partial-insulated. Poor.

Roof: Integrated roof and walls. Poor.
Interior: Low ceiling, unfinished. Poor.
Mechanical: Aging ice plant. Poor.

Appearance: Fatigued and under-maintained.

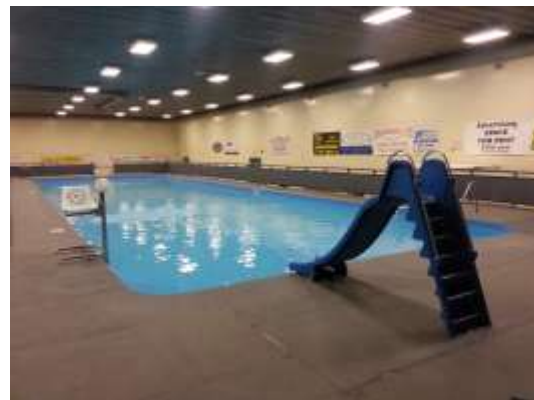
Pool configuration in curling rink

The curling-pool combination is a unique solution for providing two amenities in a small community. The curling facility envelope was never designed for pool humidity and heat conditions so the combination depends on mechanical systems working efficiently at all time. Pool use is likely accelerating building structure and shell deterioration but little visible evidence found during walk-through.
