Asset:

Kids Arena Fieldhouse

Location: Fort St. John

Asset:
North Peace Gymnastics Club

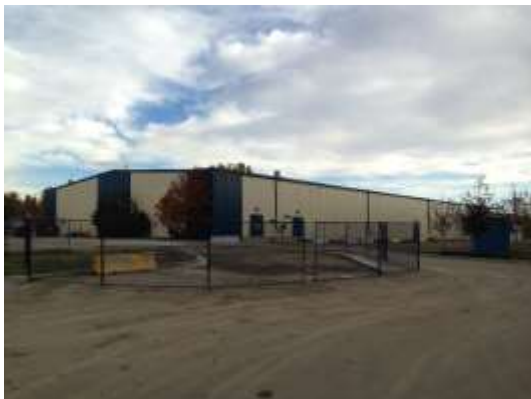
Exterior

Envelope: Steel to ground line. Fair.

Roof: Steel beams and purlins, metal deck. Fair.

Appearance: Aging but maintained. Good.

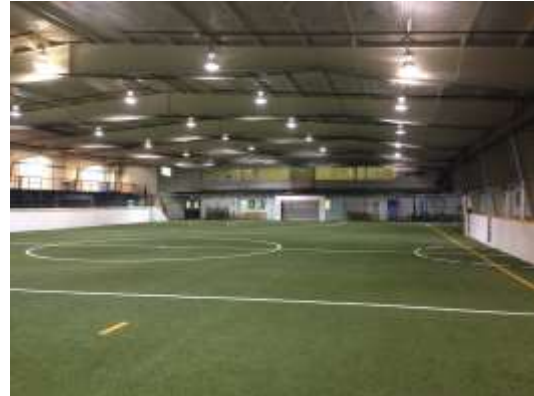
Interior

Interior: Insulated. Glass and dasher-boards retained, lighting adequate. turf approaching half-life. Very good.

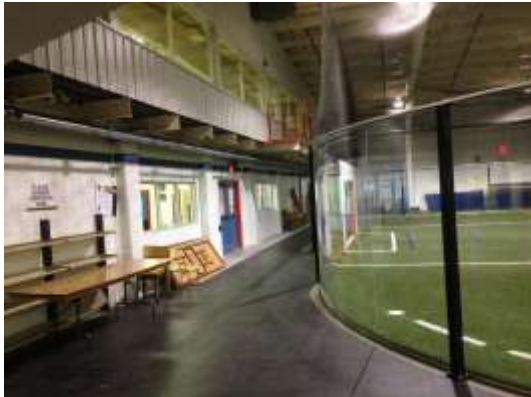
Glazed end dashboards

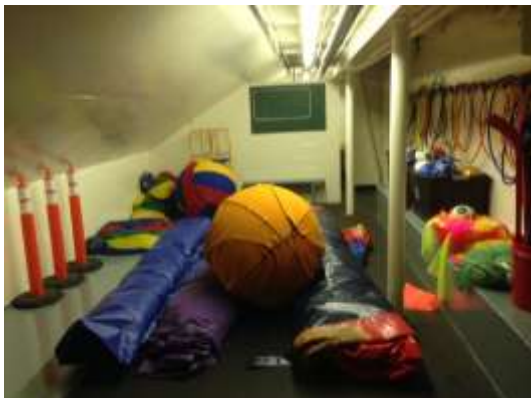
Team room under bleachers

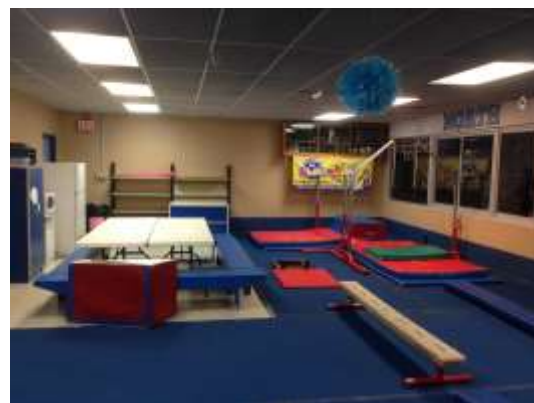
Training Room

Description: The space is the former natatorium that served the FSJ community before the North Peace Leisure Centre was built in 1997. As a gymnastics hall, the existing clear-span space is functional with adequate clear height (except for rhythmic) but overall is inadequate in area. Equipment has to be moved and shifted, losing valuable training time.

Capital interventions anticipated:
Planning for a larger replacement facility has been initiated by the Club.
