Asset:
**Buick Creek Community Hall
(Rural)**

Rating: 2.0 (scale of 1-10)

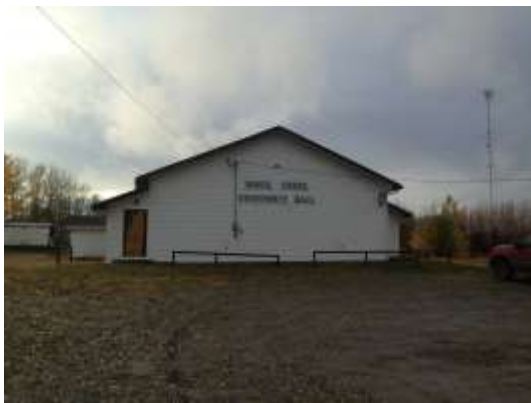
Exterior

Appearance: Neglected. Poor.

Capital interventions anticipated:
Roof needs replacement. Envelope and interior in very poor condition.

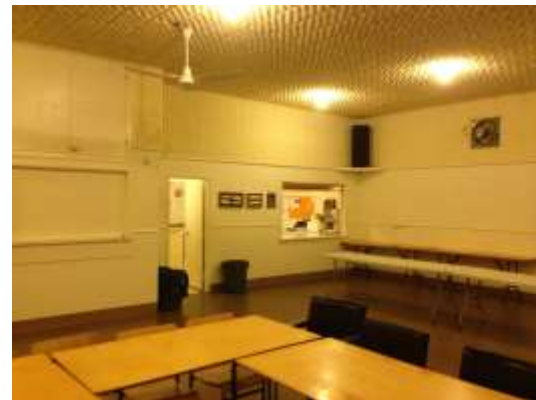
Interior

Interior: Plywood, paper tile ceiling. Poor.

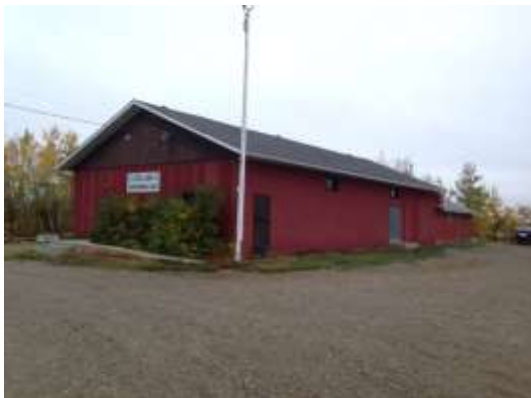
Exterior

Envelope: Board and batten wood. Good.

Roof: Pitched roof, shingles. Good.

Appearance: Aging but maintained. Good.

Lifecycle foundation, mechanical and envelope.

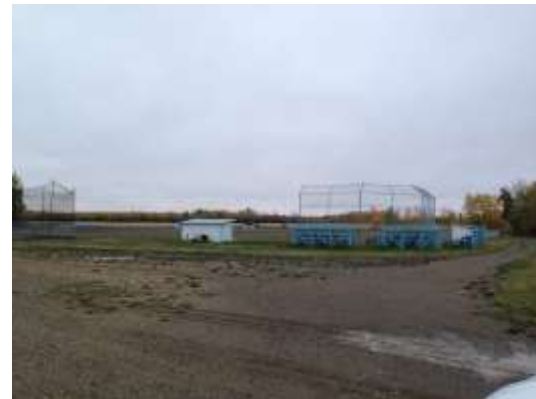
Ball diamonds and parking

Parking: Gravel, adequate size. Good.

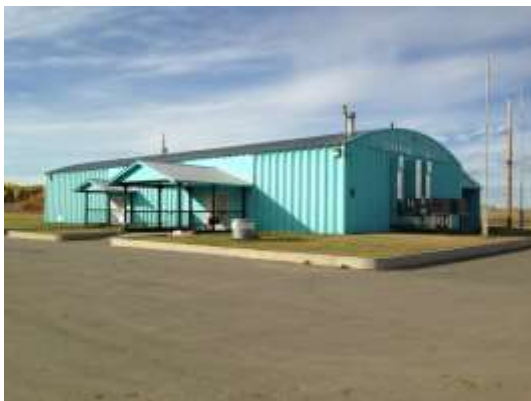
Exterior

Envelope: Pre-eng metal, insulated, plywood at entrance. Good.

Envelope failures eminent, mechanical nearing end of service life.

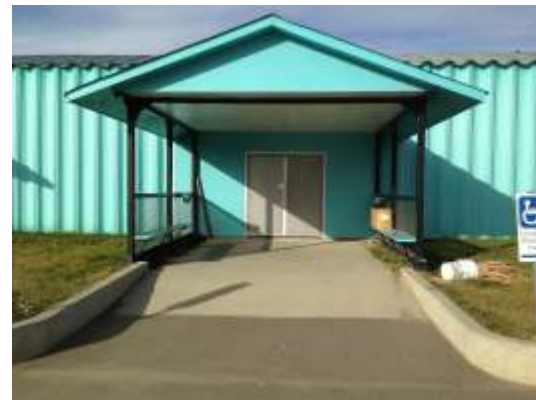
Entrance

Handicapped access: Limited (missing hardware). Fair.

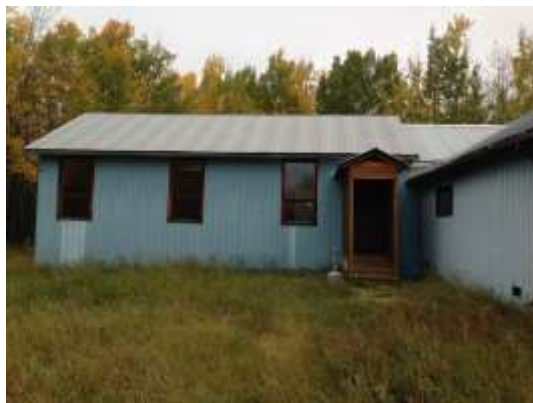
Exterior

Roof: Metal pitched. Poor.

Appearance: Building and site not maintained. Poor.

Roof needs replacement or major repairs (re-occurring). Envelope and interior in very poor condition.

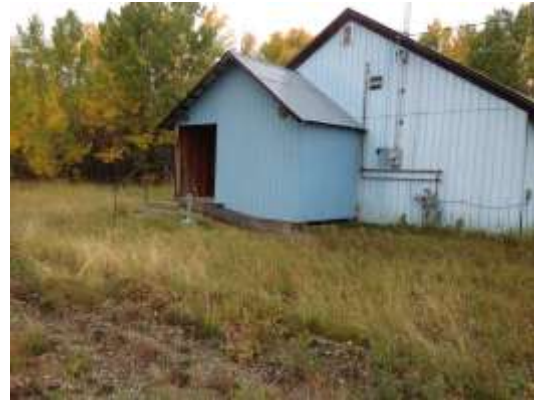
Entrance

Envelope: Wood frame; portable likely steel stud framing. Poor.

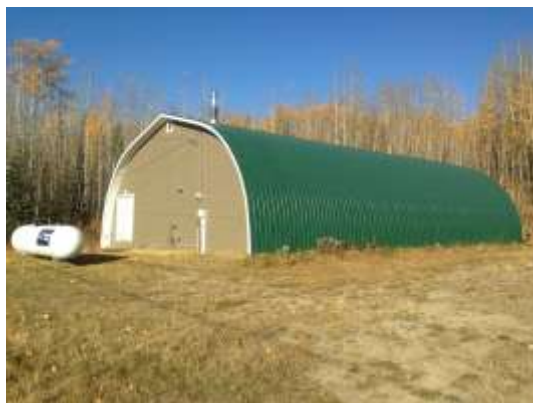
Exterior

Envelope: Raised-seam metal. No windows. Very good.

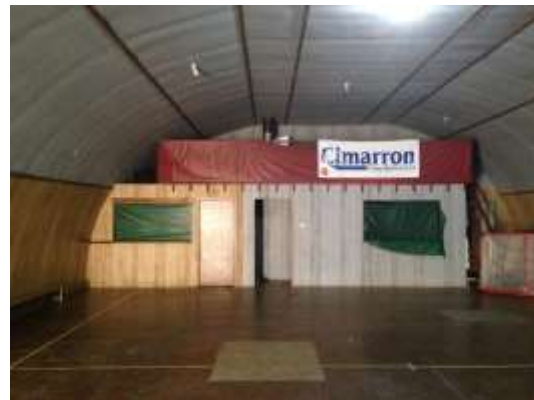
Interior: Plywood floor and walls. Fair.

Capital interventions anticipated: Interior finishes and flooring, kitchen and lighting in need of upgrade. Outhouses in poor condition.

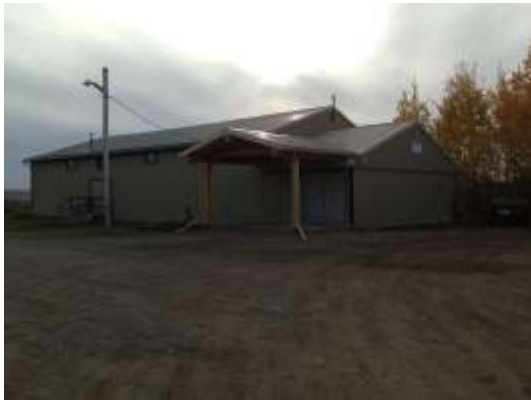
Exterior

Envelope: Raised-seam metal, wood windows. Good.

Appearance: Well maintained. Very good.

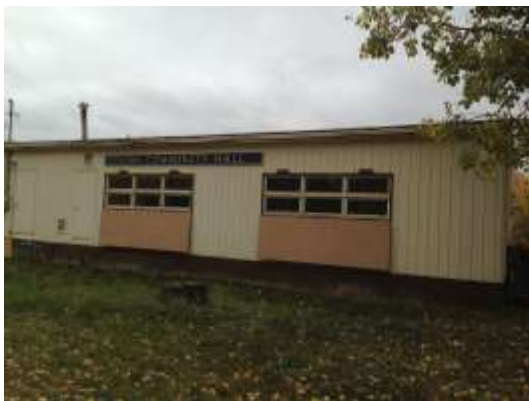
Exterior

Appearance: Poor

Capital interventions anticipated:
Systemic envelope and structural failure
within 10 years

Additional observations:
Deferred maintenance accelerating
deterioration

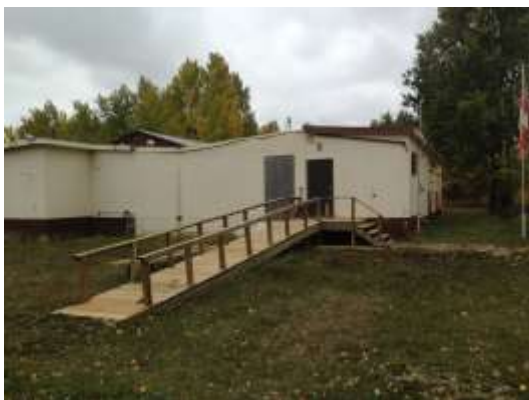
Entrance

Handicapped access: Limited (ramp)

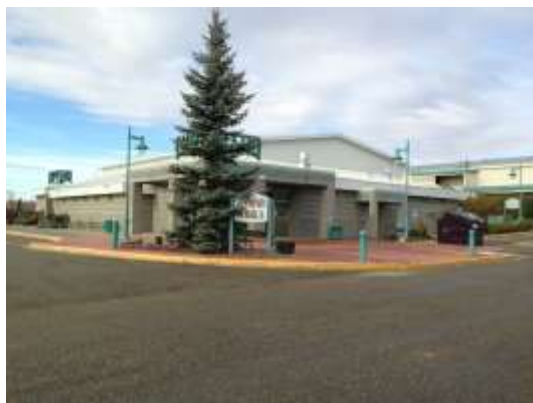
Exterior

Appearance: Aesthetically pleasing. Good.

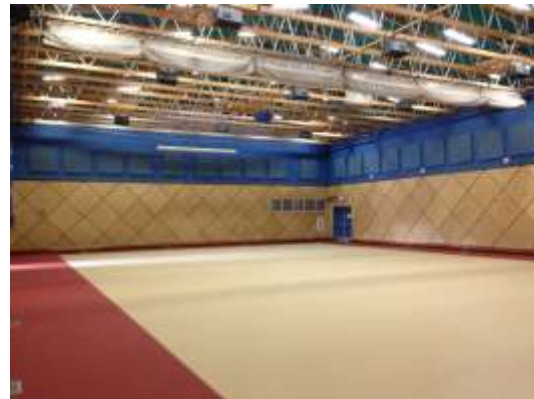
Interior

Interior: OSB panels, new Pulastic floor. Excellent.

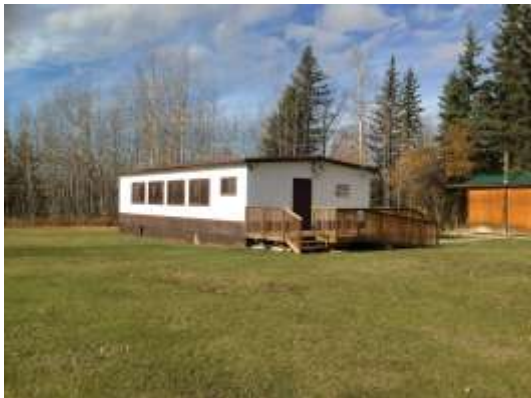
Exterior

Appearance: Fatigued and damaged. Poor.

Capital interventions anticipated: Overall poor condition and eventual replacement may make more sense than repairs.

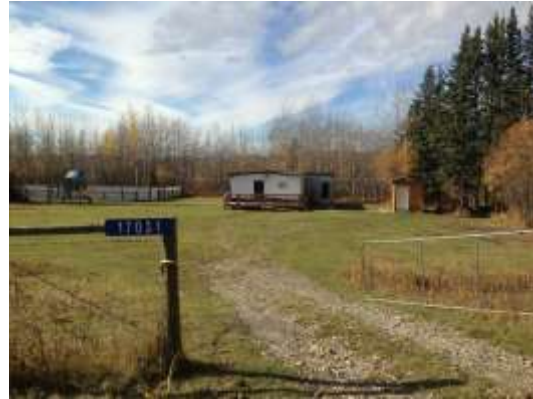
Hall, playground and outdoor rink to left

Site amenities: Damaged play apparatus.
Parking: Gravel. Adequate area.
Site secured: Fenced.
