Asset:

Lake Point Golf and Country Club

Asset:
Taylor Lone Wolf Golf Course

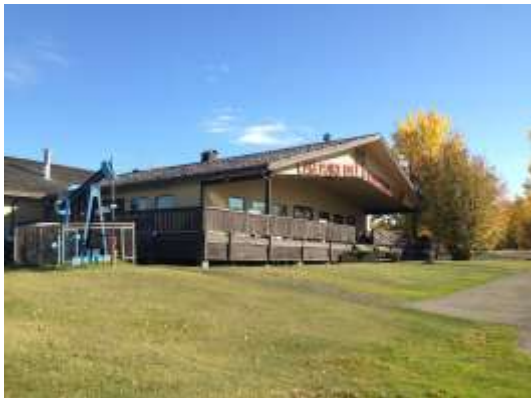
Clubhouse exterior

Roof: Shingle. Good.

Appearance: Well-maintained. Very good.

Capital interventions anticipated: Priority HVAC and electrical, envelope and finishes stage 2.

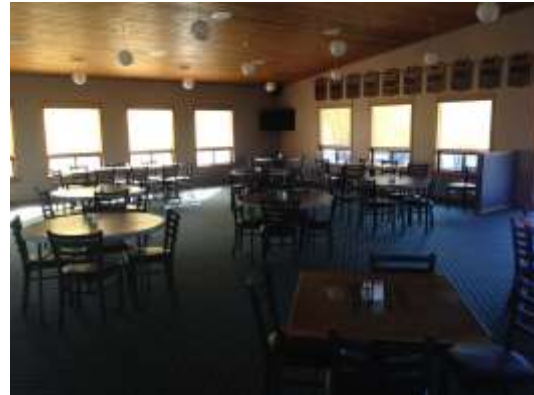
Clubhouse interior

Interior: Wood paneling, carpeting. In need of upgrading.

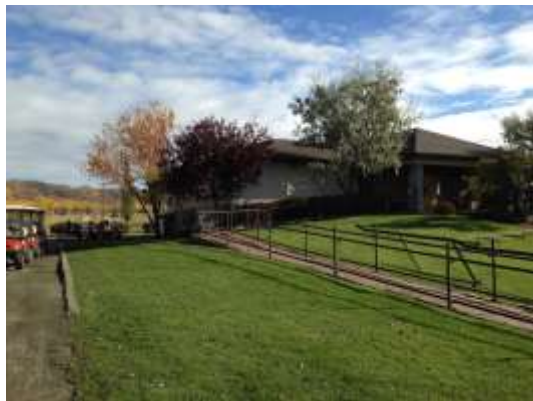
Exterior

Building type: Wood frame.
Foundation: Concrete on grade. Good.
Envelope: Wood, insulated, metal windows. Good.
Roof: Shingled, insulated.
Interior: Wood paneled and drywall.
Carpet tile. Good.

Appearance: Well-maintained. Very good.

Capital interventions anticipated: Envelope and finishes.

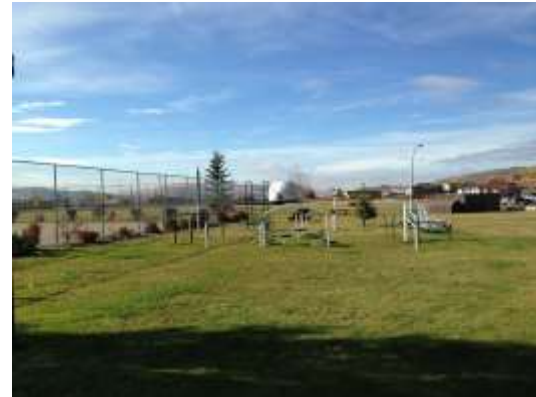
Tennis courts and outdoor fitness on site

Additional observations: District tennis courts, outdoor exercise equipment and participation trail adjacent to clubhouse.
