## ELECTORAL AREA DIRECTORS COMMITTEE MEETING A G E N D A

### ELECTORAL AREA DIRECTORS COMMITTEE MEETING MINUTES

**Facility Condition Assessment Report  
Kelly Lake Community Centre**

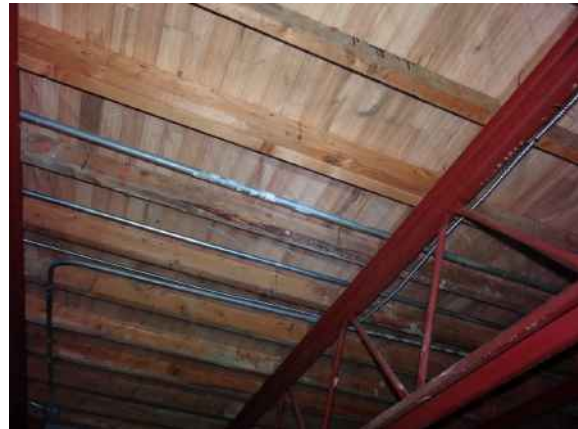
Kelly Lake Community Centre - B1010

Item	Description
Uniformat Code	B1020 - Roof Construction
Installation Year	1977
Condition	1 - Good
Expected Useful Life	75 Years
Remaining Useful Life	33 Years
Quantity / Unit of Measure	665 / SM Footprint
Unit Cost	\$208.07
Difficulty / Regional / Soft Cost Factors	1.00 / 1.00 / 1.00
Element Renewal Cost	\$138,366.55

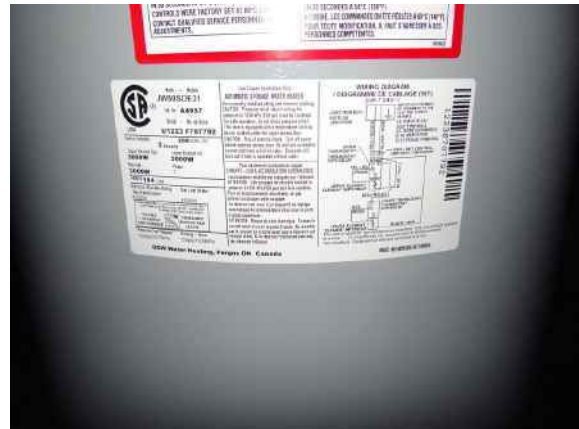
Kelly Lake Community Centre - D202009

Item	Description
Uniformat Code	D202021 - Domestic Water Tank Heaters
Installation Year	1977
Condition	3 - Poor
Expected Useful Life	12 Years
Remaining Useful Life	1 Year
Quantity / Unit of Measure	150 / Liter
Unit Cost	\$45.00
Difficulty / Regional / Soft Cost Factors	0.50 / 1.00 / 1.00
Element Renewal Cost	\$3,375.00

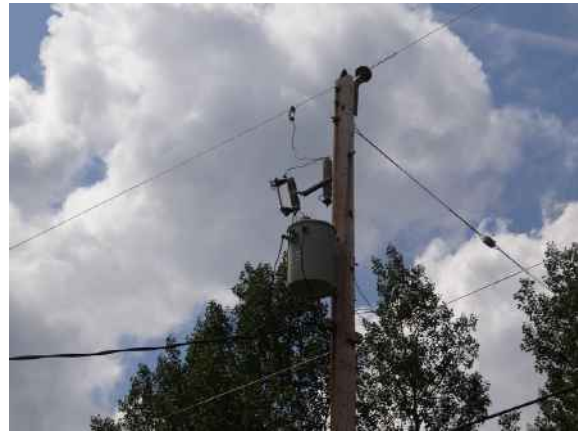
Osborn Hall - D501022

Item	Description
Uniformat Code	D501023 - Electrical Panels
Installation Year	2000
Condition	1 - Good
Expected Useful Life	40 Years
Remaining Useful Life	21 Years
Quantity / Unit of Measure	1 / Each
Unit Cost	\$4,000.00
Difficulty / Regional / Soft Cost Factors	1.00 / 1.00 / 1.00
Element Renewal Cost	\$4,000.00

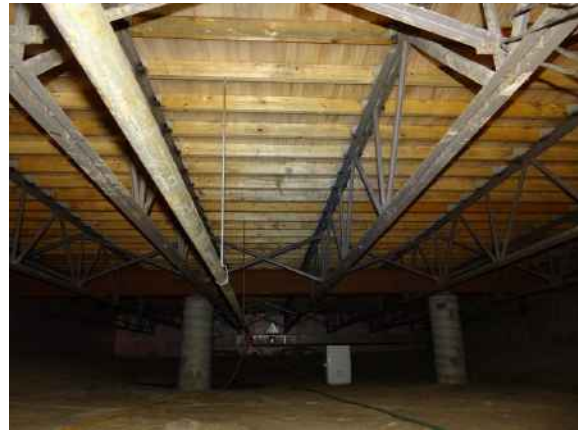
PRRD - Tate Creek Community Centre - B1010

Item	Description
Uniformat Code	B1020 - Roof Construction
Installation Year	2006
Condition	1 - Good
Expected Useful Life	75 Years
Remaining Useful Life	62 Years
Quantity / Unit of Measure	332 / SM Footprint
Unit Cost	\$208.07
Difficulty / Regional / Soft Cost Factors	1.00 / 1.00 / 1.00
Element Renewal Cost	\$69,079.24

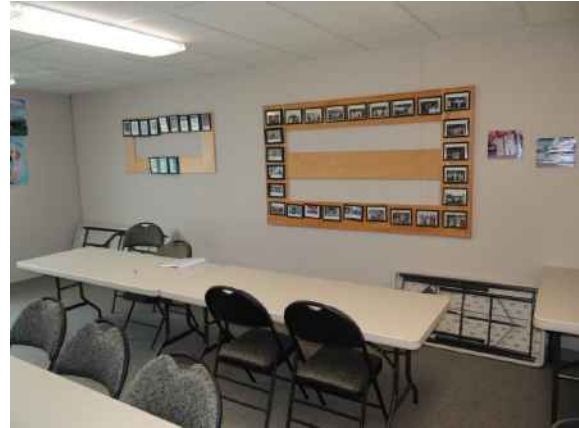
PRRD - Tate Creek Community Centre - C101001

Item	Description
Unifomat Code	C101002 - Demountable Partitions
Installation Year	1975
Condition	1 - Good
Expected Useful Life	30 Years
Remaining Useful Life	6 Years
Quantity / Unit of Measure	522 / SM Building
Unit Cost	\$95.00
Difficulty / Regional / Soft Cost Factors	1.00 / 1.00 / 1.00
Element Renewal Cost	\$49,590.00
