RE: **REMEDIAL OPTIONS REPORT**  
**PEACE RIVER LOOKOUT**

## REMEDIAL OPTIONS REPORT: A SUMMARY OF COMPLETED WORK AND SUGGESTED NEXT STEPS

Project number 060300016

Re: Preliminary Desktop Geotechnical Assessment for Proposed Lookout Upgrade  
Peace River Valley  
Approximately LSD SW 1/4-19-083-18 W6M  
100<sup>th</sup> Street, Fort St. John, BC

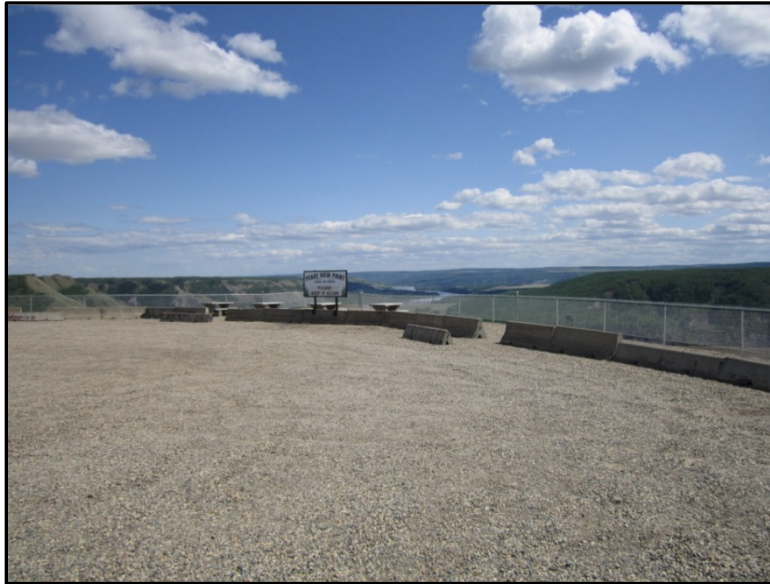
Slide 2.1: The current Peace Valley Lookout

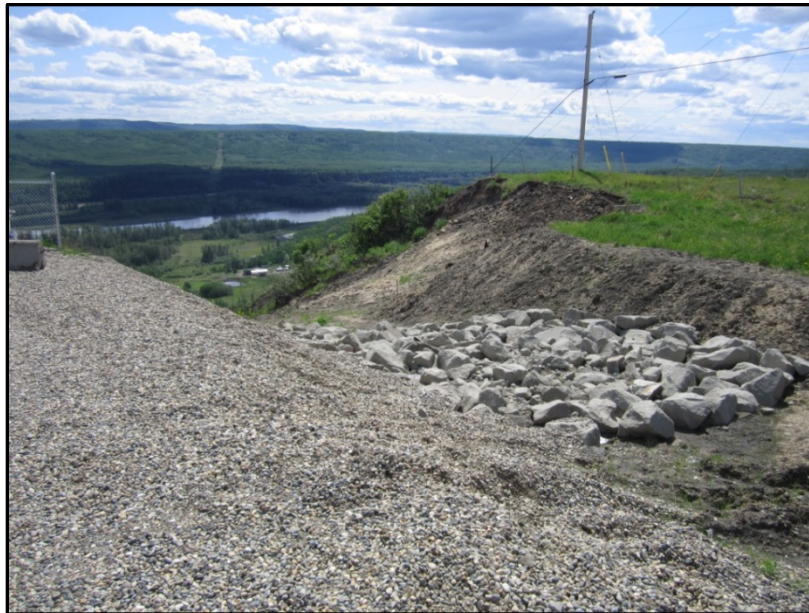
**Slide 2.2a: MOTI has made some improvements to the site such as placing fill and rip rap.**

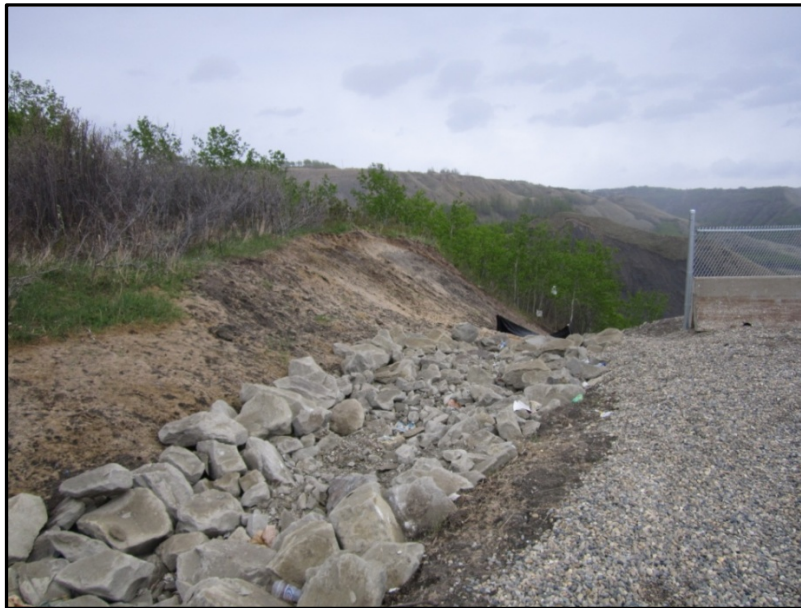
Slide 2.2b: Rip rap installed in the drainage ditch to the left of the viewing area

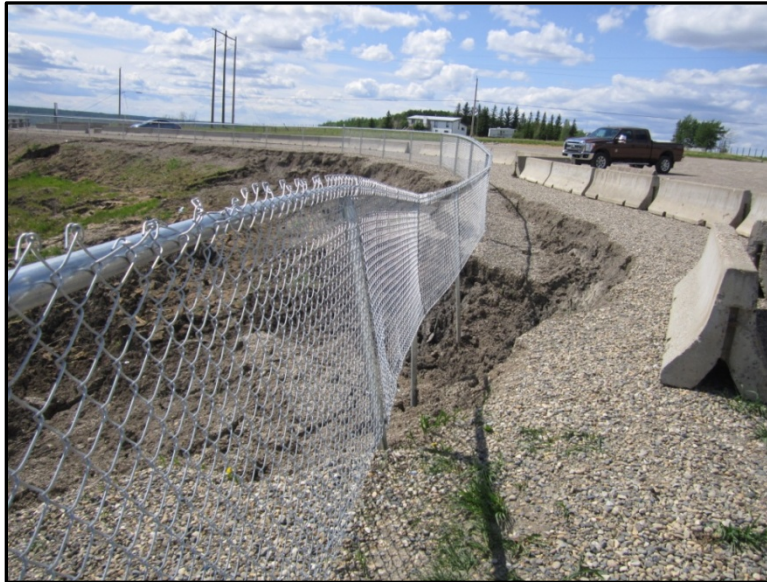
In addition to the soils and groundwater testing that was conducted, two site visits were completed in May of 2012. The site visit conducted on May 18, 2012 noted that there was some erosion along the south-east bank at the existing fence line (Slide 3.1). The May 31<sup>st</sup> follow-up visit noted that this same location had continued to slump. Enough soil movement had occurred that two fence posts were hanging in the air as the bank was no longer there to support them. In that area, the bank looked very unstable, and with more precipitation, the bank will continue to slump, leaving more of the fence unsupported. The fence has since been repaired and moved back into a stable ground area.

**Slide 3.1: Bank erosion had left two fence posts unsupported**

To ensure public safety, it is recommended that the current fence be maintained and signs be installed warning the public of the potential for slides to occur. If additional shallow slides occur, a setback of the fence should be provided to maintain the stability of the fence.

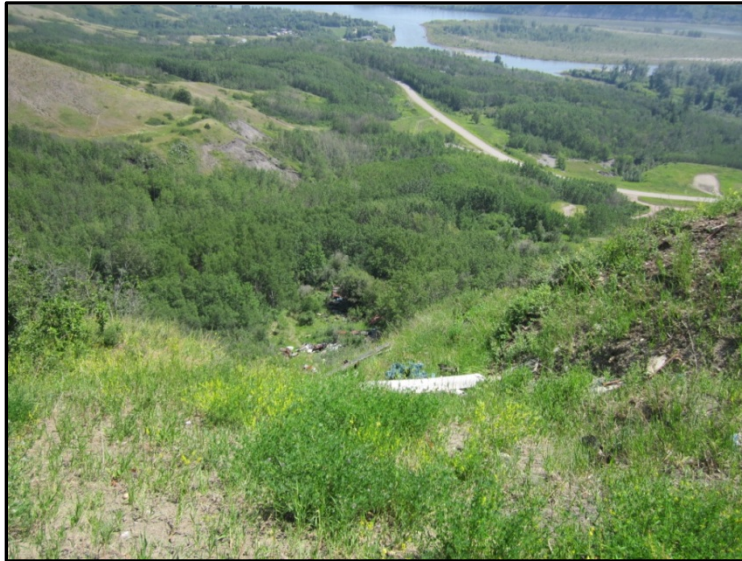
It was also noted during these two site visits that while the visible surface garbage had been cleaned up, there are still some vehicles and appliances at the bottom of the slope, adjacent to the river, although not visible from the top of the lookout (Slide 3.2). This may not be the case in the fall when the leaves are gone, and the sight-lines are opened up.

Slide 3.2: Car hulks and old appliances can be found at the bottom of the slope.

MoTI has removed the vehicles and appliances within visible sight lines. There are still some existing vehicles and appliances at the base of the bank, but they are not visible from behind the fence at the lookout. At this time, it is not deemed essential to remove this surface garbage on account of aesthetics or environmental reasons. (A fence and rip rap have been installed which will likely prevent further dumping

of waste off the lookout as vehicles can no longer access the bank.) It would be at the PRRD discretion as to whether they wish to remove the large items or not. Estimated costs to undertake this optional action can be found in Table 5.1.

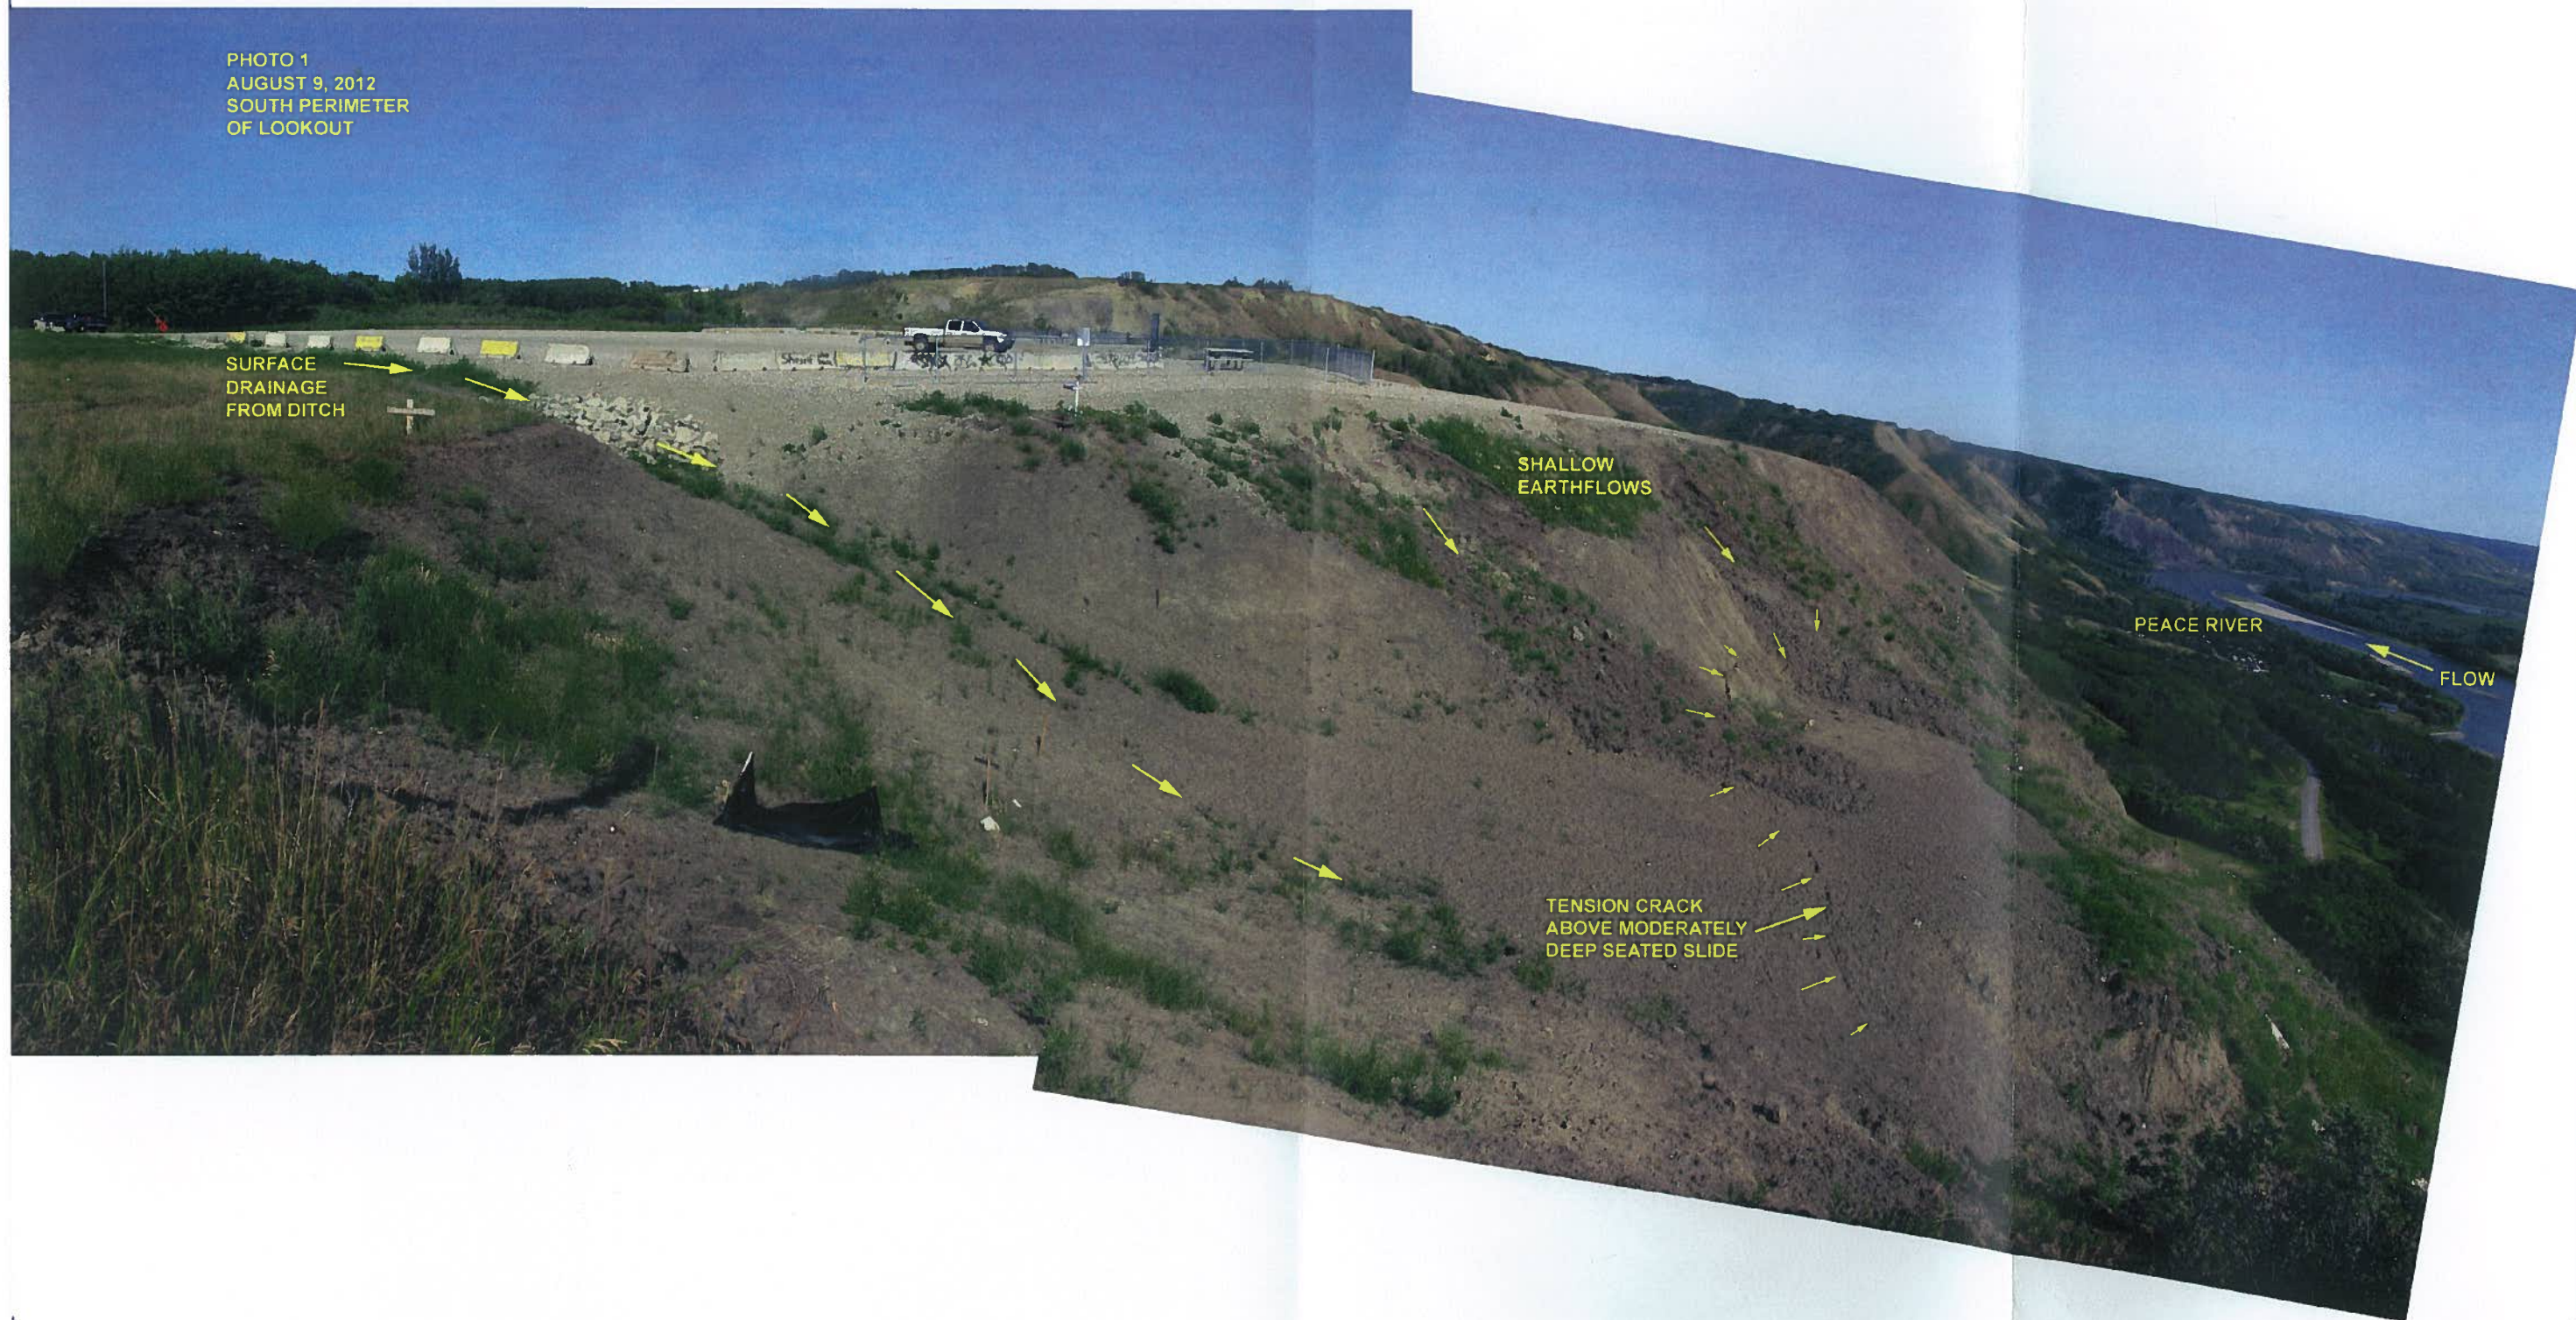
Photograph 1

There is evidence of active shallow to moderately deep sliding and earthflows occurring around the perimeter of the site as shown in Photos 1 to 4. Survey monitoring by Focus appears to indicate that there are small movements occurring around the perimeter of the lookout, although the movements were only in the 1 to 2mm range. Therefore it is considered that while survey monitoring has probably detected the shallower movements, the dataset appears too small to draw definite conclusions, and hence surveying over a longer period of time may be necessary.

PHOTO 1  
AUGUST 9, 2012  
SOUTH PERIMETER  
OF LOOKOUT

In the interests of helping to improve public safety and for “due diligence” purposes, it is recommended that PRRD should continue some form of annual monitoring of the site, and appropriate signage should be posted along the access route and on the existing fences warning the public of the potential for slides at the site. As well, the fences should be maintained and set back as necessary if additional shallow slides occur which threaten to reduce that stability of the fence.

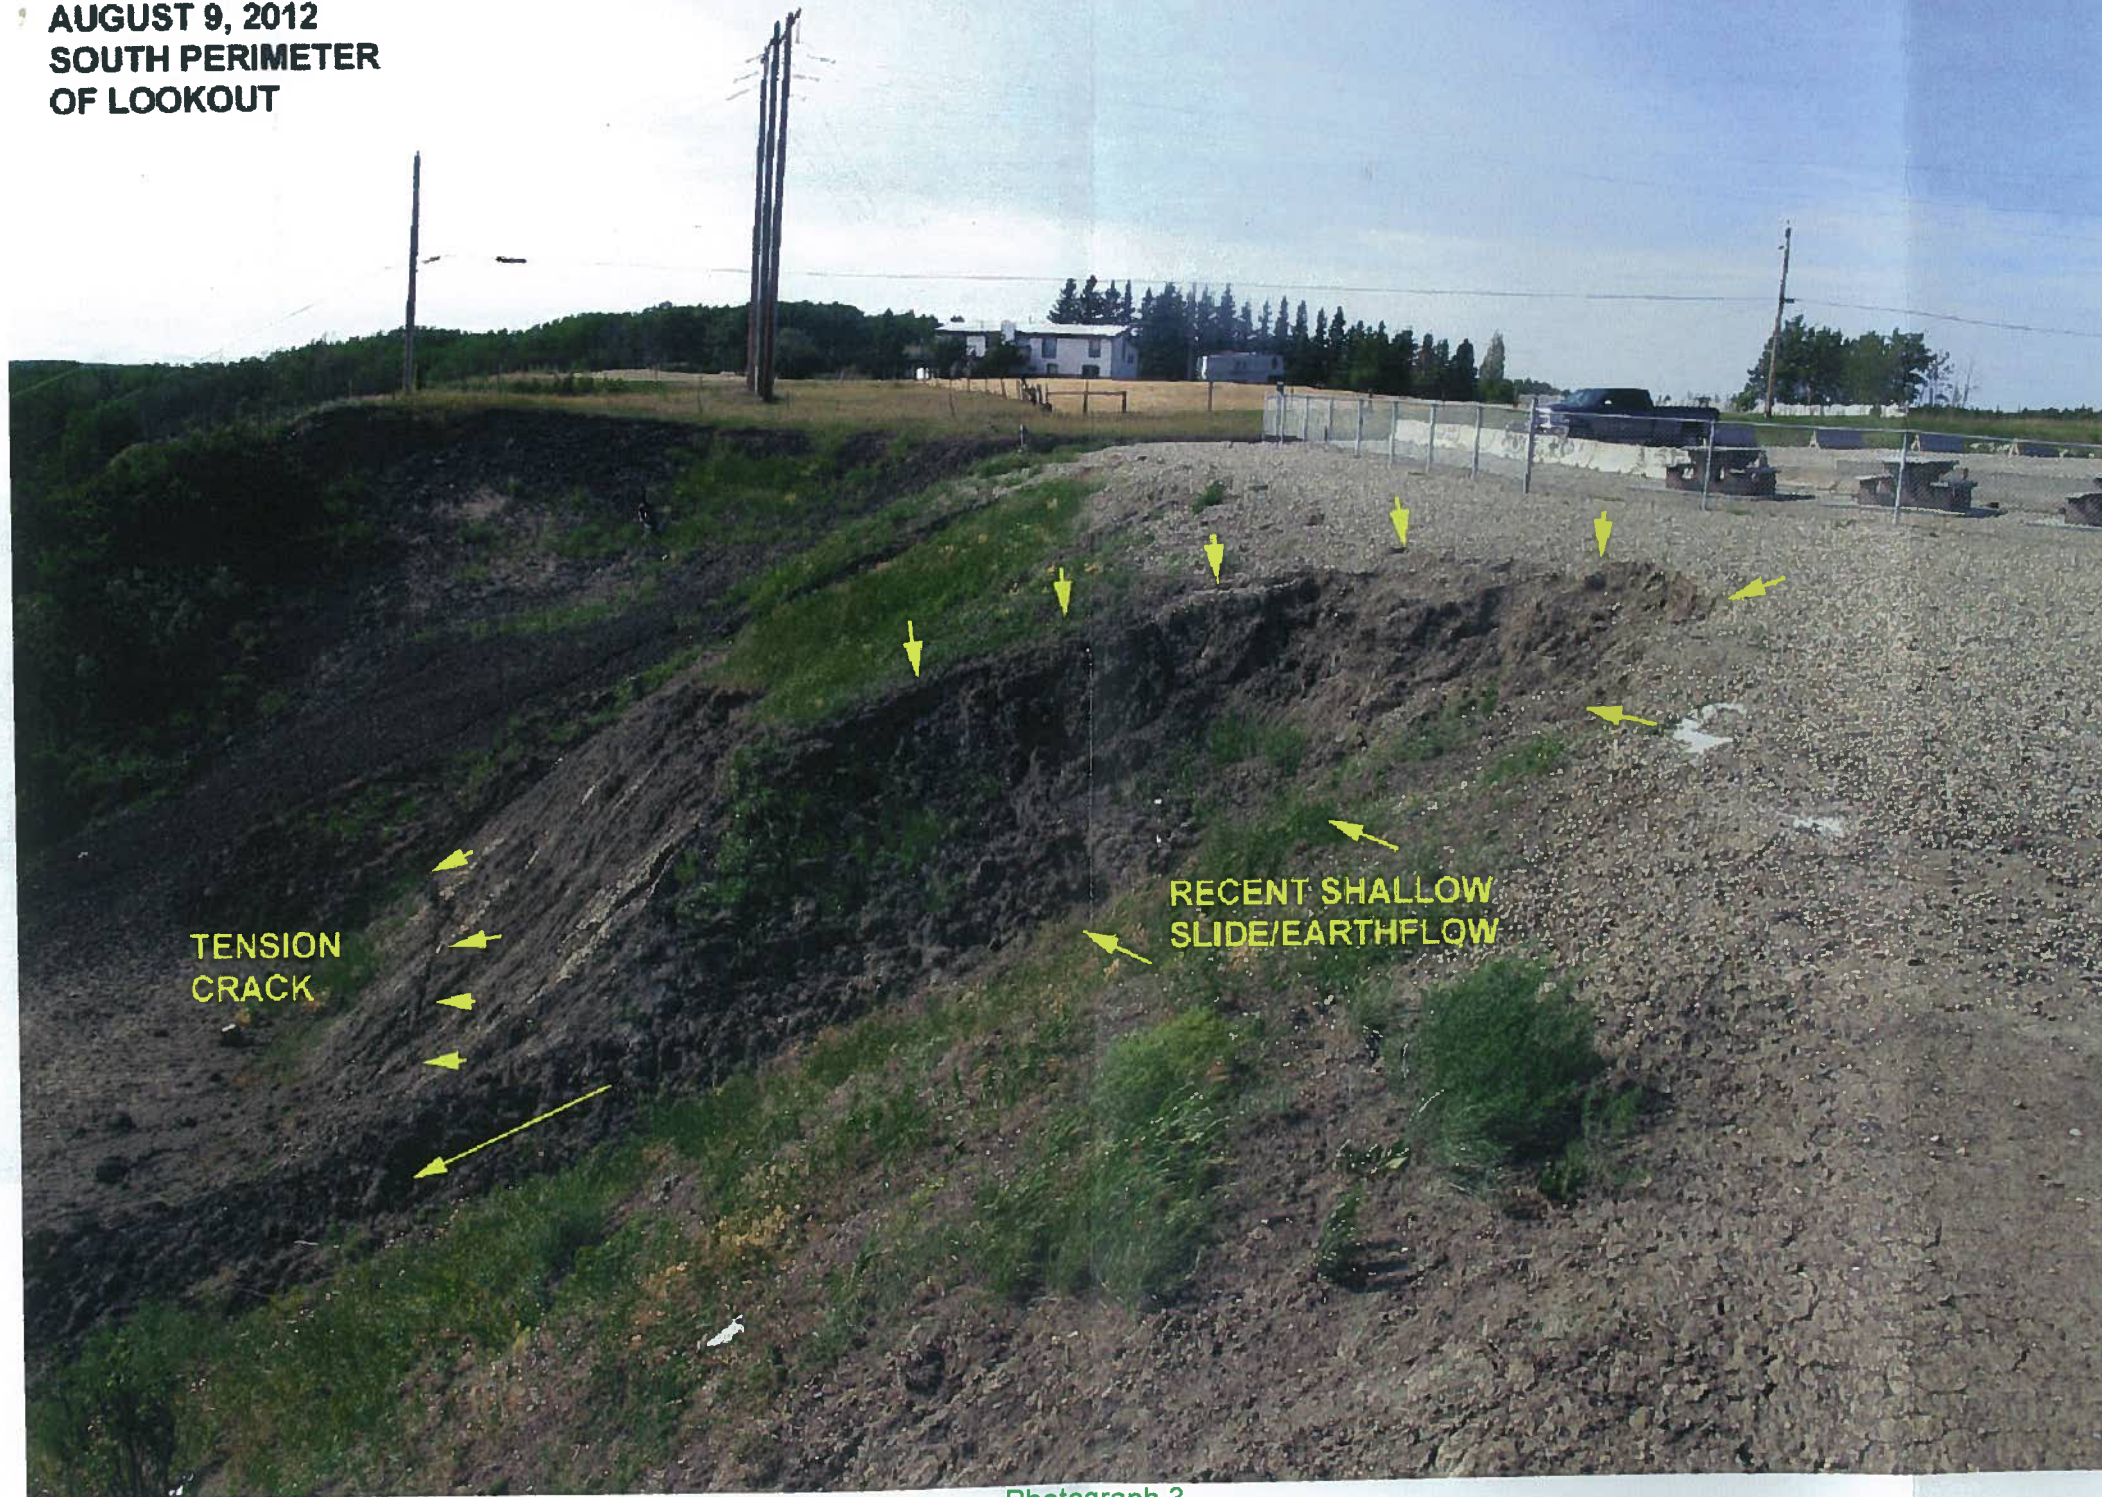
Photograph 3

PHOTO 3  
AUGUST 9, 2012  
SOUTH PERIMETER  
OF LOOKOUT

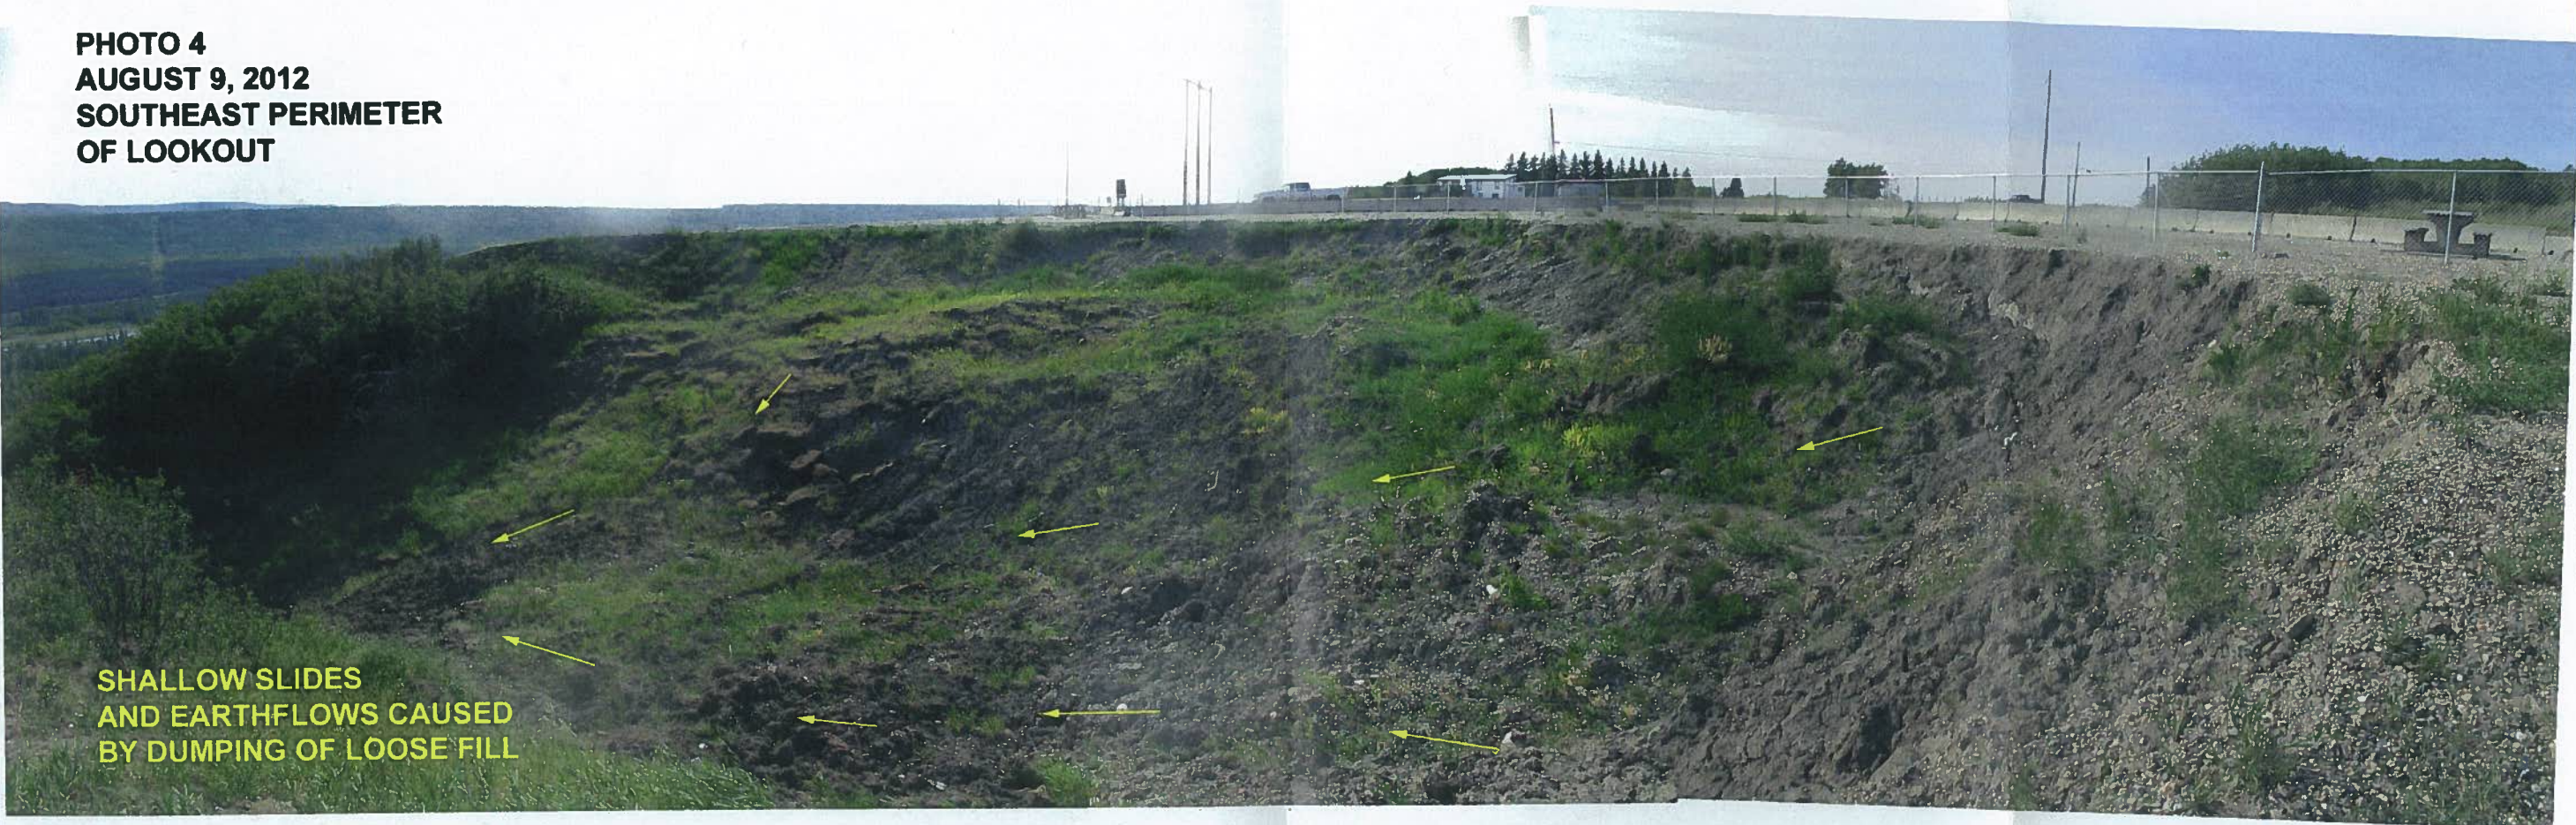
Photograph 4

PHOTO 4  
AUGUST 9, 2012  
SOUTHEAST PERIMETER  
OF LOOKOUT

SHALLOW SLIDES  
AND EARTHFLAWS CAUSED  
BY DUMPING OF LOOSE FILL
