**Alwin Holland Elementary School
(Fort St. John)**

**Bert Ambrose Elementary School
(Fort St. John)**

Bert Bowes Junior Secondary School (Fort St. John)

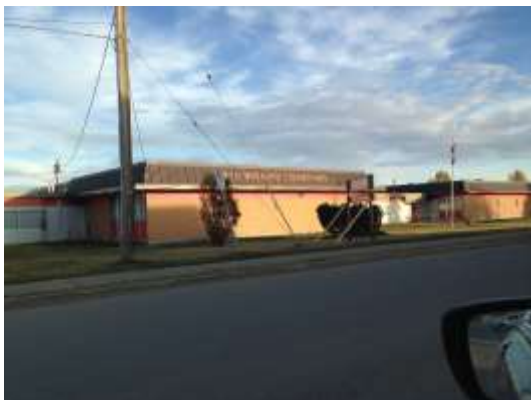
Exterior

Building type: Concrete block and wood.
Foundation: Concrete on crawlspace. Fair.
Envelope: Masonry and shingles
Roof: Built-up, membrane; gluelam. Good.
Interior: Painted CMU, wood ceiling, hardwood flooring.

Appearance: Aging and worn. Fair.
Site amenities: Playground, sports fields.
Parking: Paved and gravel.

Capital interventions: Lifecycle.

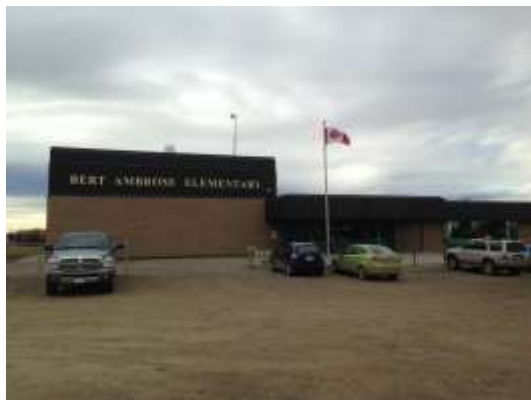
Exterior

Building type: Concrete block and wood.
Foundation: Concrete on crawlspace. Fair.
Envelope: Masonry and metal fascia.
Roof: Built-up, membrane; gluelam. Good.

Appearance: Aging and worn. Good.

Capital interventions: Lifecycle.

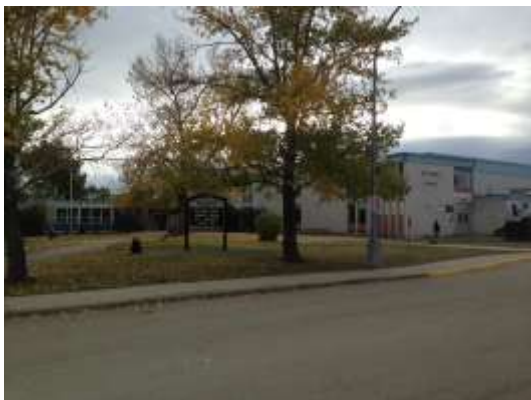
Exterior

Envelope: Masonry. Fair to good.

Appearance: Fatigued appearance. Good.

Capital interventions: Continued lifecycle including eventual structural.

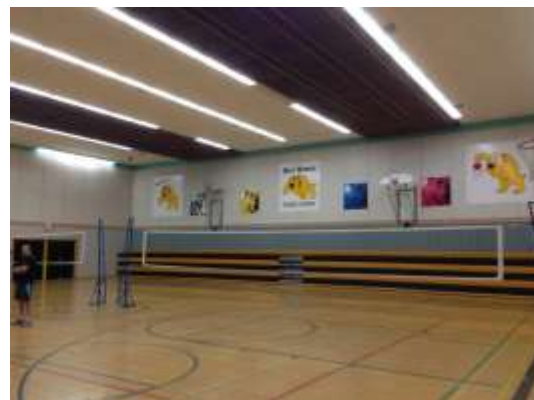
Interior gymnasium

Interior: Plywood wall panels, wood beams, hardwood flooring.

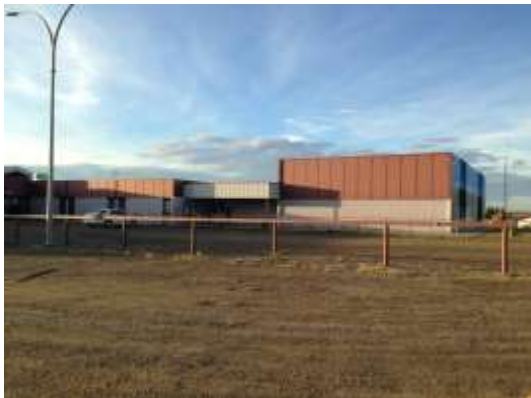
Exterior

Building type: Concrete block, metal roof
Foundation: Concrete slab on grade. Good.
Envelope: Masonry to 8', metal fascia
Roof: OWSJ, t-bar ceiling in gym. Good.

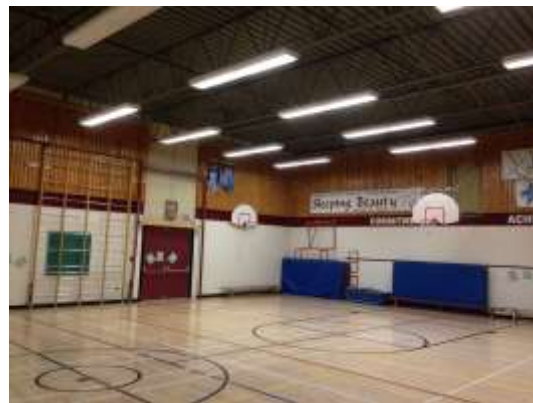
Interior gymnasium

Interior: Plywood, acoustic panels, hardwood flooring. No curtain. Very good.
Mechanical: Gas forced air. Very good.

Mechanical lifecycle probable.

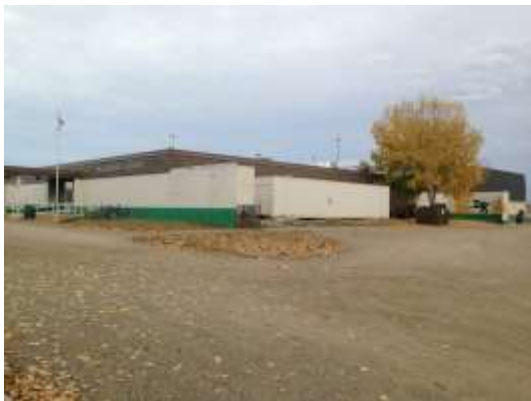
Exterior

Foundation: Concrete on grade.

Appearance: Worn but maintained. Fair.

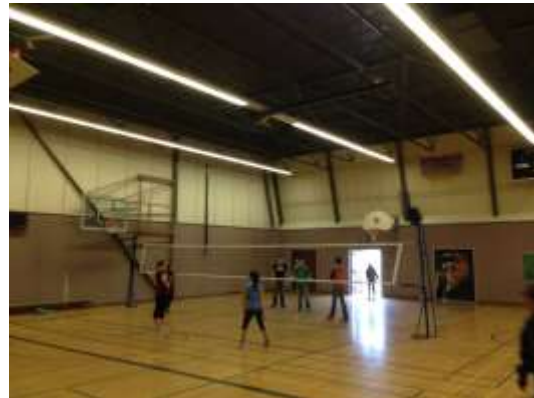
Interior gymnasium

Interior: Painted CMU, hardwood flooring.

Additional observations: Clear ceiling height low (for volleyball).

Capital interventions anticipated: HVAC in next decade.

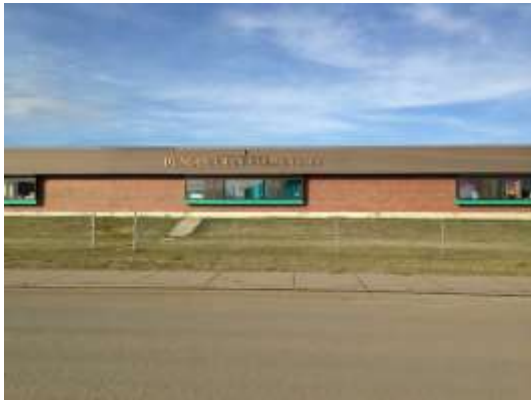
Exterior

Building type: Concrete, masonry, metal roof
Foundation: Concrete slab on grade. Good.
Envelope: Masonry to 8', metal fascia
Roof: OWSJ, t-bar ceiling in gym. Good.
Interior: Plywood, acoustic panels, synthetic sport flooring. No curtain. Good.
Mechanical: Gas forced air. Good.

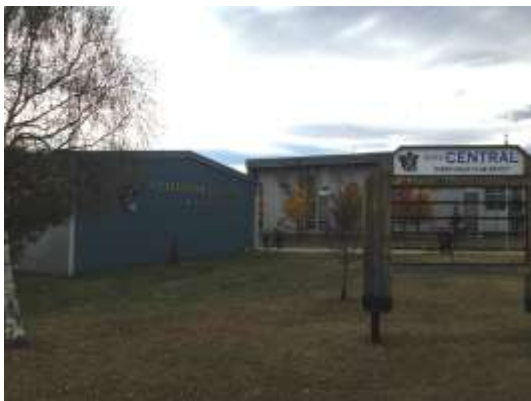
Exterior

Envelope: Insulated masonry. Fair.

Appearance: Worn, but maintained. Good.

Capital interventions anticipated: No capital will be put into this school as the priority now is to replace it entirely.

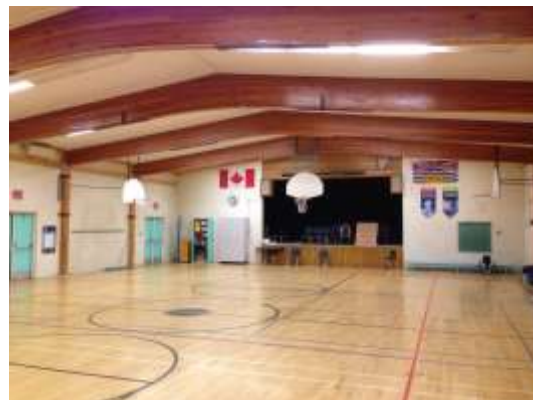
Interior gymnasium

Description: Small, low-ceiling gym with stage and dance mirrors on one wall. Basement room used for after school programs, art classes, etc. K-5 bilingual school with 390 students (20% over rated capacity).

Interior: Plywood, hardwood floor. Good.

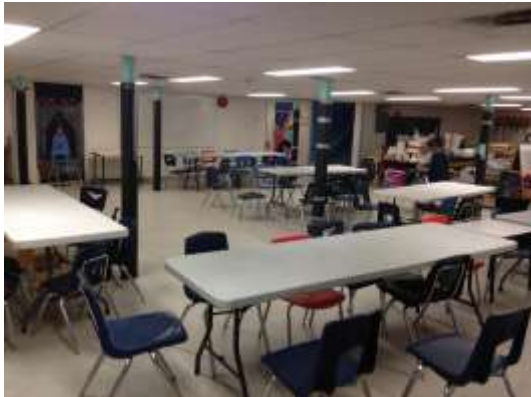
Interior basement community room

Foundation: Concrete, gym on crawlspace. Fair.

Mechanical: Obsolete but functional. Fair.

Washrooms: Inadequate for spectator load based on current codes. Poor.

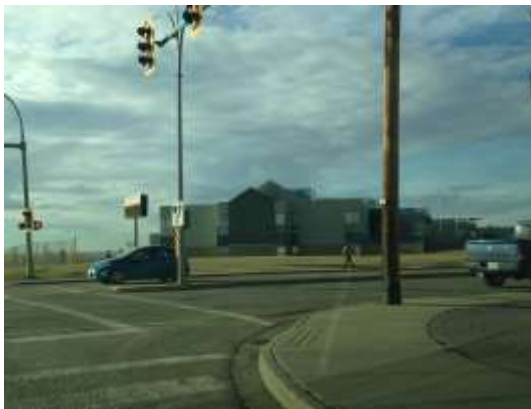
Exterior

Description: Large, high-ceiling regulation high school-sized gymnasiums. Main gym with retractable seating allows for two perpendicular volleyball courts. Second gym built through community partnership in year 2000. School is grades 9-12 with 1090 students (10% over capacity). Sports fields with gravel 400-metre track.

Foundation: Concrete on grade.

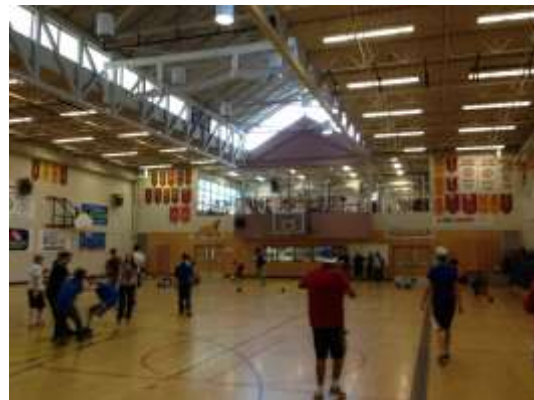
Interior main gymnasium

Interior: Painted masonry, hardwood flooring, motorized curtain in main gym.

Major mechanical upgrade within 10 years. Cosmetic work on-going. Roof at half-life.

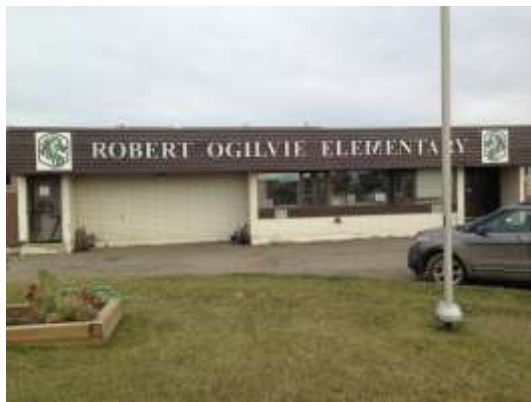
Exterior

Appearance: Aging but maintained. Fair.
Parking: Gravel. Site secured: Fenced.

Capital interventions: Lifecycle.

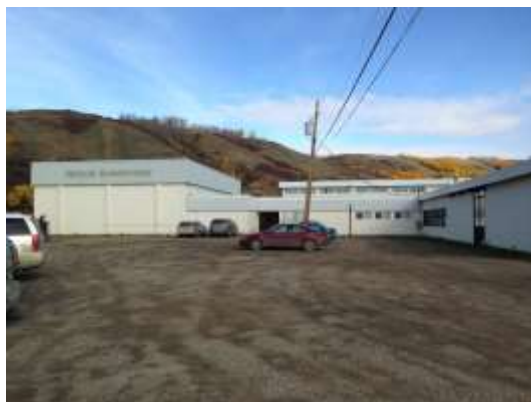
Exterior

Foundation: Concrete on crawlspace.
Envelope: Insulated concrete block.
Roof: Wood beams, wood deck, b/u roof.
Interior: painted CMU and plywood.
Mechanical: Gas forced air. Electrical reaching capacity. Fair.

Appearance: Fatigued but maintained.
Site amenities: Playground, field.
Parking: Gravel.
Site secured: Partial fenced.

Capital interventions anticipated: mechanical and building envelope.
