Asset:

College Park Ball Diamonds (Fort St. John)

Location: Fort St. John (next to UNBC / Northern Lights College)

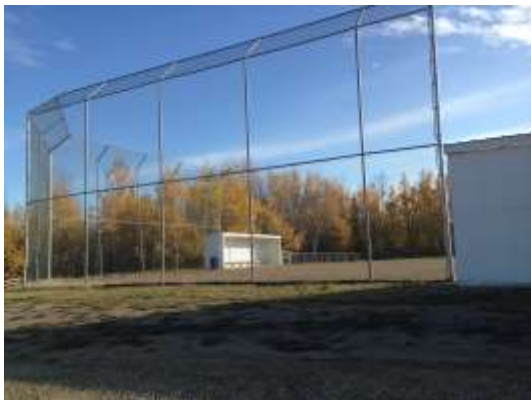
Typical diamond

Site structures: Chain-link backstops, plywood and frame dugout shelters on concrete pads. Metal/wood bleachers (currently removed).

Dugout structures will need to be replaced in 5-10 years. Maintain positive surface drainage from gravel infields to prevent water damage – up to 70% of the game occurs on the dirt.

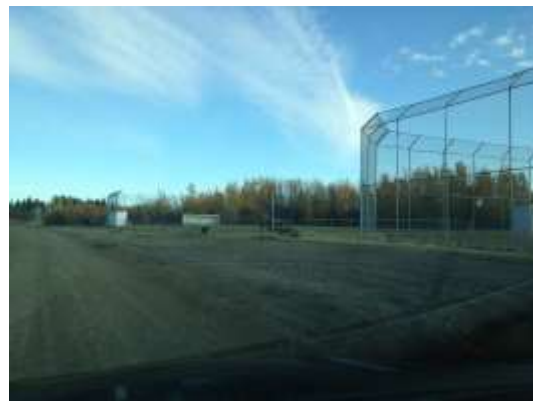
Parking: Gravel. Adequate supply.

Typical diamond and parking

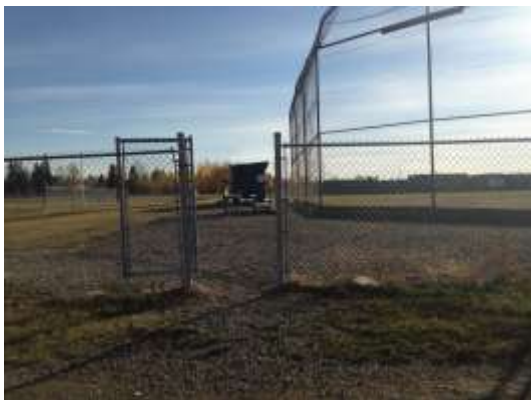
Ball diamond view

Site structures: Concrete block with wood roof field house (washrooms and food concession). Chain-link backstops, plywood and frame dugout shelters on concrete pads. Perimeter chain or wood fencing around each diamond.

Appearance: Aging but not neglected. Good.

Capital interventions anticipated: Dugout structures will need to be replaced in 5-10 years. Maintain positive surface drainage from gravel infields to prevent water damage.

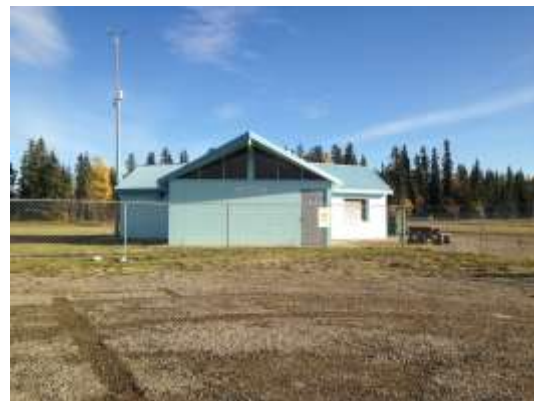
Fieldhouse view

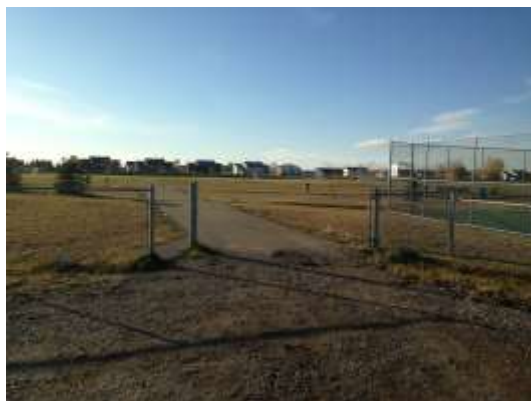
Soccer pitches

Soccer fields should ideally be oriented north-south, recognizing the site was too narrow to do so. Tennis courts appear to be in good condition. Annual field maintenance required.

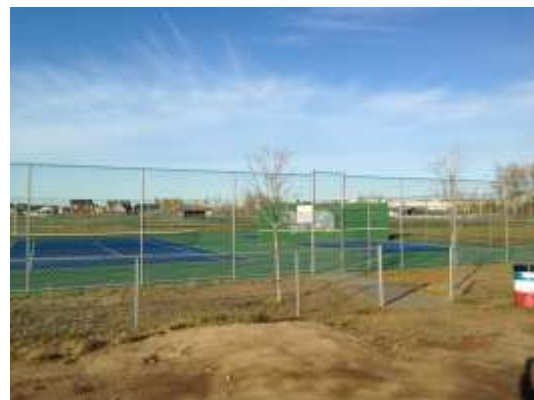
Tennis courts

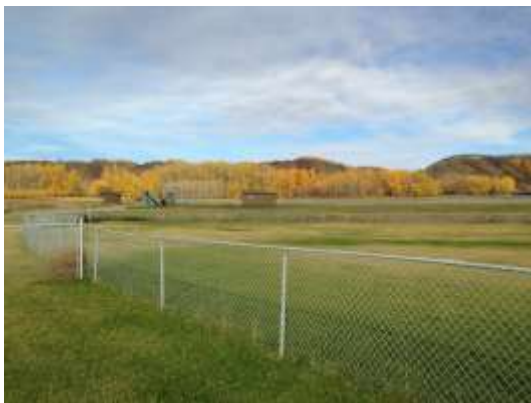
Ball diamonds view

Appearance: Overall site well maintained. Very good overall.

Dugout structures will need to be replaced in 10-15 years. Maintain positive surface drainage from gravel infields to prevent water damage.

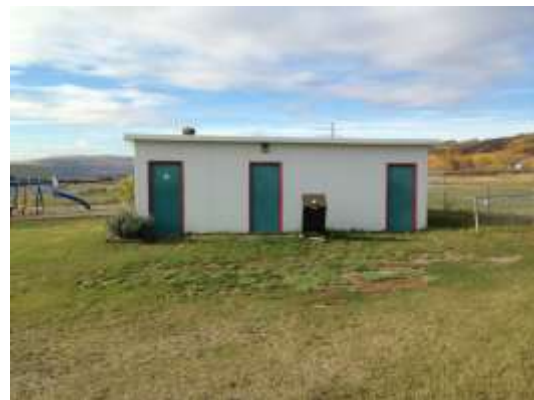
Washrooms fieldhouse
