Asset:

## North Peace Leisure Centre

**Rating: 5.0** (scale of 1-10)

**Rotary Spray Park (Centennial Park)**

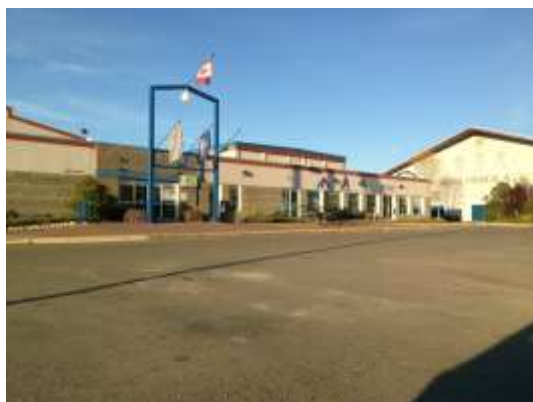
*Exterior*

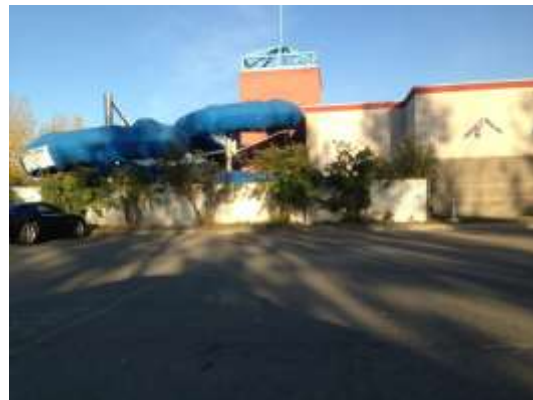
*Exterior with waterslide jackets*

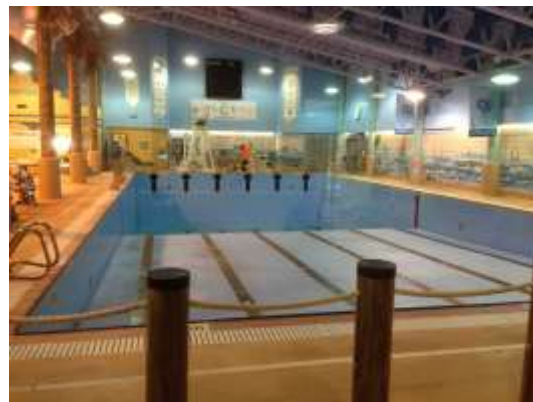
Description: Aquatic facility includes a 6-lane, 25-metre program tank (FINA non-conforming as tank is 11.6m wide and should be 15.4m - technically only 5 lanes wide). The facility also includes springboards, leisure water with wave generator (too short to function effectively), waterslide, steam room and sauna, men's and women's locker rooms, family change rooms, office space and a meeting room. The facility has been plagued with technical problems during its entire 17 year life.

*Program tank (11.6m x 25m)*

Foundation: Concrete slab on grade, concrete tanks below grade (leakage issues). Poor.

Capital interventions anticipated: Premature replacement for this problematic pool inevitable within 15 years. Capital should be directed for replacement and only minimal amounts to extend service life of existing pool.

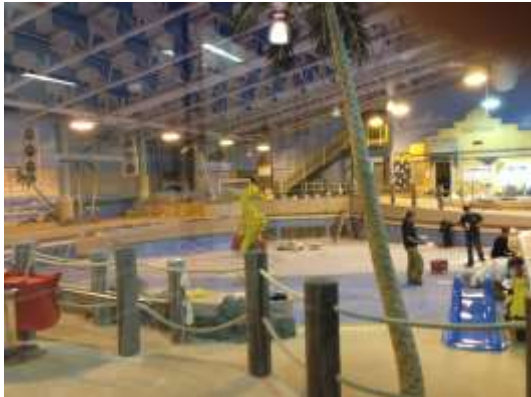
*Leisure tank*

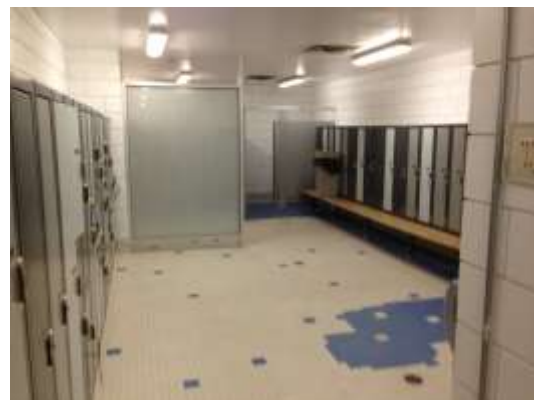
Locker rooms: Upgraded in 2010. Showers still inadequate. Very good. Washrooms: Public washrooms at entry (3 stalls per gender). Very good.

*Locker Room*

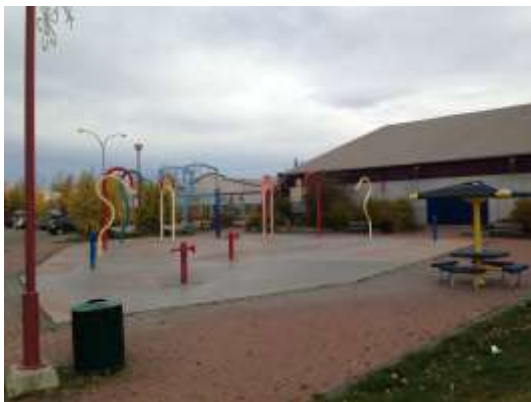
Description: Spray toys on zero-beach basin, picnic seating adjacent. No washrooms or change rooms in close proximity.

*Spray park*

Harsh winters will prematurely deteriorate equipment and slab, but no major issues observed. Convenience washroom(s) or change cabanas should be considered, but not essential.
