## Halfway Graham Rodeo Grounds

## North Peace Fall Fairgrounds

## North Peace Light Horse Gymkhana

## Wonowon Horse Club Gymkhana / Rodeo Grounds

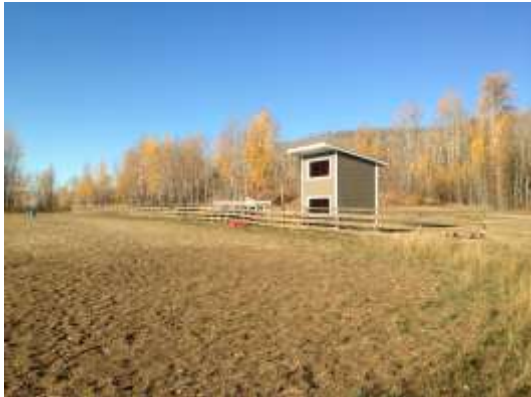
Description: Rodeo grounds consists of fenced arena, dilapidated bleachers and officials booth and open space for animal holding and spectator movement.

*Rodeo grounds*

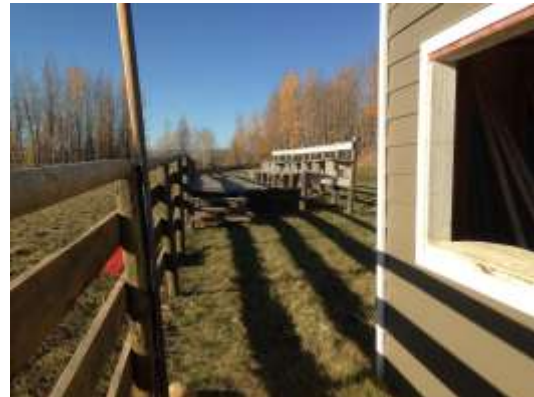
*Spectator area*

Building type: Wood-frame shed.  
Foundation: Wood on concrete pads.  
Poor.

Envelope: Un-insulated plywood. Poor.  
Roof: Plywood. Poor.  
Mechanical: None  
Kitchen: n/a  
Washrooms: Outhouses

Appearance: In disrepair. Poor.  
Site amenities: Hall across road.

Capital interventions anticipated:  
Replace bleachers.

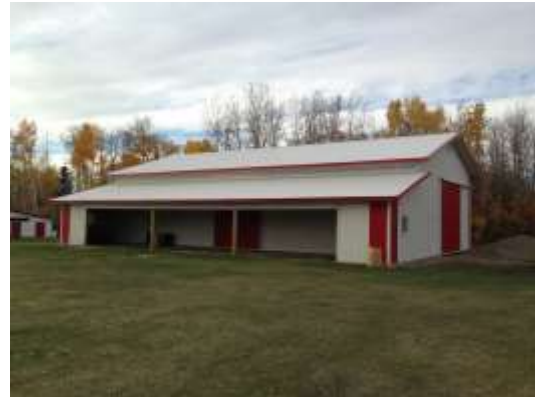
New barn structure

Year renovated/expanded: Buildings added incrementally each decade. Newest structure (pictured above) completed in 2014.

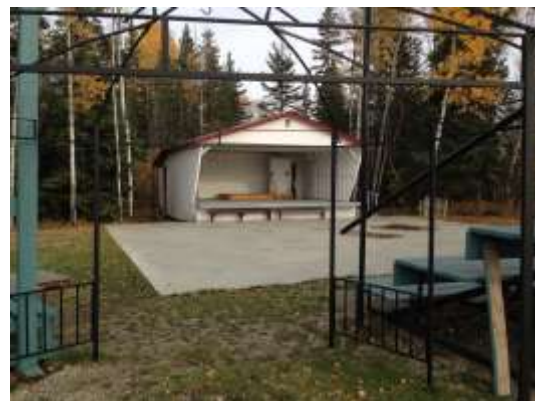
Outdoor stage and seating bleachers

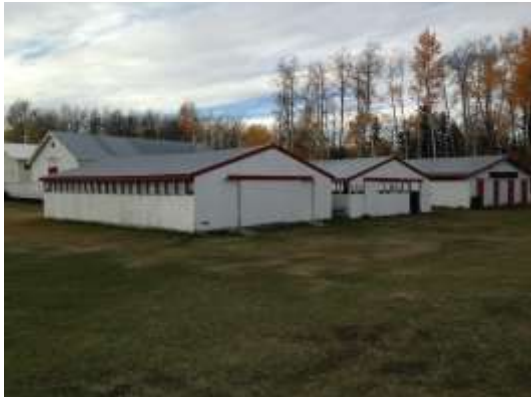
*Typical buildings*

Foundation: Post on pads. Fair.

Envelope: Wood, uninsulated. Fair.

Roof: Wood, uninsulated. Poor.

Interior: Unfinished. Poor.

Eventual systematic and incremental replacement of failed barns, booths and sheds. Electrical required, but no plumbing.

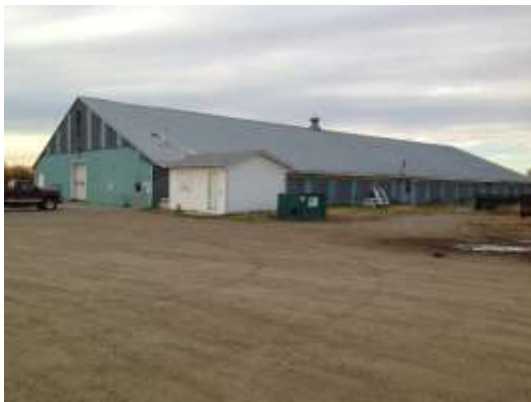
*Exterior*

Building type: Metal cladding on wood frame. Poor.

Envelope: Metal clad, no insulation.

Roof: Leaking, very bad condition. Poor.

Capital interventions anticipated: All buildings in need of repairs.

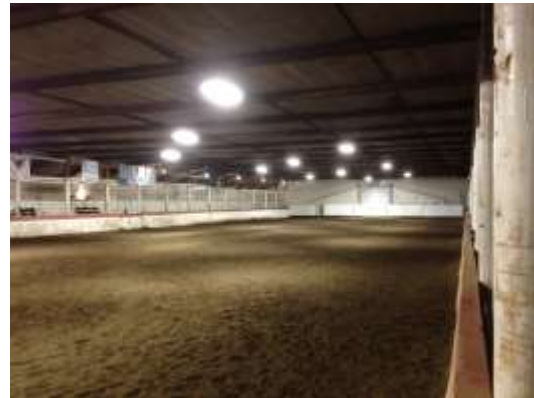
*Interior*

Interior: Barns need new flooring. Poor.

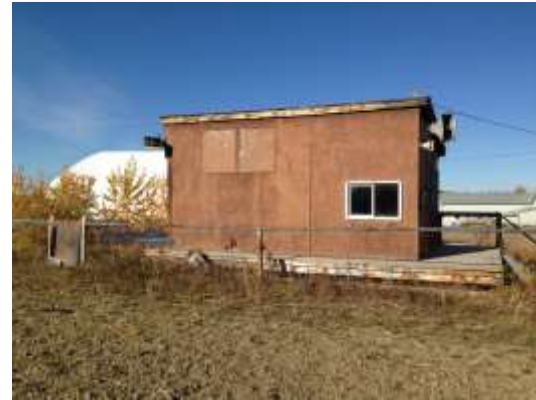
Official's building

Building type: Wood, wood and metal.

Foundation: Wood on concrete pads.

Poor.

Envelope: Uninsulated. Poor.

Roof: Shingled. Poor.
