Asset:
**Baldonnel Elementary School
(Rural)**

**Buick Creek Elementary School
(Rural)**

Asset:
**Charlie Lake Elementary School
(Rural)**

Clearview Elementary – Junior Secondary School (Rural)

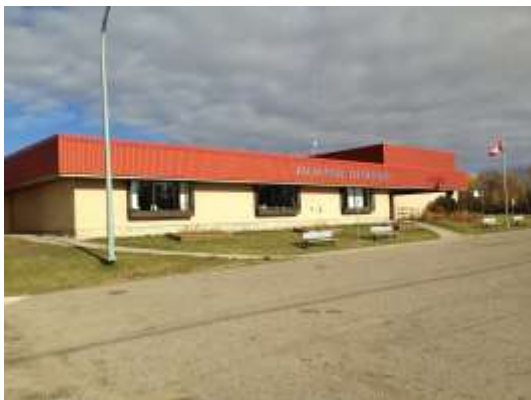
Exterior

Building type: Concrete block, metal roof
Foundation: Concrete slab on grade. Good.
Envelope: Masonry to 8', metal fascia
Roof: OWSJ, t-bar ceiling in gym. Good.
Interior: Plywood, acoustic panels, synthetic sport flooring. No curtain. Very good.
Mechanical: Gas forced air. Very good.

Appearance: Well maintained. Excellent.

Capital interventions anticipated: None.

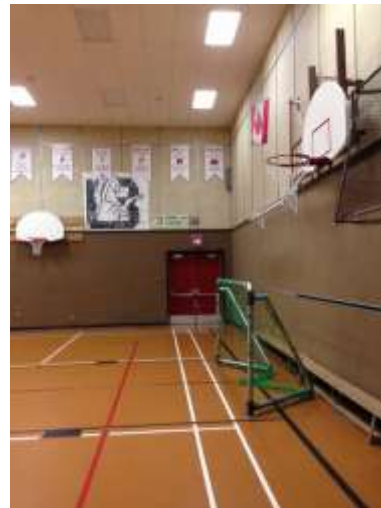
Gym interior

Utilization: Gym used by community 1-2 nights per week. Standard elementary school gym too small for basketball.

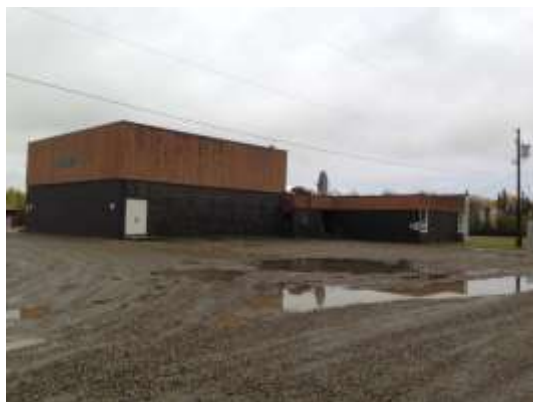
Exterior

Building type: Combination of portable classrooms and fixed gymnasium component.

Foundation: Gym slab-on-grade. Good.

Envelope: Gym CMU to 8-feet, metal above. Classrooms pre-manufactured.

Roof: Open-web steel joists OWSJ, metal deck. Good.

Appearance: deferred maintenance. Fair.

Capital interventions anticipated:
Envelope and mechanical within 10 years.

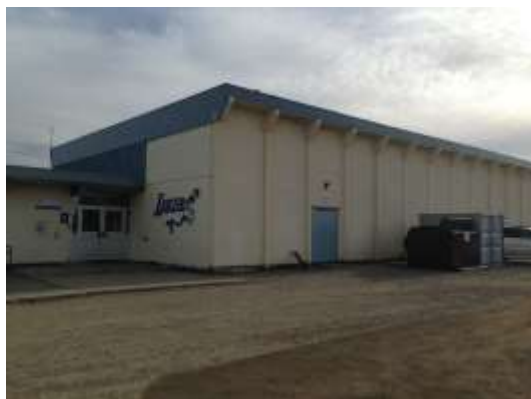
Exterior

Year built: Estimated 1970's
Year renovated/expanded: 1990's; \$1 million in repairs recently for structural, roof and mechanical problems.

Building type: Concrete
Foundation: On crawlspace.
Envelope: CMU and wood. Fair.
Roof: Glulam beam on wood deck, membrane. Fair.
Interior: Fabric on plywood to 8-feet, hardwood floor. Good.

Appearance: Worn and aging. Poor.
Site amenities: Playground funded by PRRD. Community hall across road.
Parking: Gravel.
Site secured: Partial fenced.

Capital interventions anticipated: Slated for replacement subject to funding.

Additional observations: School is one of two identified (Central Elem. the other) in SD60 development plan to be replaced within 10 years funding permitting.

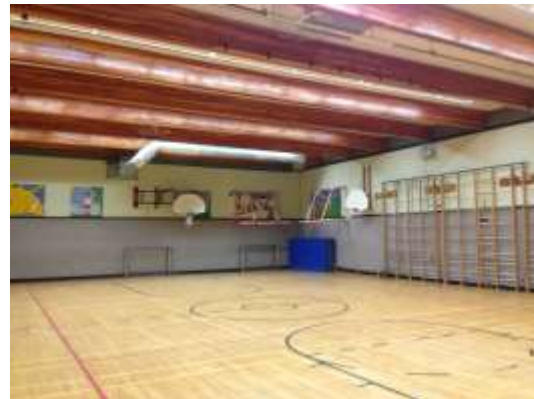
Gym interior

Utilization: Community use of gym everyday. Excellent.
Functionality: Adaptable. Very good.
Occupant load: Nominally, up to 300.

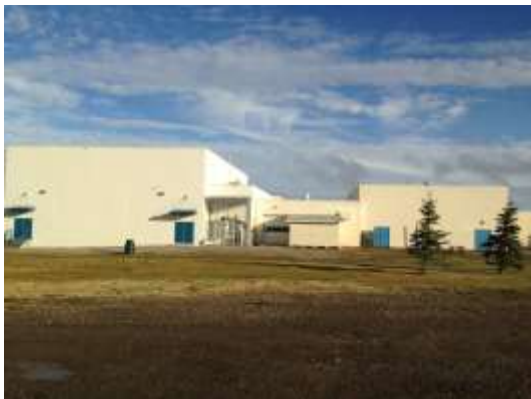
Exterior

Year built: School and old gym 1990's.

Building type: CMU walls, metal roof.

Envelope: Concrete block, metal.

Roof: Built-up (membrane).

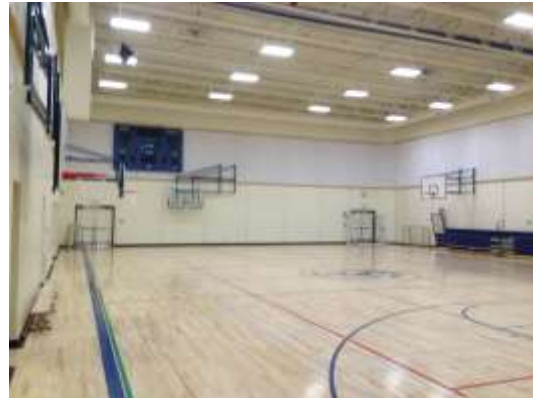
New gymnasium

Functionality: New gym built to middle school standards (larger, taller, better equipped). Versatile. Rated excellent.

Occupant load: Up to 450 in new gym plus 200 in old. Very good.

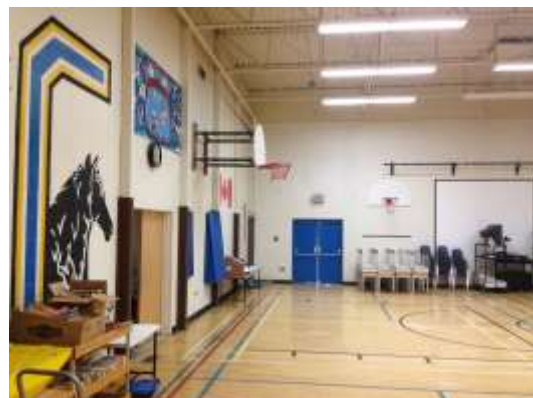
Old gymnasium

Interior: Plywood panels to 8-feet, acoustic panel above, hardwood floor, motorized curtain divider.

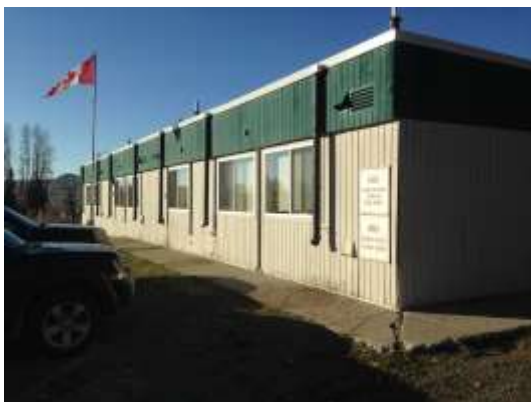
Exterior

Building type: Pre-manufactured portables. Good.

Foundation: Post-on-pad, crawlspace. Fair

Envelope: Pre-engineered sandwich panels. Good, but shorter building life.

Roof: Same. Good.

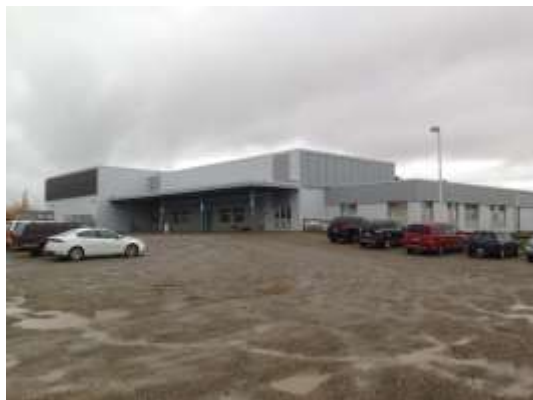
Exterior

Building type: Concrete, CMU infill, metal roof. Very good.

Foundation: Concrete, on crawlspace.

Envelope: Insulated concrete block, OWSJ trusses and metal roof deck.

Roof: Built-up, membrane. Good.

Capital interventions anticipated:
Lifecycle including roof, some mechanical.

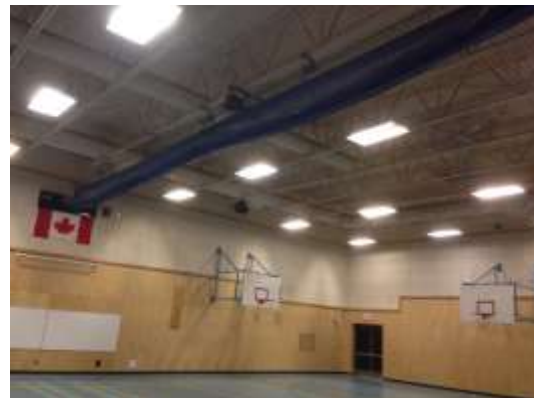
Interior gymnasium

Functionality: Adaptable. Motorized curtain subdivides the gym.

Interior: Plywood to 8-feet. Synthetic sport floor (good for all sports except basketball).

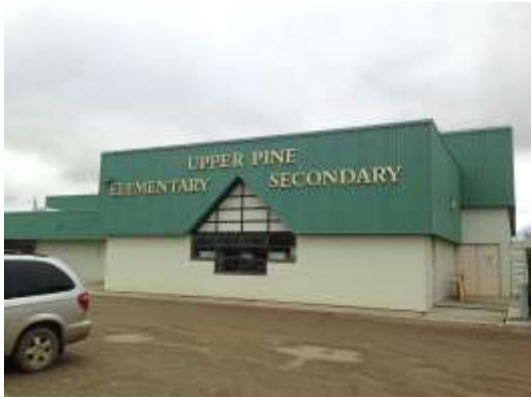
Exterior

Building type: Masonry and metal. Good.
Foundation: Concrete slab-on-grade. Good.

Envelope: Masonry, stucco, metal fascia. Good.

Roof: Built-up (membrane).

Capital interventions anticipated: Only cosmetic for next decade.

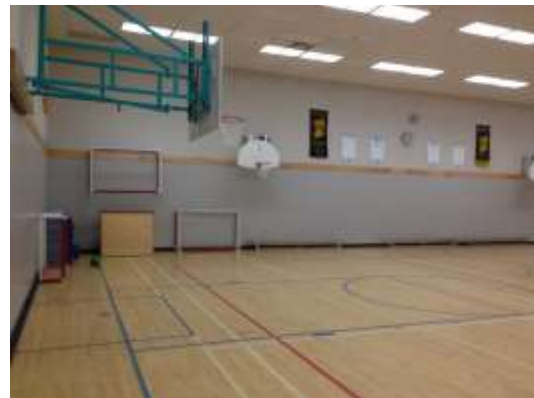
Interior gymnasium

Functionality: Adaptable. Very good.

Interior: Plywood paneling, hardwood floor, t-bar ceiling.

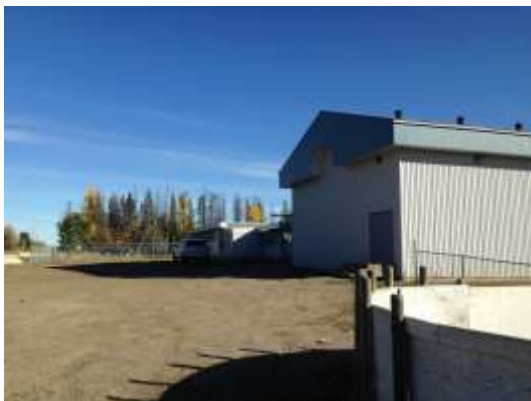
Exterior

Building type: Wood frame, metal cladding. Fair.

Envelope: Insulated wood frame with metal siding. Good.

Roof: Wood truss and deck, pitched roof metal clad. Good.

Appearance: Some damage to metal cladding and vents on outside. Fair.

Overall, school will need cosmetic, mechanical and building envelope

upgrades in the next decade. The gym may need less. Building will require new roof in less than 10 years, building envelope work in 10 years and mechanical upgrades in about 15 years.

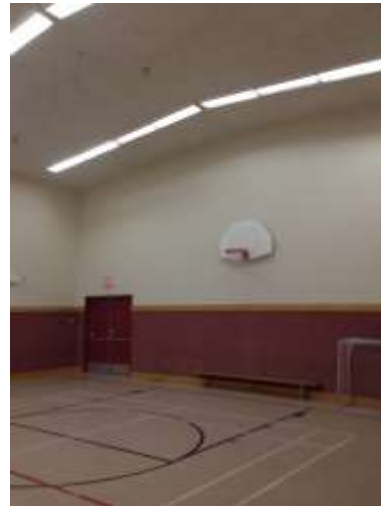
Interior gymnasium

Utilization: Apparently heavily used by community up to four nights a week.

Interior: Wood (lower 6-feet) and stucco upper and ceiling. So far, for economical materials no premature wear evident. Very good.

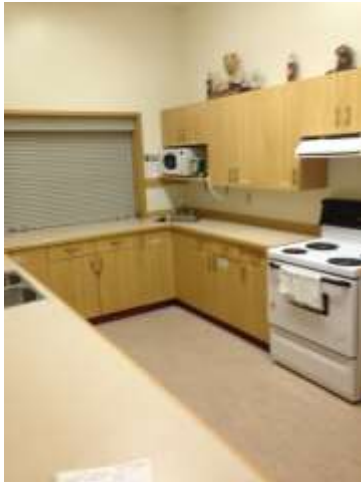
Attached kitchen

Kitchen: Residential quality, more of a serving kitchen. Rollshutter. Lots of storage. Good.
