# Energy Efficiency Opportunity Assessment of Corporate Buildings

**Tumbler Ridge**

**Prepared by:** Enerfficiency Consulting  
458 Abbs Road  
Gibsons, BC V0N 1V0  
604 - 886 - 9864

November, 2009

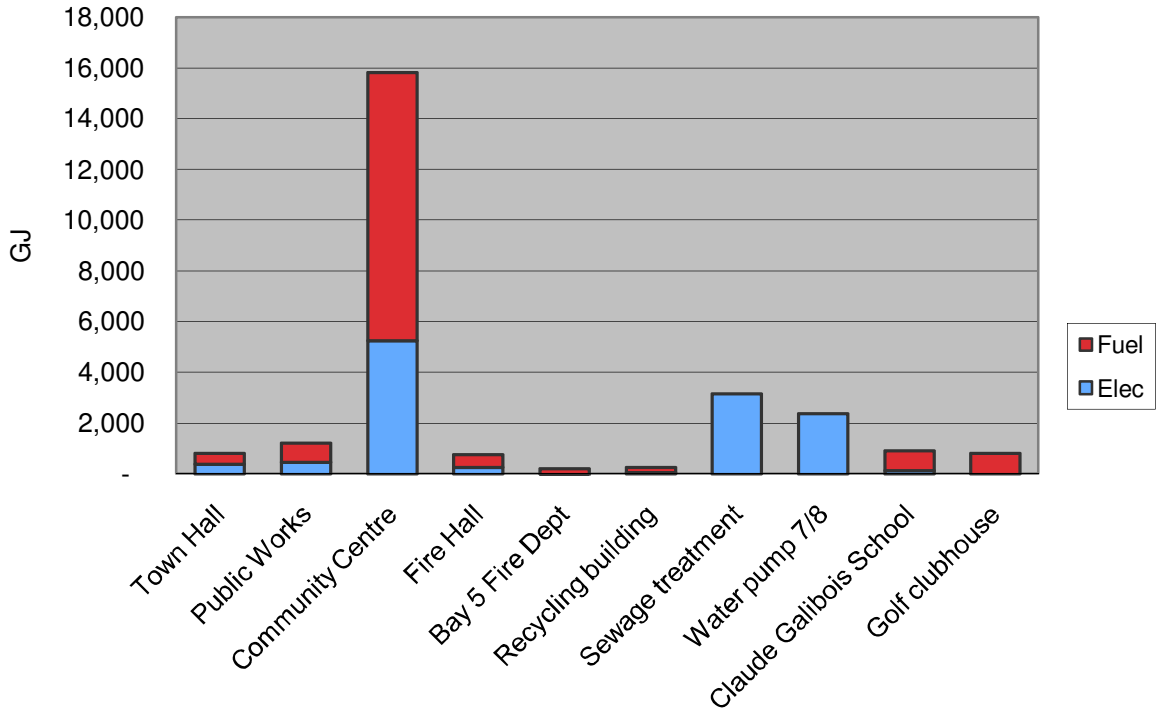
**Energy Consumption by Building**

The largest energy consumer is the Community Centre, accounting for 60% of consumption. The next largest consumers are the Sewage Treatment Plant and Pumps 7/8, although most of their energy usage is process related. The Community Centre also produces by far the greatest amount of GHG emissions, accounting for 70% of the total. Although the Sewage Treatment Plant and Pumps 7/8 are large energy consumers, they produce relatively few GHG emissions, as their consumption is all electric.

Energy intensity, in terms of consumption per unit area, is a useful way of comparing building to other similar facilities, although not applicable to all building types. The most energy intensive facility is the Bay 5 Fire Department, which has an energy intensity of 61 ekWh/ft<sup>2</sup>.

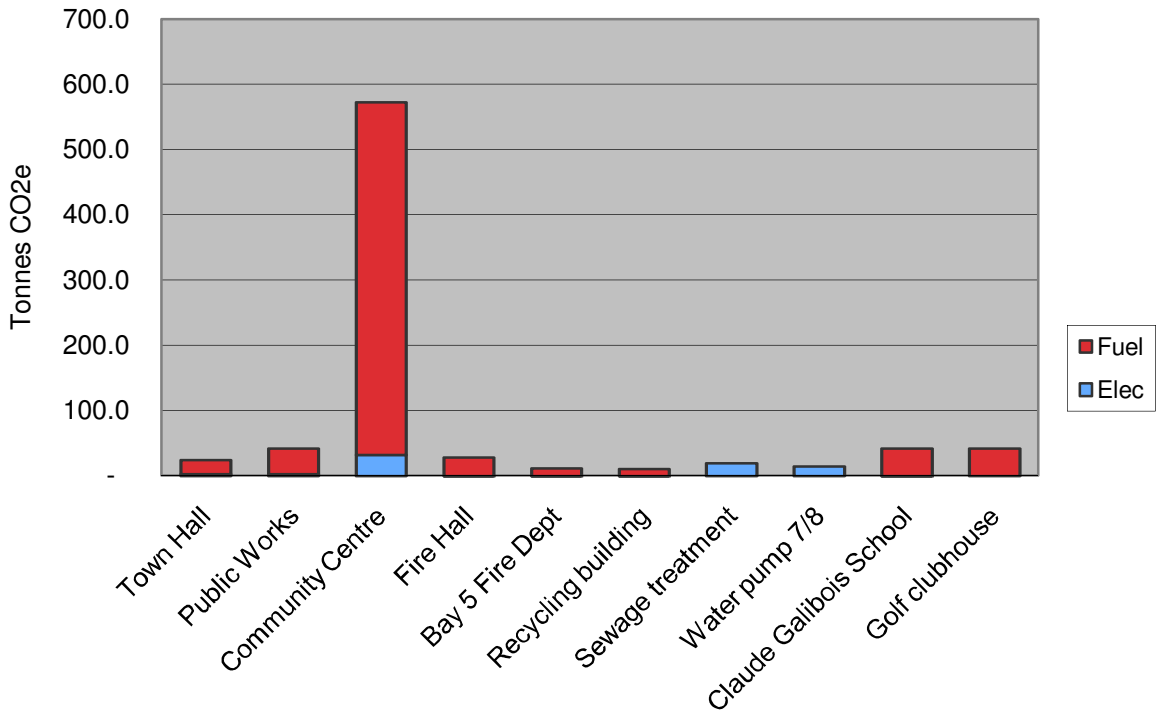
**Greenhouse Gas Emissions by Building**

Total energy consumption for the facilities is 26,365 GJ and \$343,967 annually. Electricity consumption is 3,346,289 kWh and \$200,777 , while fuel consumption is 14,319 GJ and \$143,190 . Eight of the buildings use natural gas as the primary heating fuel, while two (Sewage Treatment and Pump 7/8) use electricity. Total greenhouse gas (GHG) emissions are 804 tonnes CO<sub>2</sub>e, 91% from fuel combustion.

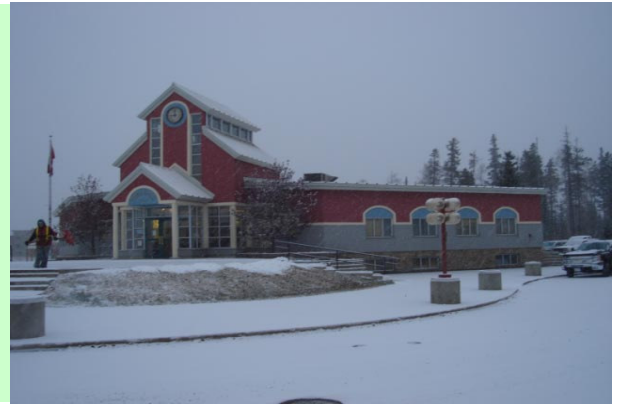
Annual Energy Cost

Elec	104,520 kWh	\$ 6,271	2.3 tonnes CO <sub>2</sub> e
Fuel	431 GJ	\$ 4,310	22.0 tonnes CO <sub>2</sub> e
Total	807 GJ	\$ 10,581	24.3 tonnes CO <sub>2</sub> e

Town Hall	Typical
Elec	10.8 ekWh/ft	14.2 ekWh/ft
Fuel	12.4 ekWh/ft	15.4 ekWh/ft
Total	23.2 ekWh/ft	29.6 ekWh/ft

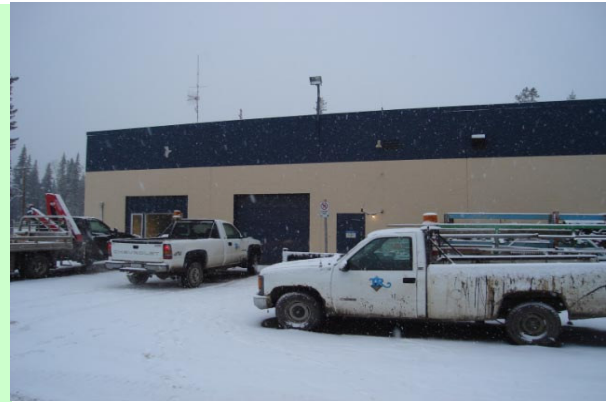
Annual Energy Cost

Elec	125,440 kWh	\$ 7,526	2.8 tonnes CO <sub>2</sub> e
Fuel	766 GJ	\$ 7,660	39.1 tonnes CO <sub>2</sub> e
Total	1,218 GJ	\$ 15,186	41.8 tonnes CO <sub>2</sub> e

Public Works	Typical
Elec	15.1 ekWh/ft	14.0 ekWh/ft
Fuel	25.7 ekWh/ft	24.8 ekWh/ft
Total	40.8 ekWh/ft	38.8 ekWh/ft

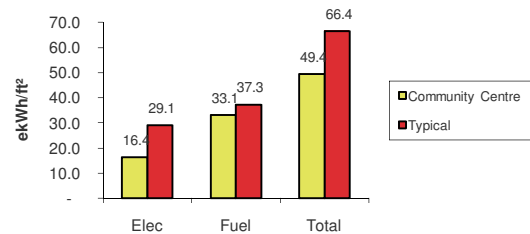
Community Centre	Typical
Elec	16.4 ekWh/ft	29.1 ekWh/ft
Fuel	33.1 ekWh/ft	37.3 ekWh/ft
Total	49.4 ekWh/ft	66.4 ekWh/ft

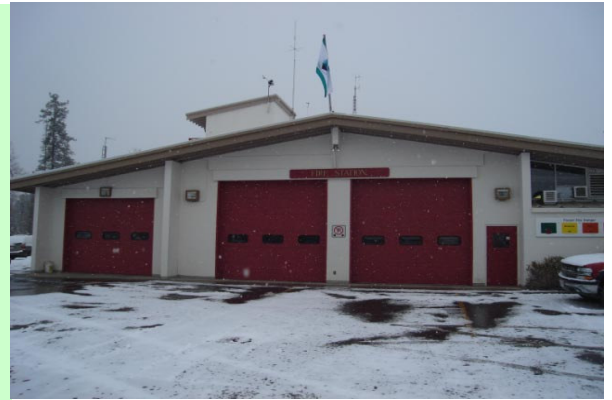
Annual Energy Cost

Elec	69,147 kWh	\$ 4,149	1.5 tonnes CO <sub>2</sub> e
Fuel	520 GJ	\$ 5,200	26.5 tonnes CO <sub>2</sub> e
Total	769 GJ	\$ 9,349	28.0 tonnes CO <sub>2</sub> e

Fire Hall	Typical
Elec	14.3 ekWh/ft	11.8 ekWh/ft
Fuel	29.8 ekWh/ft	16.7 ekWh/ft
Total	44.1 ekWh/ft	28.5 ekWh/ft

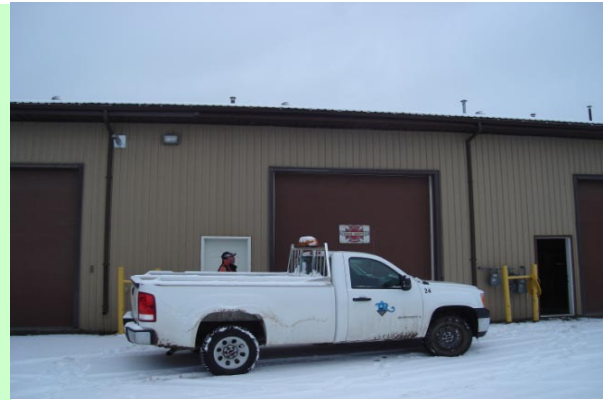
**Annual Energy Cost**

Elec	2,882 kWh	\$ 173	0.1 tonnes CO <sub>2</sub> e
Fuel	210 GJ	\$ 2,100	10.7 tonnes CO <sub>2</sub> e
Total	220 GJ	\$ 2,273	10.8 tonnes CO <sub>2</sub> e

Bay 5 Fire Dept	Typical
Elec	2.9 ekWh/ft	- ekWh/ft
Fuel	58.3 ekWh/ft	- ekWh/ft
Total	61.2 ekWh/ft	- ekWh/ft

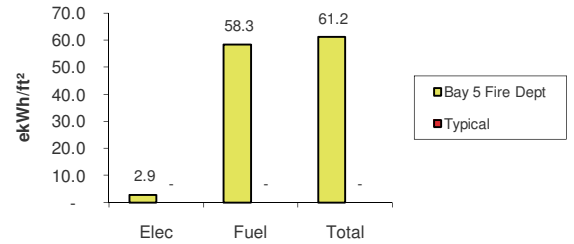
**Energy per ft<sup>2</sup> - Bay 5 Fire Dept vs Typical**

This is a leased storage bay used to store vehicles and equipment. It is wood frame construction. There are some large cracks allowing air leakage around the door. Electricity consumption is very low, while gas consumption is very high, perhaps due to a gas leak.

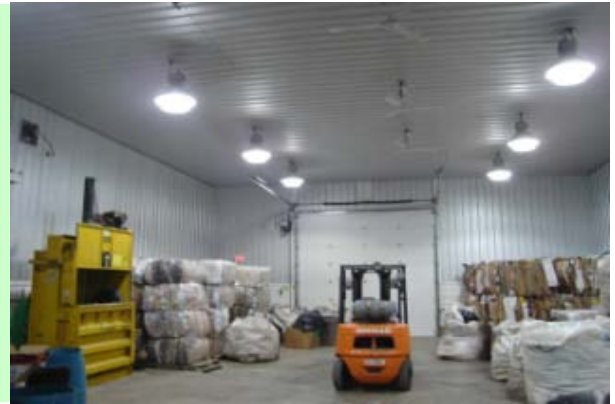
Annual Energy Cost

Elec	15,140 kWh	\$ 908	0.3 tonnes CO2e
Fuel	202 GJ	\$ 2,020	10.3 tonnes CO2e
Total	256 GJ	\$ 2,928	10.6 tonnes CO2e

Recycling building	Typical
Elec	6.3 ekWh/ft	- ekWh/ft
Fuel	23.4 ekWh/ft	- ekWh/ft
Total	29.7 ekWh/ft	- ekWh/ft

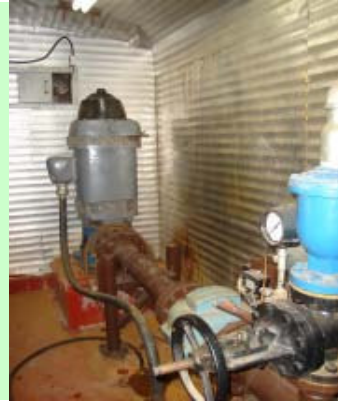
**Annual Energy Cost**

Elec	658,080 kWh	\$ 39,485	14.5 tonnes CO2e
Fuel	- GJ	\$ -	- tonnes CO2e
Total	2,369 GJ	\$ 39,485	14.5 tonnes CO2e

Water pump 7/8	Typical
Elec	#DIV/0! ekWh/ft	- ekWh/ft
Fuel	#DIV/0! ekWh/ft	- ekWh/ft
Total	#DIV/0! ekWh/ft	- ekWh/ft

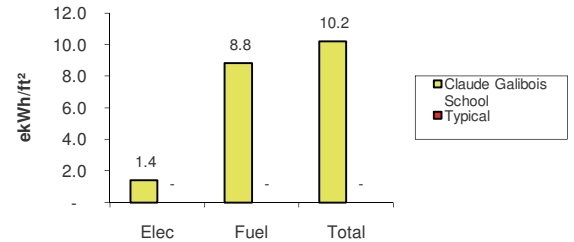
<i>Claude Galibois School</i>	<i>Typical</i>
Elec	1.4 ekWh/ft	- ekWh/ft
Fuel	8.8 ekWh/ft	- ekWh/ft
Total	10.2 ekWh/ft	- ekWh/ft

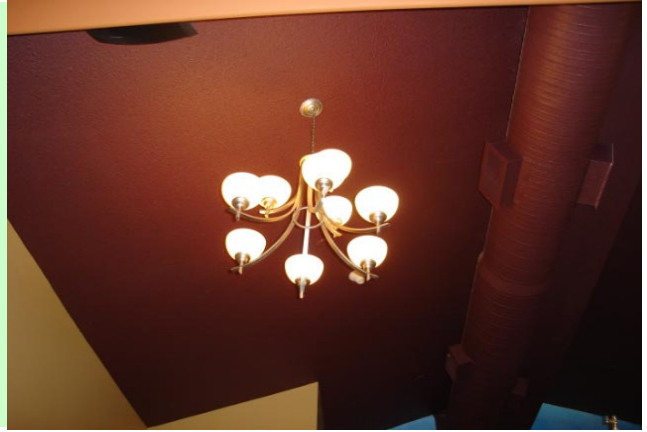
**Annual Energy Cost**

Elec	- kWh	\$ -	-	tonnes CO <sub>2</sub> e
Fuel	807 GJ	\$ 8,070	41.2	tonnes CO <sub>2</sub> e
Total	807 GJ	\$ 8,070	41.2	tonnes CO <sub>2</sub> e

<i>Golf clubhouse</i>	<i>Typical</i>
Elec	- ekWh/ft	- ekWh/ft
Fuel	38.7 ekWh/ft	- ekWh/ft
Total	38.7 ekWh/ft	- ekWh/ft
