Clearview Arena

Structural Walk-Through

Force Engineering Group Inc. (Force) was engaged by the Peace River Regional District in September 2017 for the purposes of conducting a visual review of the current conditions of structure known as the Clearview Arena. The intent of this review is to guide the Regional District in its future decisions regarding the viability of the structure. This review is based solely on the sight-exposed condition of structural elements only. The testing, calculation, and measurement of the building have been excluded from the scope of works. This is a “walk-through” only.

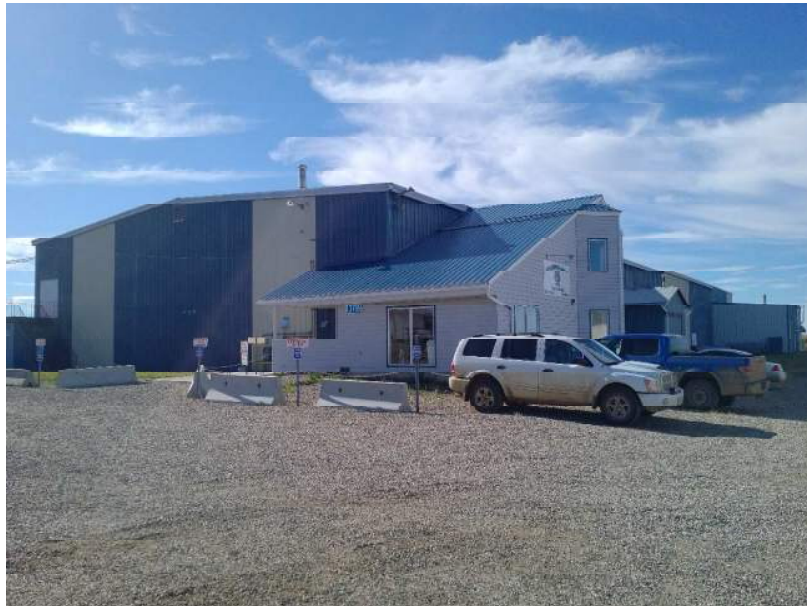
Clearview Arena September 28th, 2017

The first phase of construction occurred in 1975-76 and was comprised of the original 200'x80' building, designed by local Architect Killick Metz. Plans from the era denote the building structure was to be a concrete block (Masonry) building with a hybrid wood/steel roof, known as T/JL type trusses. (Similar to the current Chetwynd Arena) The foundation was to be a concrete pile and grade beam assembly. Evidently, sometime after the plans were prepared, the primary structure was changed (likely due to cost and location) to a pre-engineered steel building, consisting of primary steel frames at 20'-0" centres and steel purlins. Subsequent renovation plans from 1989 also indicate the original foundation remained a grade beam, presumably on an altered pile layout to coincide with the frame spacings. As there was no provision for a plant, the original ice surface must have been a natural ice surface, limiting its use. At some point a wood framed shed along the north elevation was added to house ice resurfacing equipment.

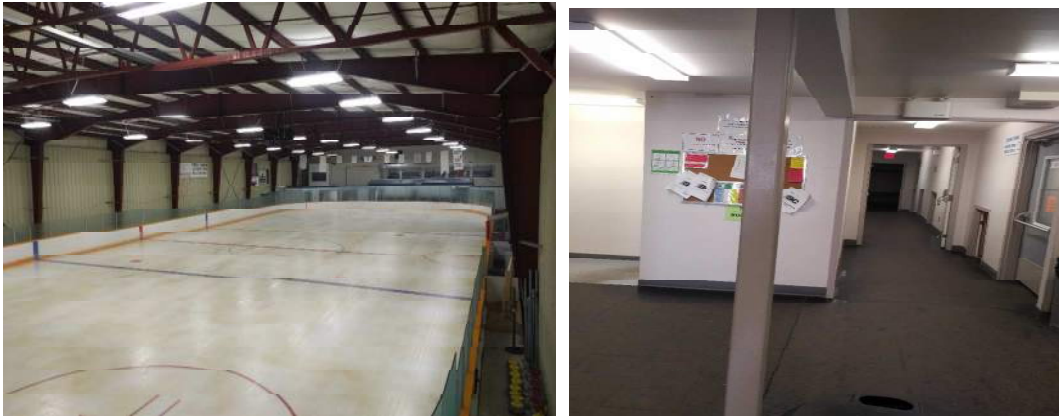
Clearview Interiors - General

The overall condition of the facility was at par with what we would expect for a 40+ year old building, operated by minimal staff and a limited operating budget. Wear to common areas was minimal, paint is refreshed yearly, although the rink area showed age though heavy wear and deterioration of painted surfaces, damage from pucks and flying objects.

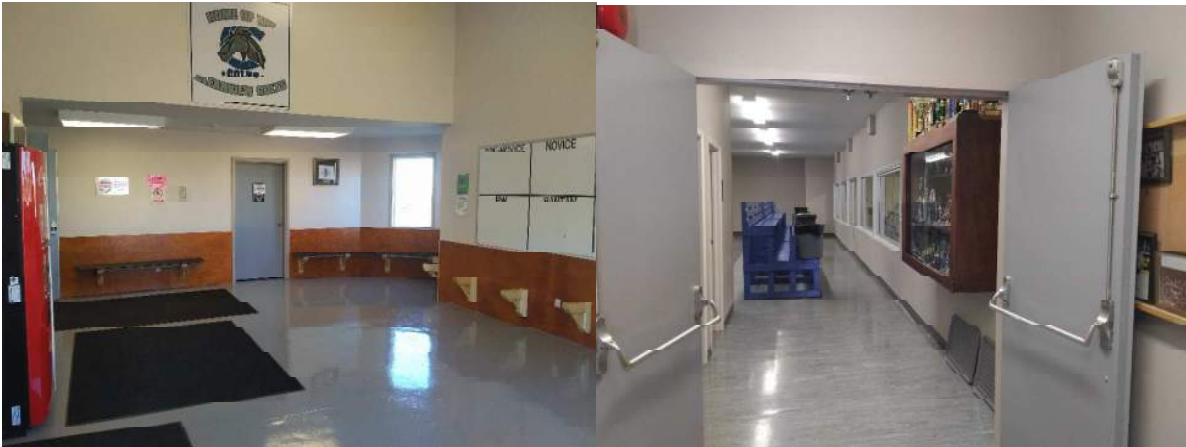
Entrance Lobby (Left) and Second Floor Viewing (Right)

The interior visibility in the rink was initially limited due to heavy interior fog as a result of the lack of ventilation and dehumidification equipment. Relative humidity at 100% further accelerates wear on painted surfaces, and accelerates corrosion of steel and wood members. We commend staff for their efforts to patch and maintain the exposed vapour barrier which aids in the steel preservation.

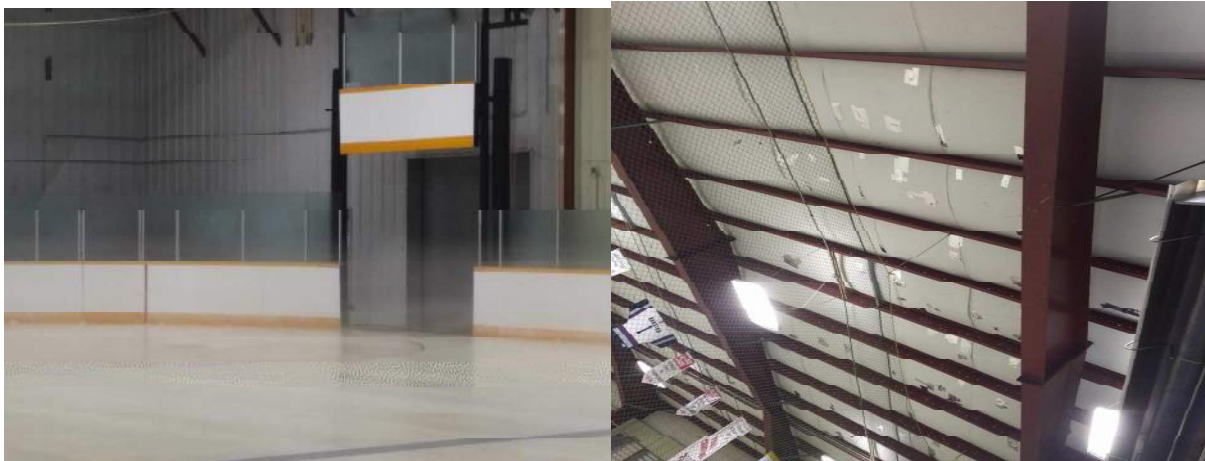
Fog and Condensation (Left) and Vapour Barrier Patchwork (Right)

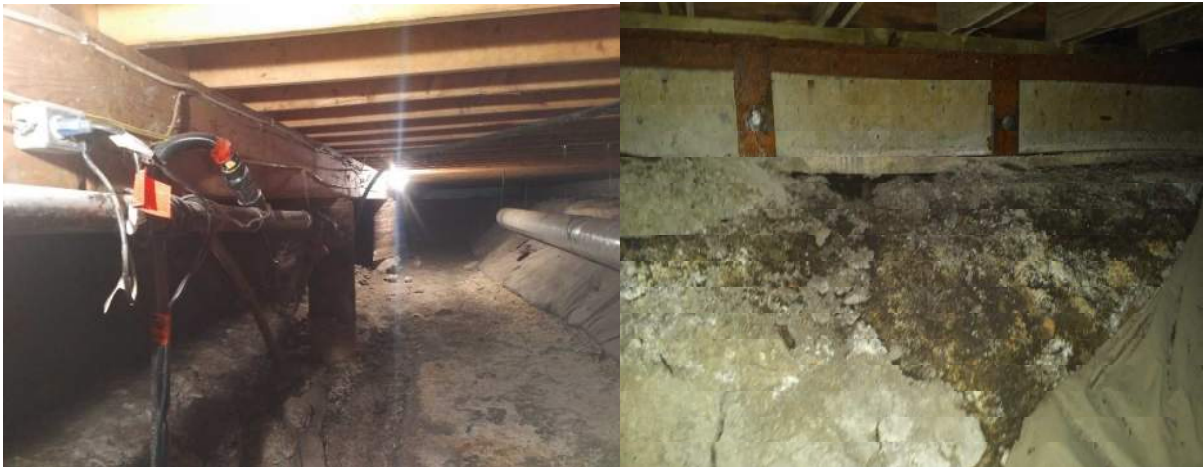
The crawlspace area is located from grids 1 to 2, from A to B. Access to the crawlspace is via a hatch in the mechanical room 109. This area is part of the original 1975 building plan and is the only crawlspace in the building. Its primary purpose is for the routing of HVAC ducts and piping servicing for the dressing rooms, as well as a service exit point for the sewer main. The main floor above is framed as conventional wood joists with plywood sheathing over, whilst the crawlspace is essentially clay covered with poly vapour barrier. Evidence of sloughing is found along the east and south walls, potentially allowing exterior ground water to enter, though at the time of our visit the area was dry and the sumps functional. The wood floor above is supporting a wood beam located midway between grids 1 and 2, which appears to be functioning without duress. Dirt is in contact with the beam at the south and north ends, which is a concern for long term decay. Some crushing of shims at beam support points is noted.

Crawlspace General and Perimeter Grade Sloughing

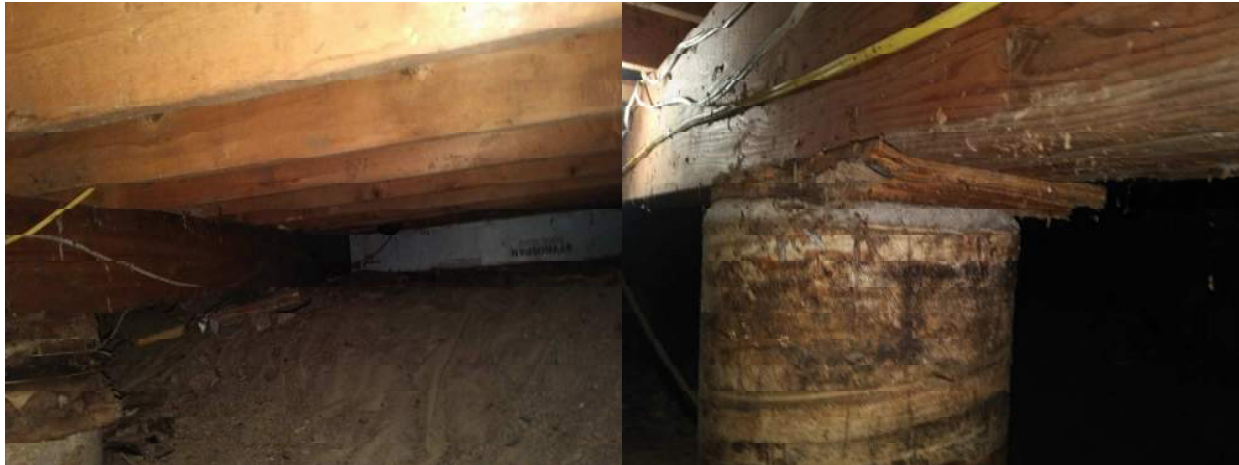
Beam End in Contact with Grade, Plywood Shims Under Beam Deteriorating

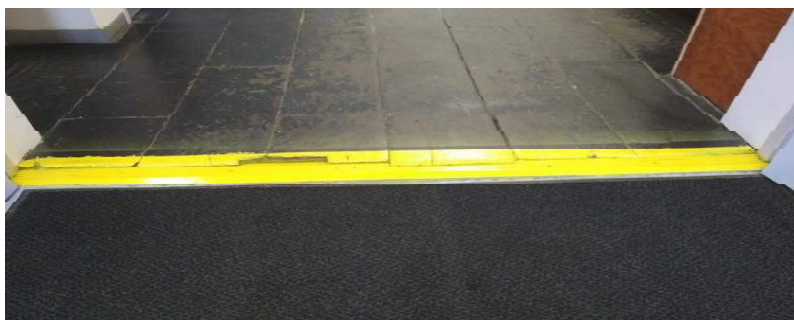
The entrance addition was constructed in 2000, and consists of a two storey wood framed addition on grade beam and piles. This area is located to the north of Grid B. It remains essentially in the same state as built, and exhibits no major signs of movement, or damage. Exterior, residential grade, siding originally used to clad the exterior is damaged due to abuse, rocks from parking areas, and general wear. Some areas are damaged to the extent where water ingress to the building envelope, and structure behind, is possible, though not yet detrimental at this time. A distinct seam between the addition and original construction is evident; however is not thought to be the result of structural movement.

Floor Unevenness Between 2000 and 1975 Phases

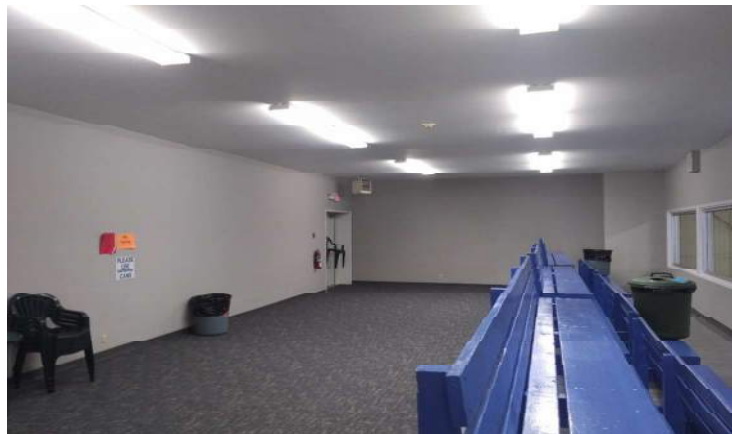
The second floor is largely assembly space with its own washrooms. A small two tier seating stand exists for spectator use in a heated area. Exit doors are located in the SE corner, and are known to have functional difficulties, not believed related to structural movements. The washrooms are not code compliant but do provide additional capacity to the building. Plumbing overflows in the past have occurred, but are not believed to induce decay in the supporting wood structure. There are no notes on plans to indicate the actual structural arrangements of the second floor, thus confirmation of capacity for assembly use cannot be confirmed, as there were no exposed areas.

Second Floor Viewing Room

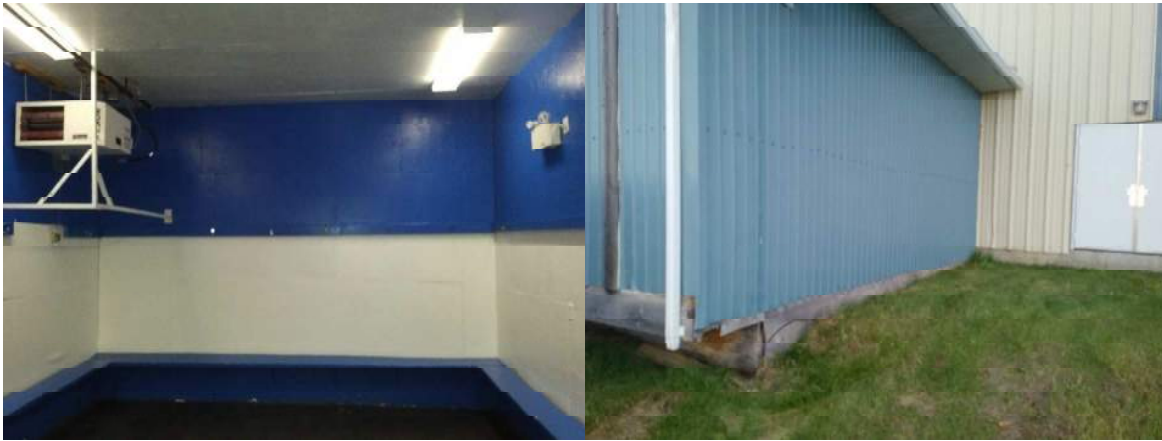
Dressing Room 107 is an addition placed sometime between 1975 and 1989. It originally contained the ice resurfacer, though now functions as a dressing room. It has no plumbing facilities, and is noted by staff as drafty, and hard to heat. The structure appears to be all wood, hastily conceived and executed. Metal cladding does not match the other portions of the building. Foundation may too be wood, though is concealed by grade at the date of our review. Settlement towards the north is also apparent. We could find no definitive plans or structural arrangements. Its roof elevation is substantially below the eave of the main arena structure and there is no evidence to suggest the wood framing is designed for the substantial drift loads that the building code mandates.

Dressing Room 4 (Room 107) Interior and Exterior

Movement between the 1989 and original 1975 portions of the building is noted, and lateral force resolution along this line is suspect. We anticipate significant repairs in this area. The former ice resurfacers room, currently used as dressing room 107 is deemed uneconomically viable to repair and replacement should be considered.

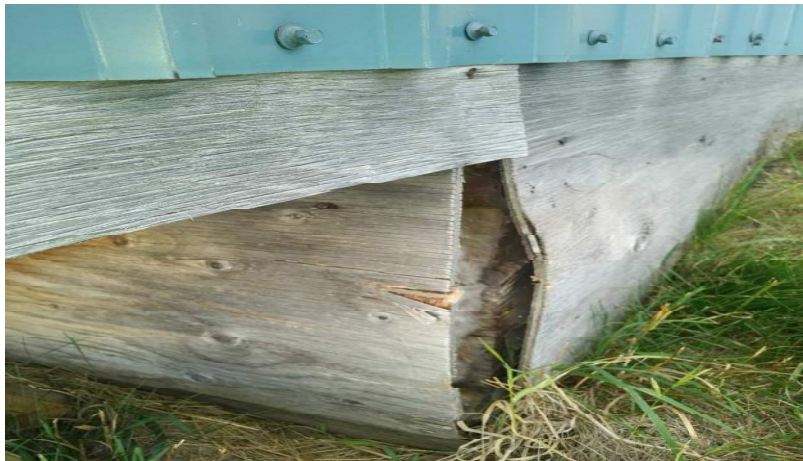
Dressing Room 107 Foundation

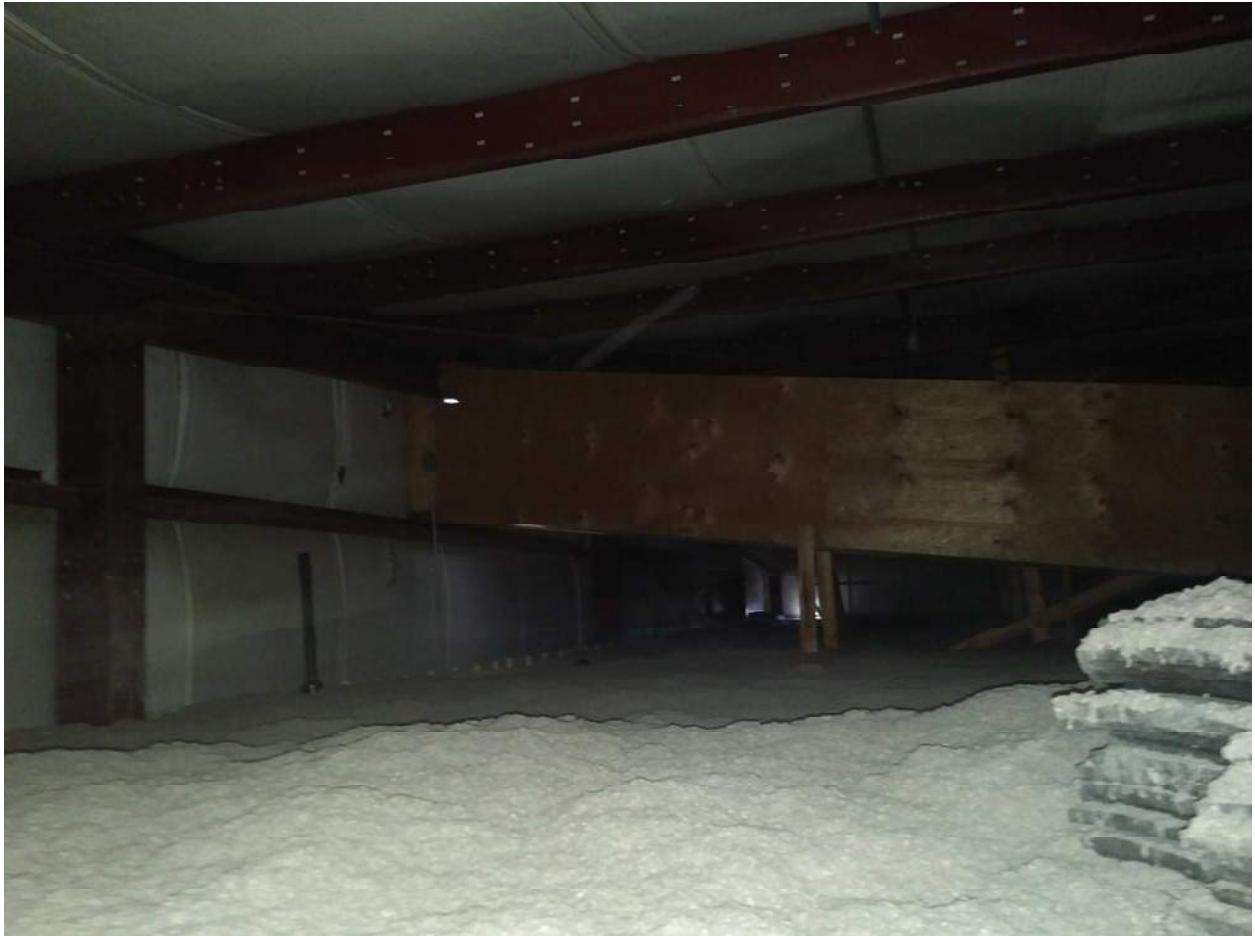
Above the second floor an attic space exists which has the endwall framing of the pre-eng building exposed. It is devoid of equipment, though a large, combustible wood duct exists to convey the rink exhaust towards the fan in the endwall. Access to the space is above room 203 (Lockers) through a non-fire rated hatchway. No excessive corrosion or distorted structural members were observed in the space.

Attic Over Second Floor. Steelwork in near Original Condition

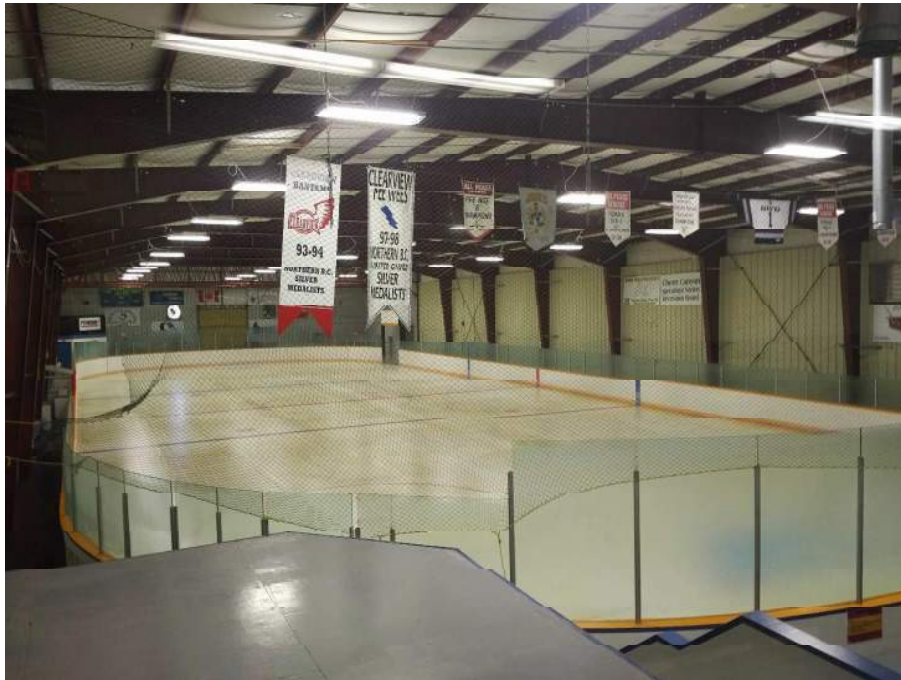
As noted earlier, the main arena original build, is a Butler Building pre-engineered structure. It consists of steel frames at 20'-0" centres with 8" deep steel purlins at ~ 5'-0" spacings. Each steel frame consists of 5 bolted together components, designed to transmit loads to the pile and grade beam foundations. As these types of frames generate large vertical and horizontal reactions at their base, its presumed the piles and details at each frame were changed from the Killick Metz plans to accommodate the added load. In dealing with the horizontal reaction force, either large diameter piles capable of resisting the outward force can be used, or smaller diameter piles can be employed with a tie between opposite walls, similar to how a collar tie in wood rafter framing resolves thrust. Though we were unable to locate original plans, it appears the designer went with the latter solution, as the 1989 plans note altering the steel tie below the rink surface, presumably to allow the heat floor piping to be accommodated.

1975 Frame (Butler) Building

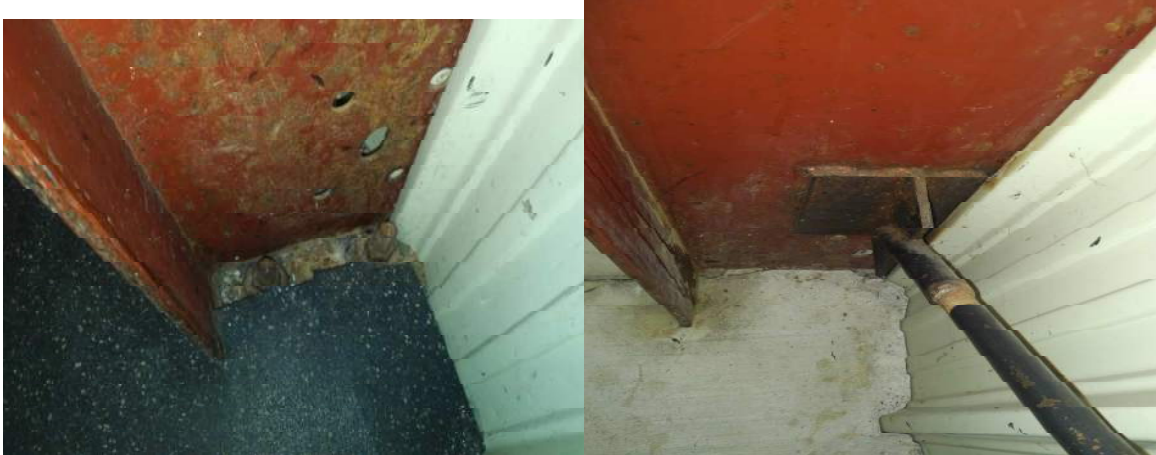
floor slabs did not contain appreciable cracks or indications that the frames have displaced significantly either vertically or laterally. Exterior exposed grade beam along the north (Grid “B”) was not significantly distorted to the eye.

Exposed Anchor Bolts (Left) and Relocated, Welded Brace (Right)

The building frames are inherently laterally stable along their axis. To provide lateral restraint against roll-over along the building’s length, metal rods and turnbuckles are employed to transmit these forces to the foundation. We generally found these pieces to be tight and intact, though it appears the braces along grid “B” from “5” to “6” have been relocated from a previous position, likely due to the dressing room 107 addition or other modification. When relocated, no turnbuckles to provide tension were used, and they were directly welded. In the current configuration they are very loose and will permit movement, and thus forces would be larger than anticipated.

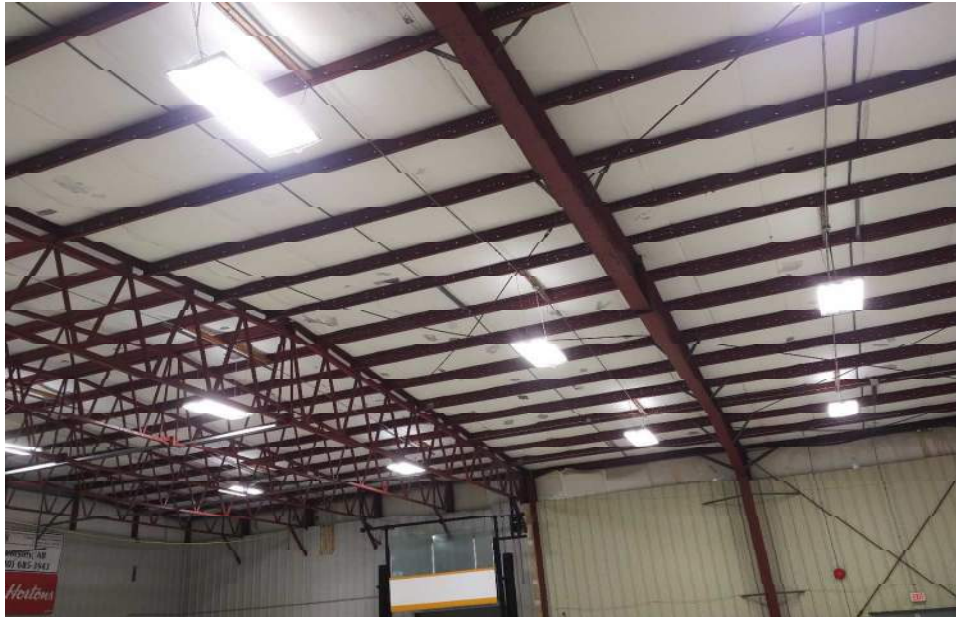
Similarly rod bracing has been employed in the roof diaphragm, to transmit roof forces to the walls, and then to the foundation. While they appear unaltered, its clear the brace between grids “10” and “11” has appreciable sag. It is unclear if this is a result of original construction, or the addition of the 1989 structure which occurred adjacent to the brace rods. The pattern of bracing is somewhat different than we are accustomed to on modern facilities and we are not able to determine if this is erected to manufacturer plan, though it is mimicked in the concealed Attic space.

Sagging Roof Diaphragm Brace B/T Grids 10 and 11

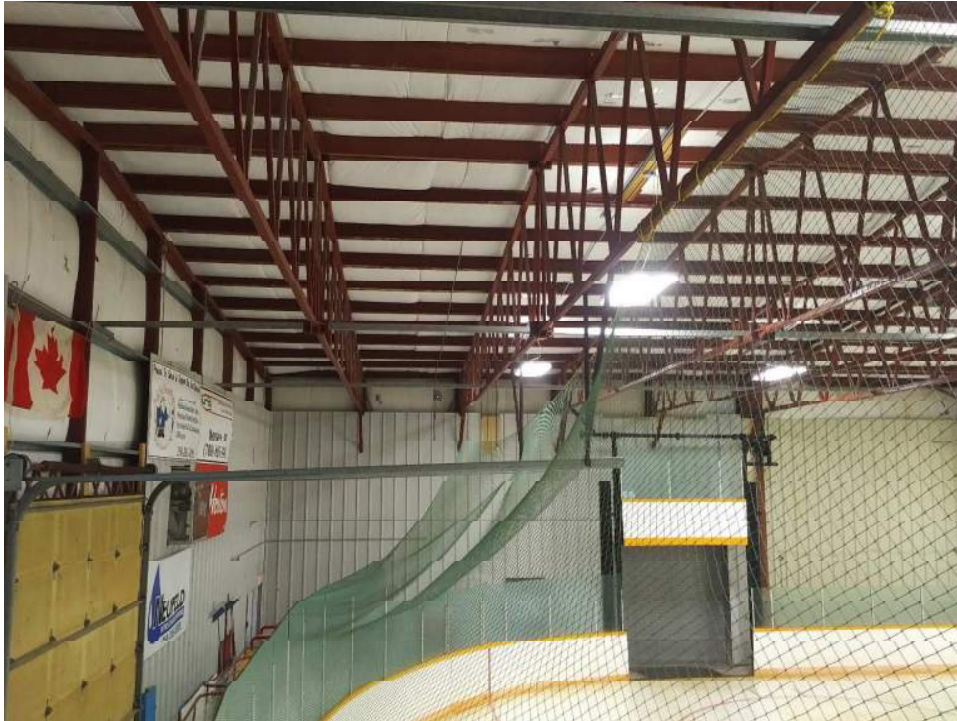
The 1989 addition is instantly recognizable within the building, as the frames change type and spacing. Rather than employ the same style of frame used in 1979, the addition designers opted to use a truss style peaked roof at 8'-0" spacing with straight column walls matching the spacing of the roof trusses. The change is likely rooted in the era, whereas the material costs were substantially more than labour costs, thus the less weight of steel employed, the lower the building cost. The inverse of that is true today in the modern economy, where labour costs far outstrip materials, thus the truss style of construction used in 1989 would not be cost effective now due to the large labour cost in fabrication of trusses, whereas frame welding is nearly all robotically automated now.

A Change in Structure Type is Evident in 1989 Addition

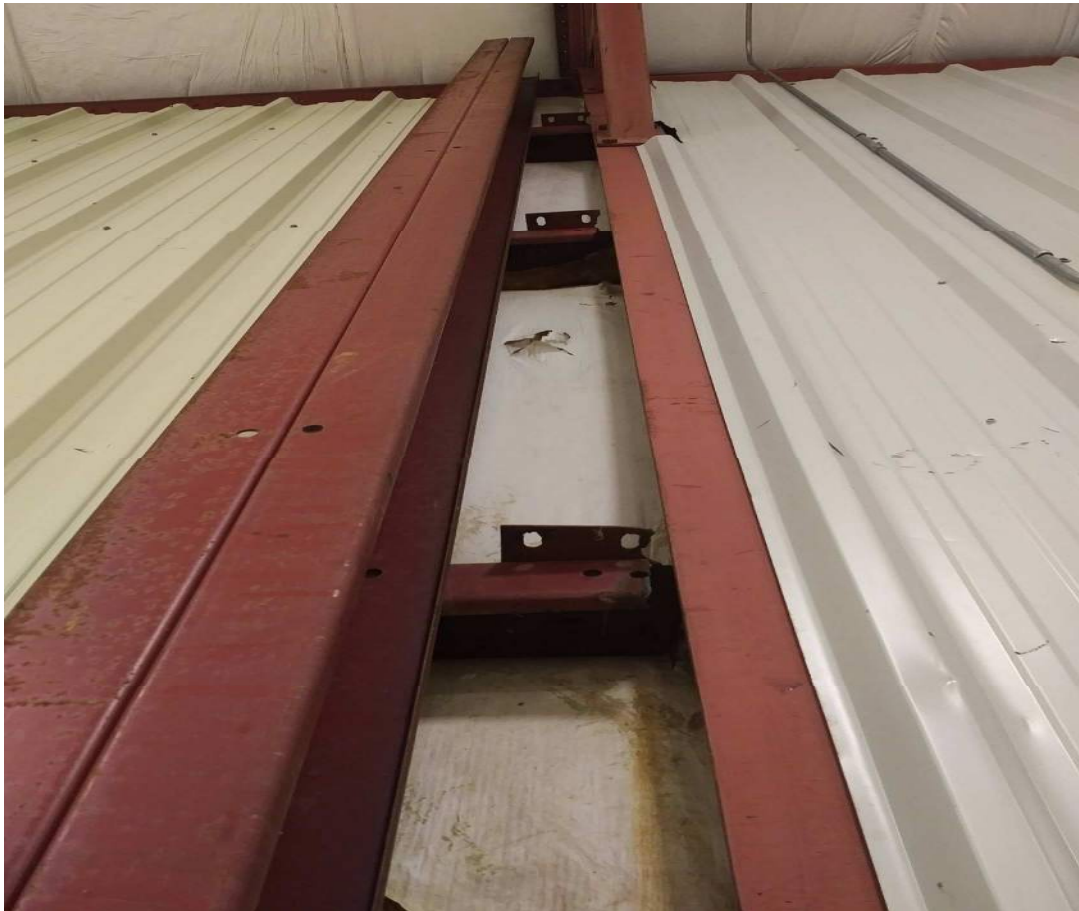
Evidence on site suggests the original 1975 end wall was cut away after the 1989 addition was erected, and there is virtually no connection of the wall purlins @ grid 11 between the 1975 and 1989 portions. Movement is evident at this joint, screws on cladding are loose on the exterior too. It is entirely unclear from plans and site observation, how the designer intended to replace the lateral force resolution of the original 1975 building as there seems to be only vertical force considerations.

Seam Between 1975 Building (Left) and 1989 Building (Right)

The stability and interaction between the original building and the 1989 addition remain our largest concern, and are directed to be further studied to garner the insight required to make effective repairs and ensure the structure can withstand lateral and vertical loads.

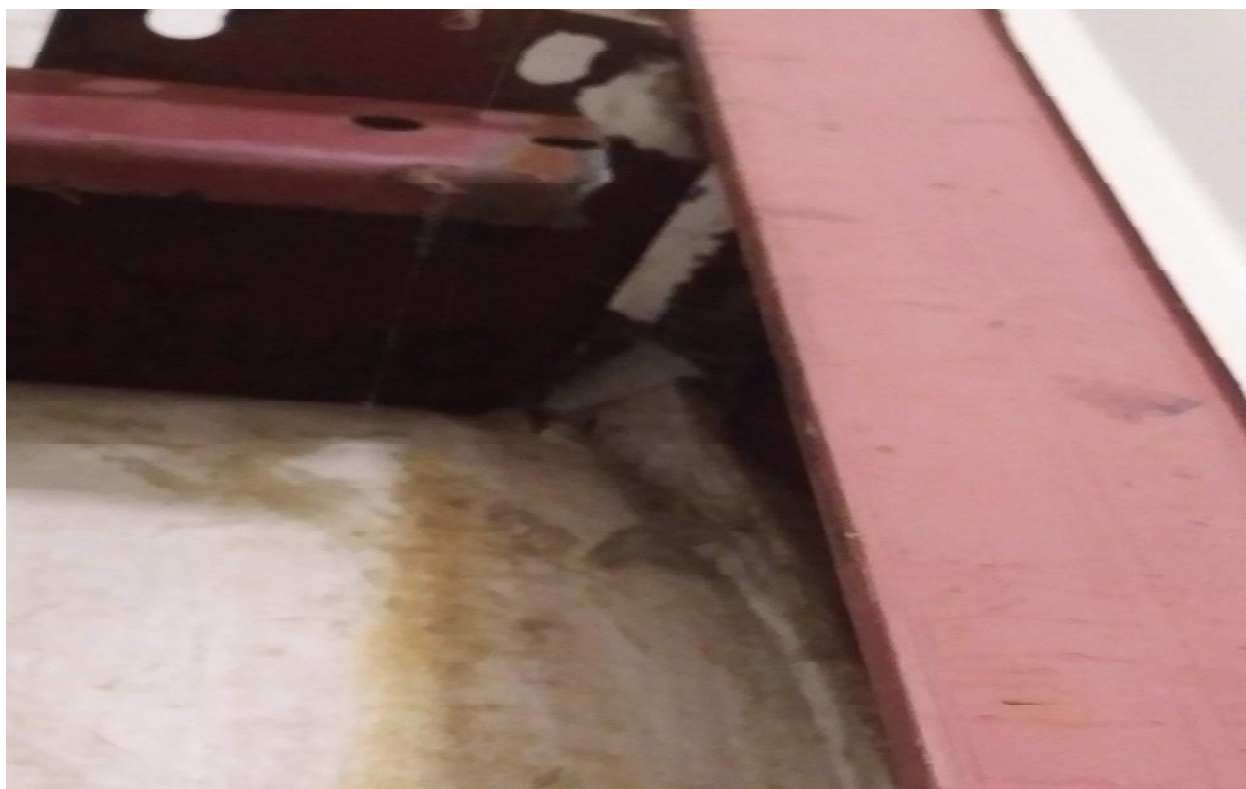
No Apparent Connection Between the 1975 and 1989 Buildings

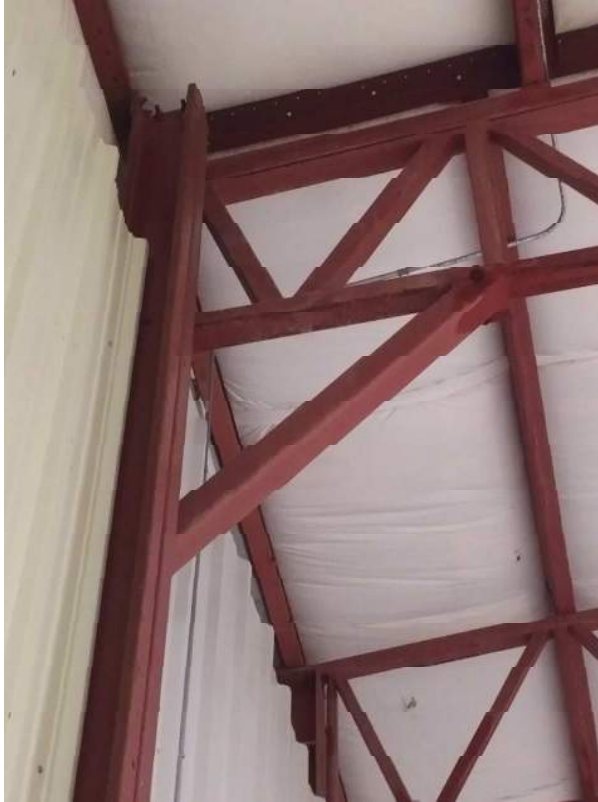
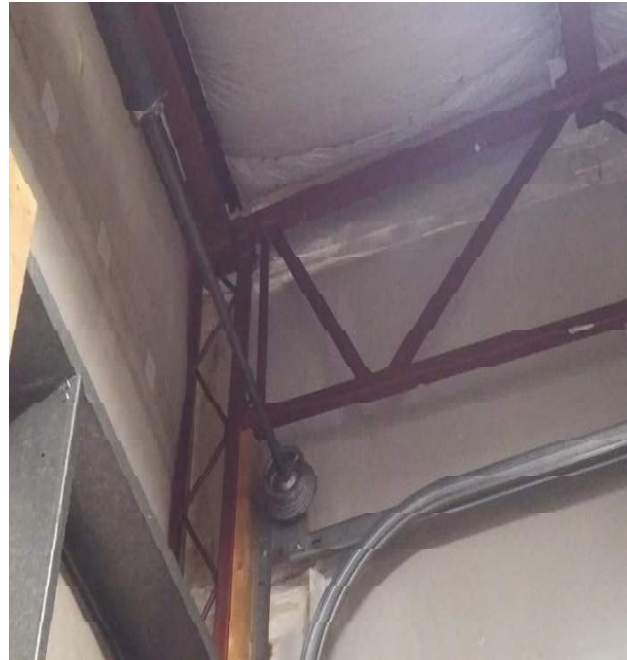
There is only one set of lateral bracing in the north and south walls of the 1989 addition. None exists in the west wall, and only small knee braces of indeterminate capacity exist in the north south axis. There seems to be no mechanism to drag forces between the two distinct construction types.

Typical Arena Truss @ Grids A and 11 (Left), and Roof Truss to Vertical Wall Truss Room 104

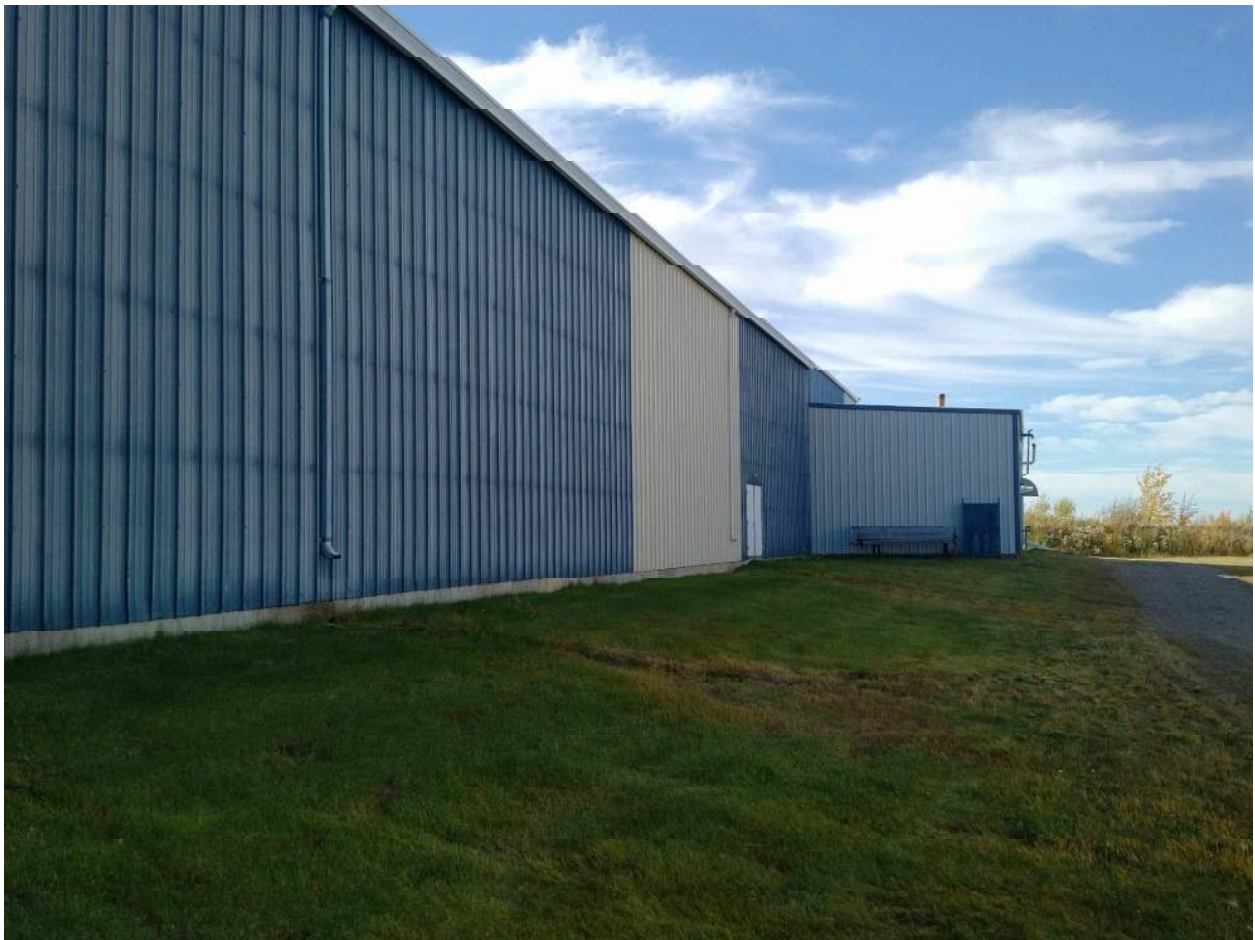
The main arena buildings, both 1975 and 1989 portions are clad with exposed faster metal cladding. Metal cladding is directly screwed to the steel purlins between frames or trusses. The roof is approx. a 1:12 pitch, and uses the same exposed faster application.

Arena North Wall (Looking towards Ice Resurfacing Room)

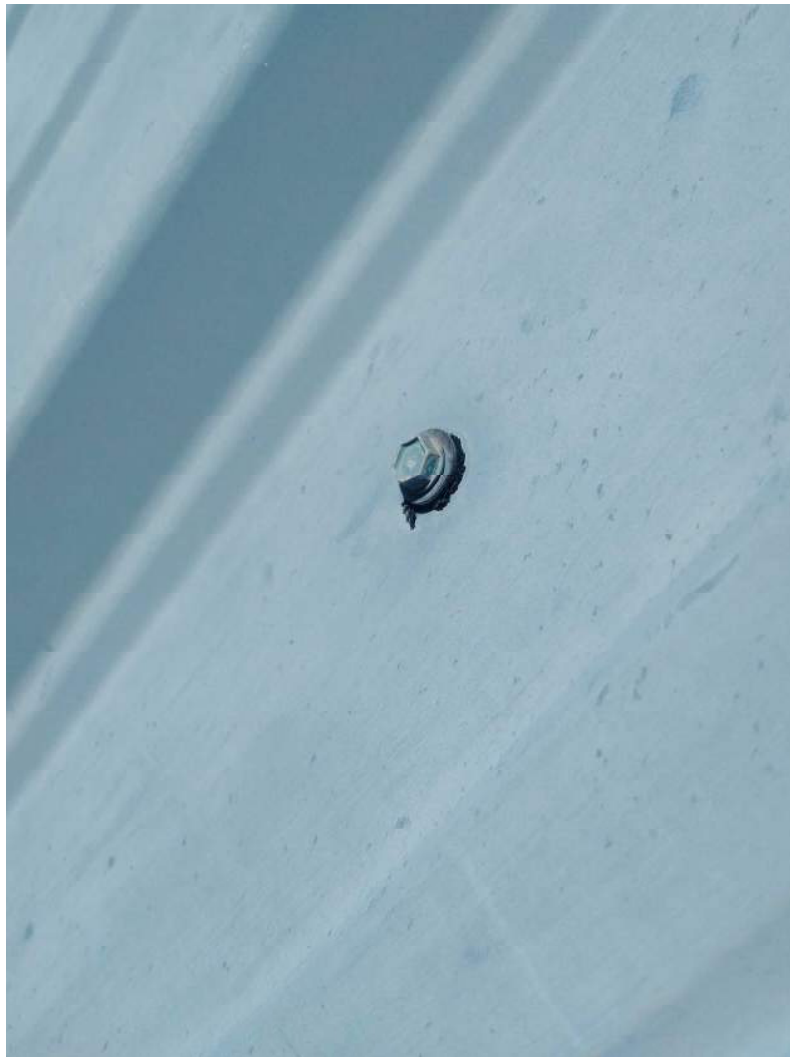
While this technique is the cheapest available, it has a consequence. The exposed fasteners utilize a flexible neoprene washer for moisture seal. These fasteners are exposed to extreme wear due to sunlight degradation, and thermal expansion and contraction. Metal siding is constantly expanding and contracting due to temperature changes night to day. Eventually the washers become brittle, cladding holes elongate, and the structure begins to leak and decay. Nominal leaks are in fact reported at Clearview Arena , and its 40 year age suggests fastener replacement is overdue.

Typical Fastener Washer Degradation Throughout

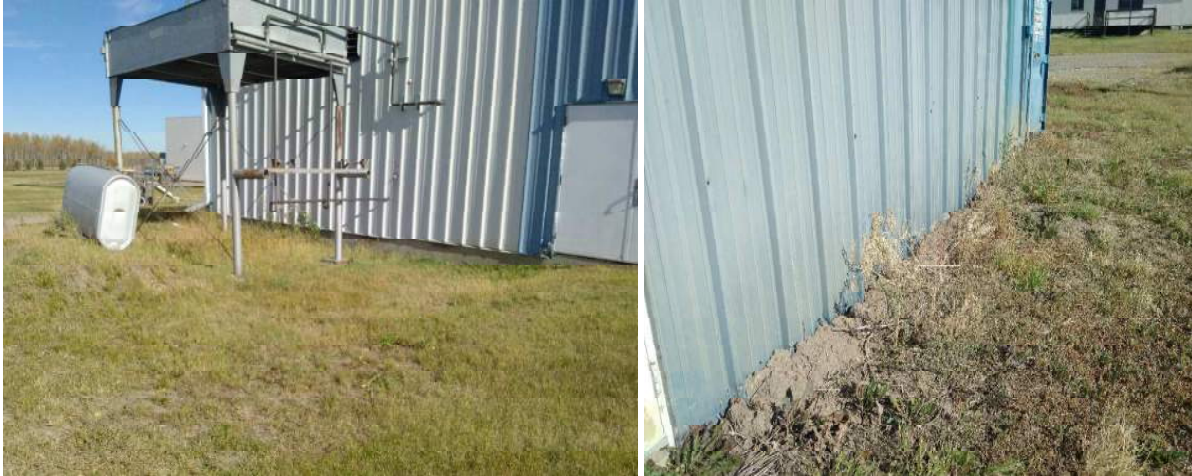
Grading along the building is acceptable only along the north elevations which has only minor repair areas. All other elevations require re-shaping to direct water away from the foundation and steel structure. Water, and the repetitive freeze thaw cycles has adverse effects on foundations, heaving floors and steel corrosion. Rainwater leaders and eavestrough are no longer functional, or disconnected in many areas. Cumulatively, drainage factors will contribute to structural failure.

West Wall Grades Slope towards Building. Grade at SE Corner is Over Cladding
