STAGE 1 AND LIMITED STAGE 2 PRELIMINARY SITE INVESTIGATIONS: PEACE VALLEY LOOKOUT

Project number 20003 and 20003.001 | Reference number 030300386P

REMEDIAL OPTIONS REPORT: A SUMMARY OF COMPLETED WORK AND SUGGESTED NEXT STEPS

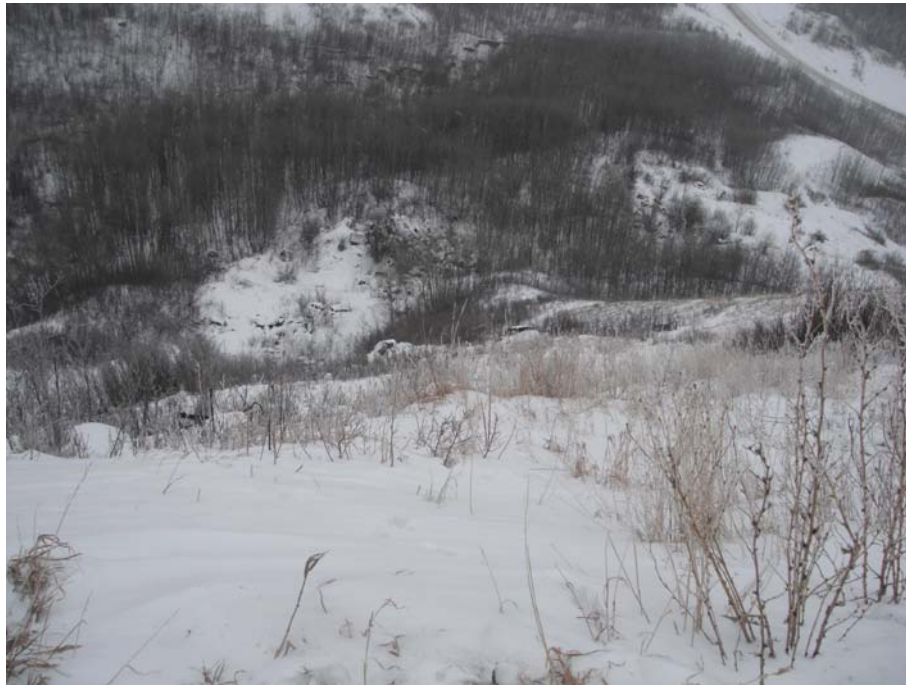
Photo #2 – Bank on east side of the Property, looking towards the east.

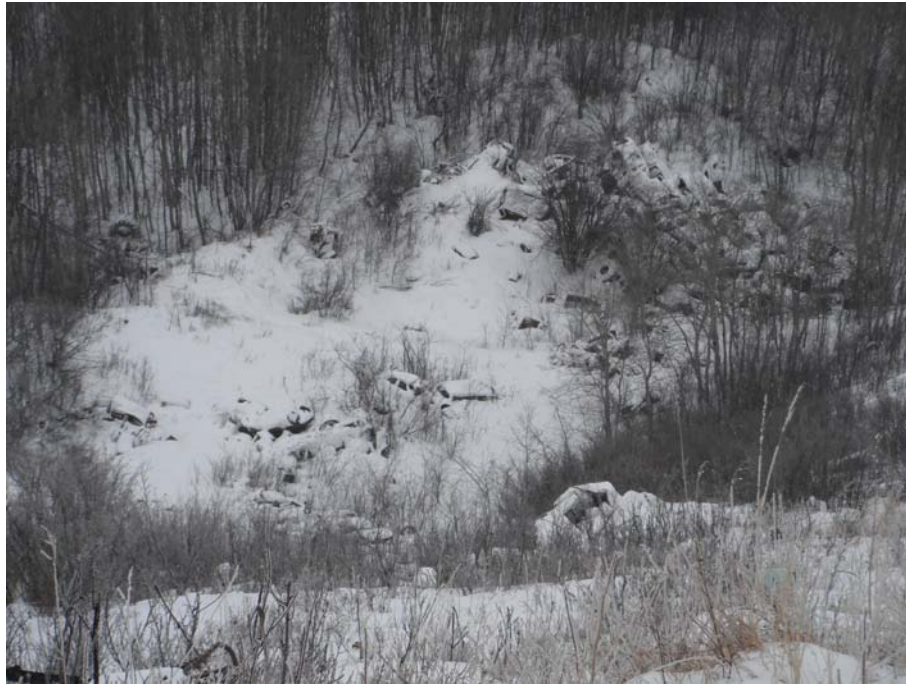
Photo #5 – View of abandoned vehicles at the bottom of the bank on the east side of the Property (photo taken looking east).

There is a ravine located east of the Property. Numerous vehicles and household appliances have been abandoned on the slope of the ravine. No other structures were noted to the further east of the Property.

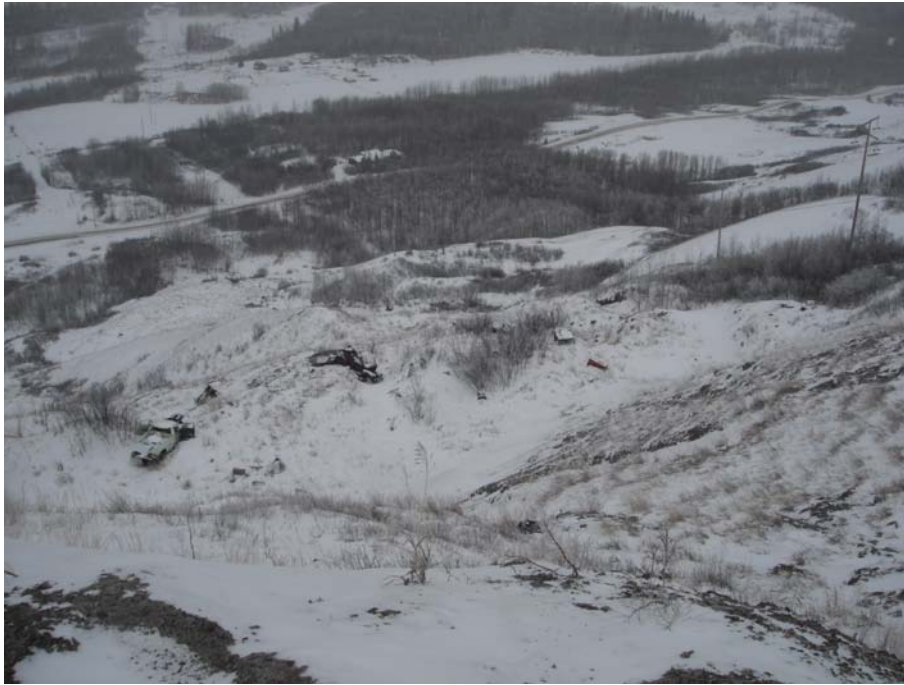
Photo #7 – View of abandoned vehicles on the south edge of the Property (photo taken looking south). Concrete blocks in drainage ditch on northeast corner of the

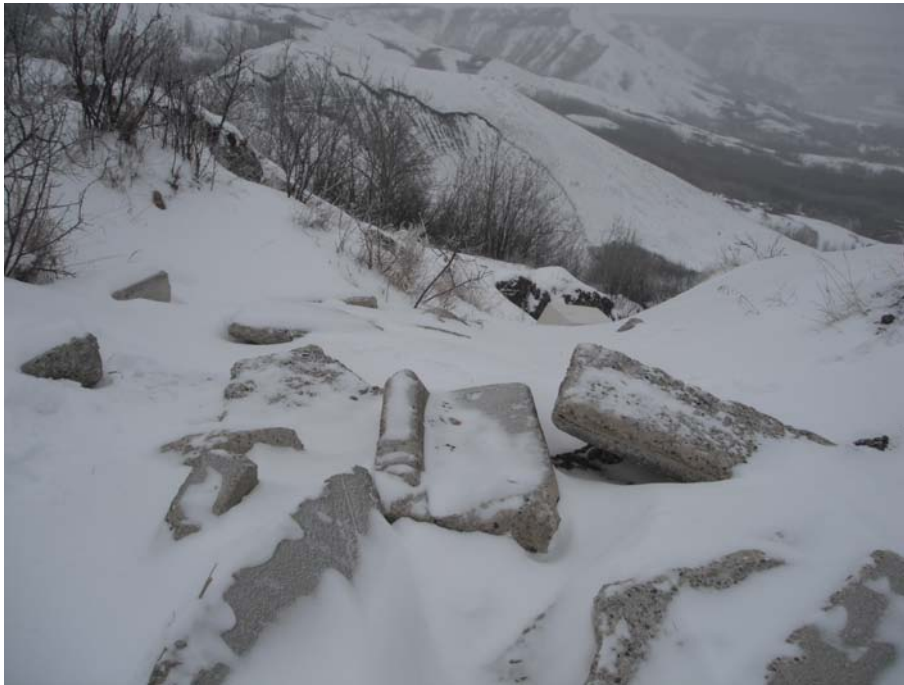
Photo #8 – View of concrete blocks in drainage ditch on northeast corner of the Property (photo taken looking east).

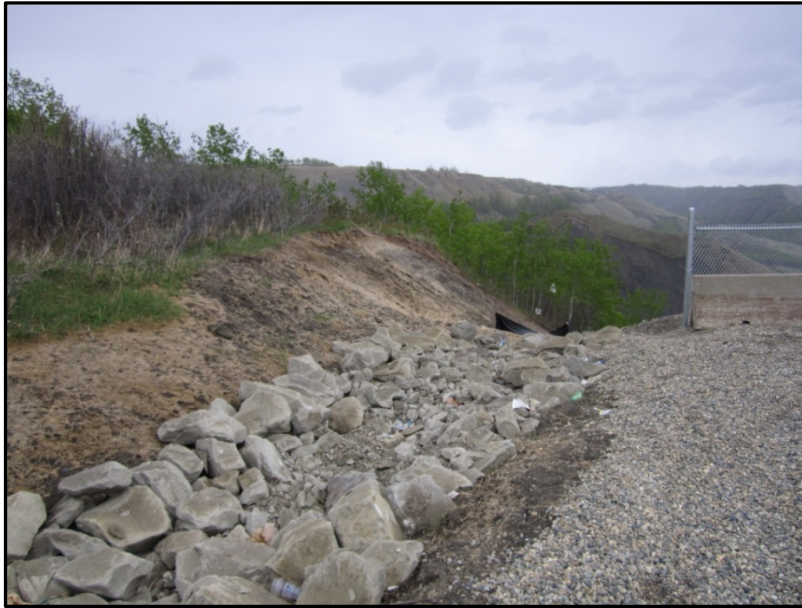
Slide 2.2b: Rip rap installed in the drainage ditch to the left of the viewing area
