PEACE RIVER LOOKOUT DRAINAGE PLAN

PEACE RIVER REGIONAL DISTRICT

PROJECT NO.: 181-13098-00

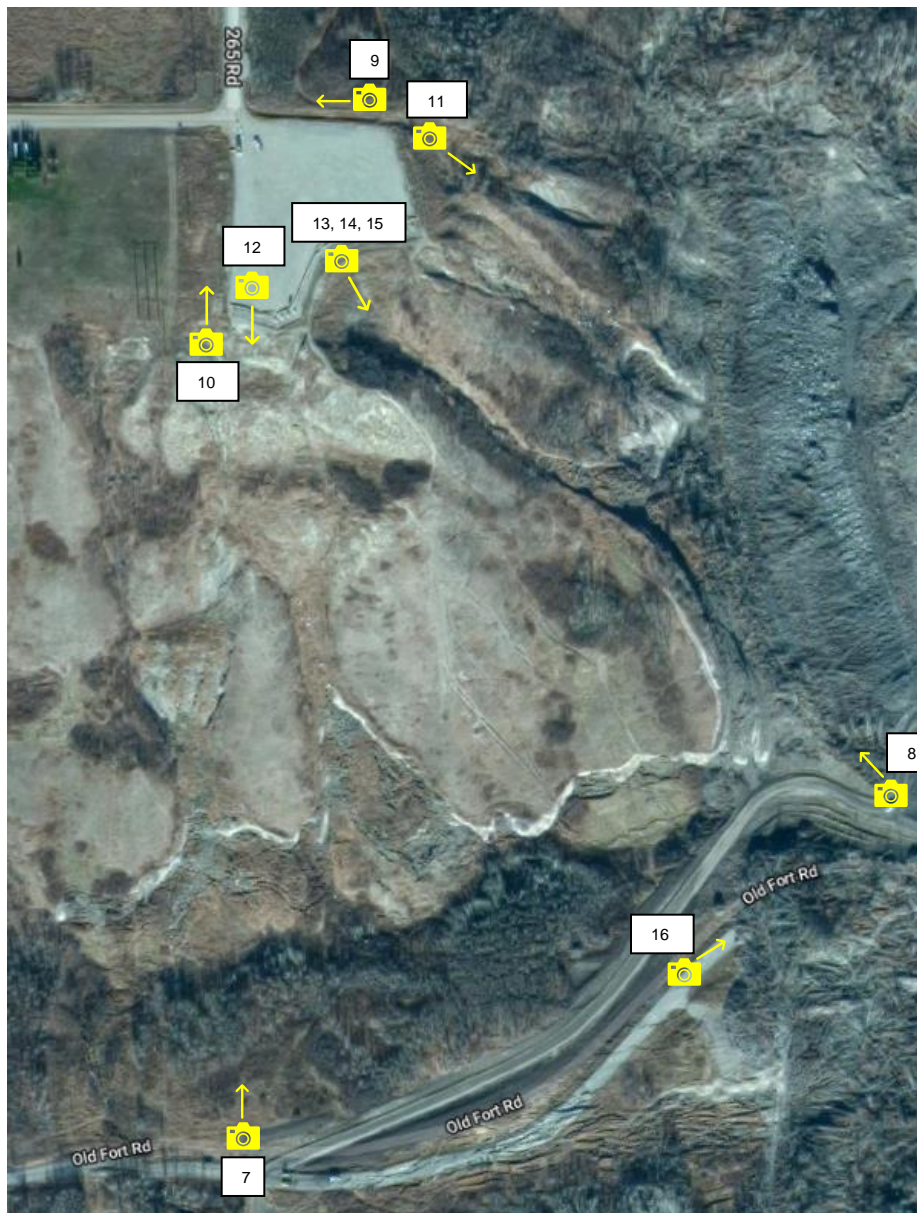
Figure 4. Google maps imagery showing locations of photos captured at Peace River Lookout (April 2019)

Figure 4 provides a guide to the photo capture locations throughout the report.

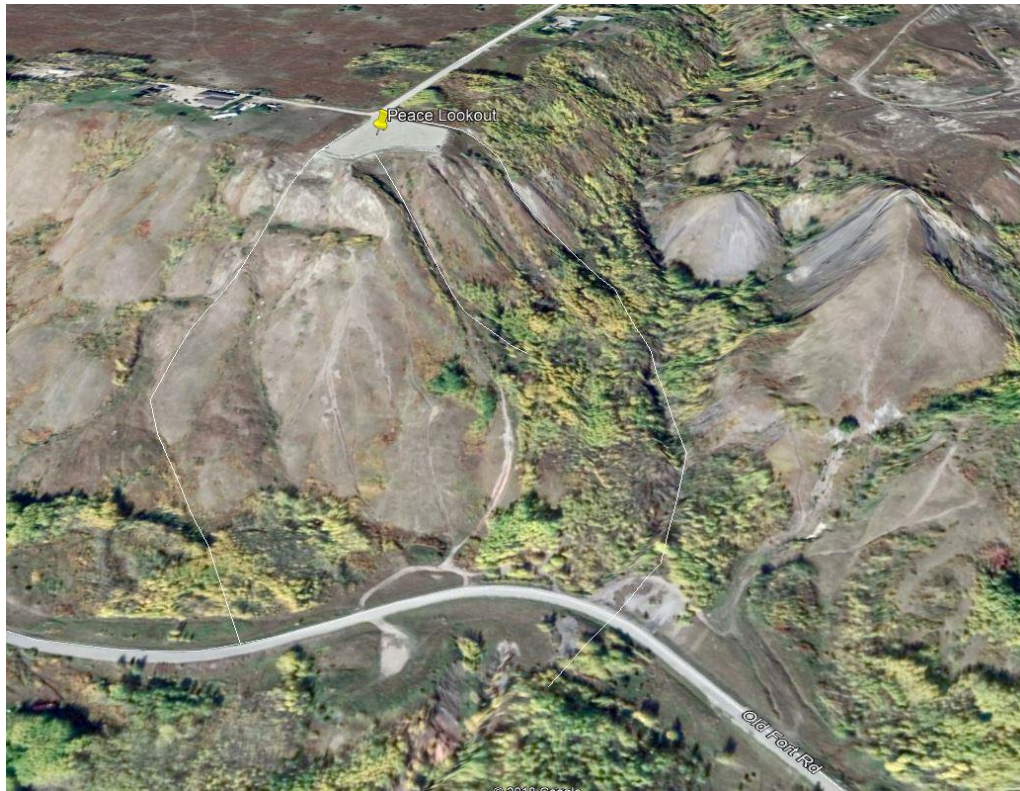
Figure 5 shows the 3 drainage paths flowing from the Peace River Lookout to Old Fort Road in the valley. The west (left), middle, and north drainage paths are represented with thin white lines.

Figure 5. Google Earth imagery of the sites outflow drainage paths pre-landslide.

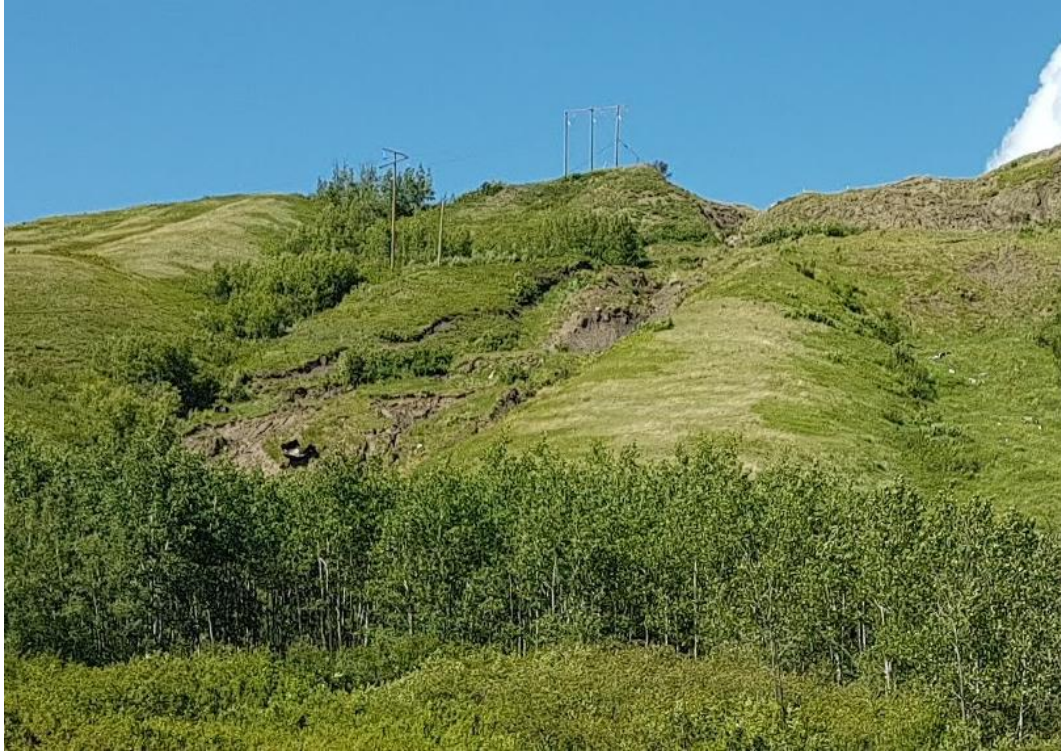
Figure 7. West drainage path as of June 2018.

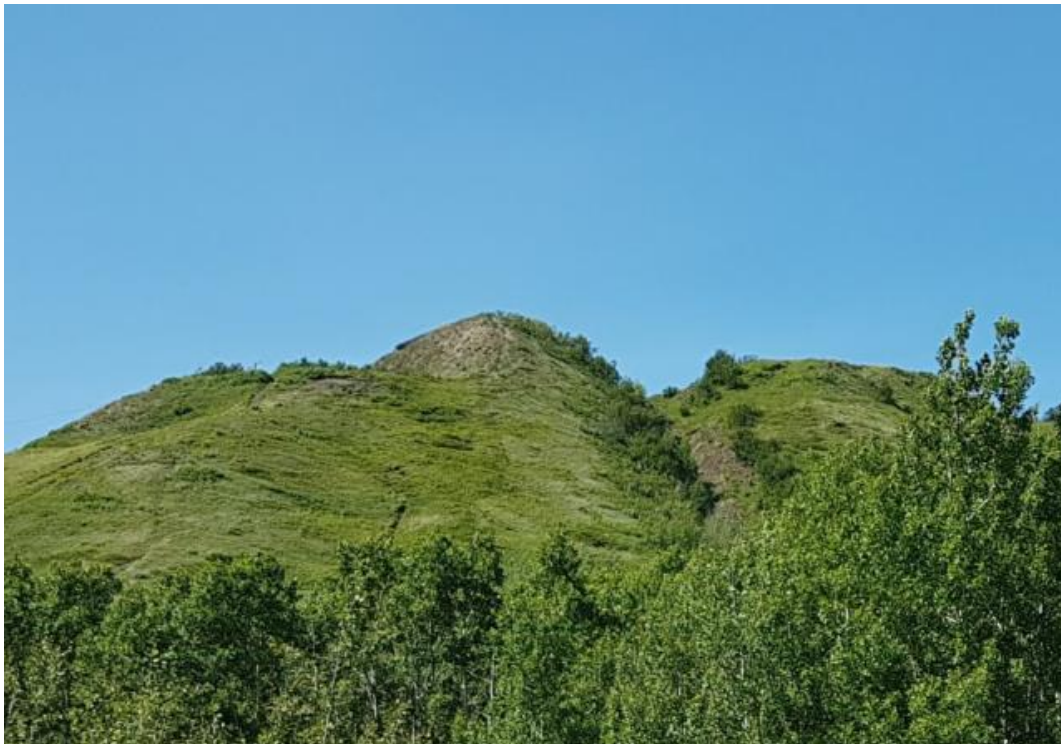
Figure 8. East drainage path as of June 2018.

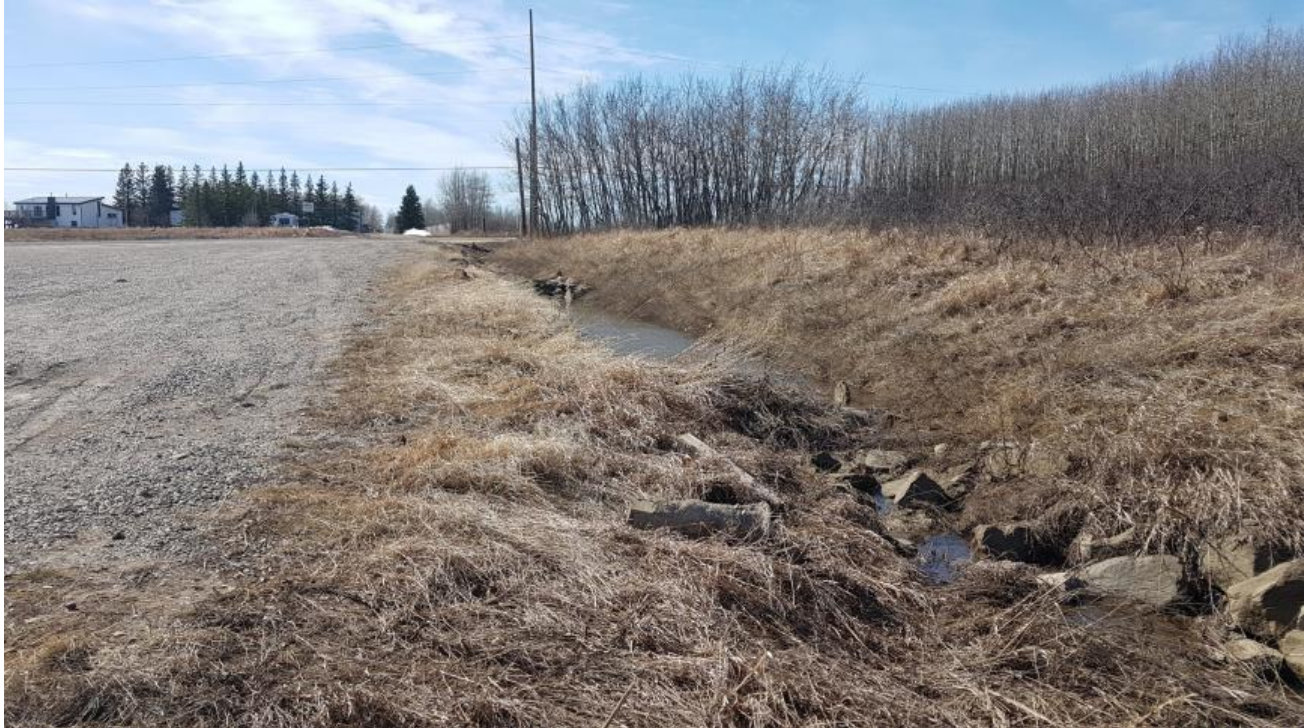
Figure 9. Existing north collection ditch conveying drainage at the top of the lookout as of April 2018.

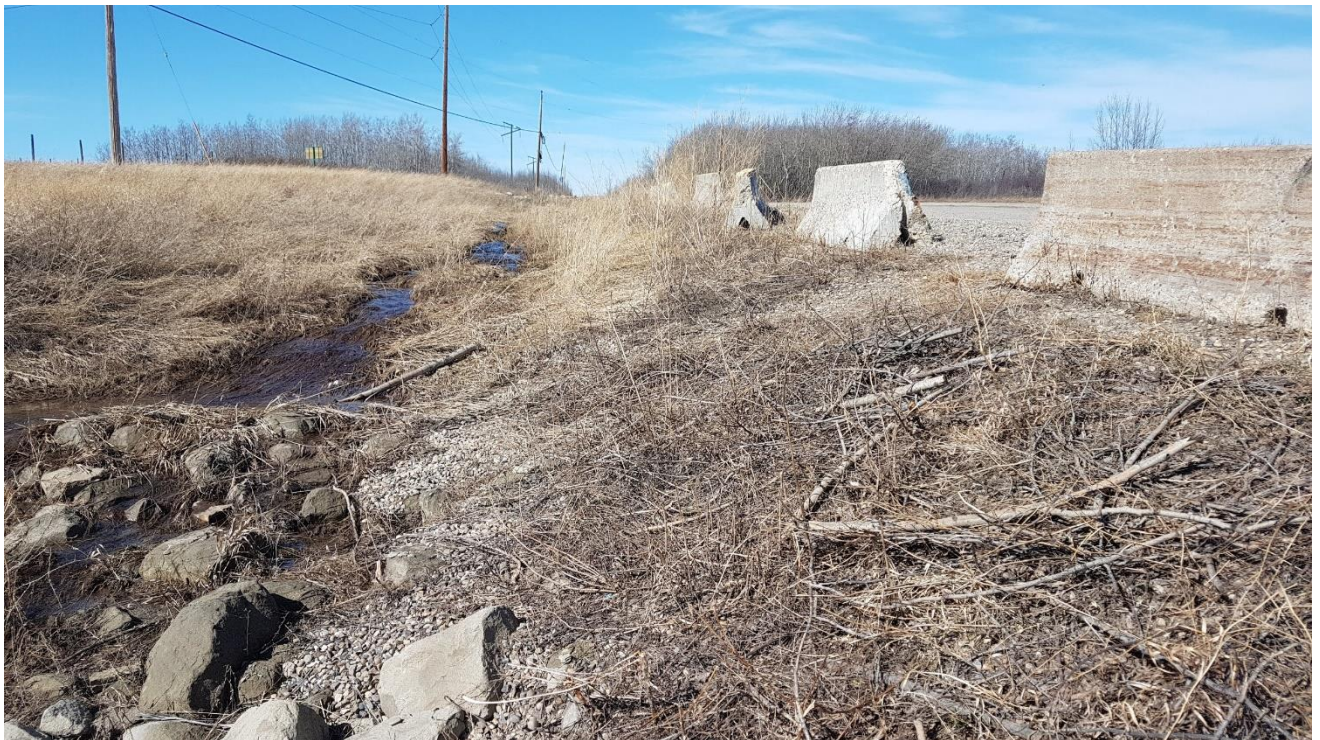
Figure 10. Existing west collection ditch conveying drainage at the top of the lookout as of April 2018.

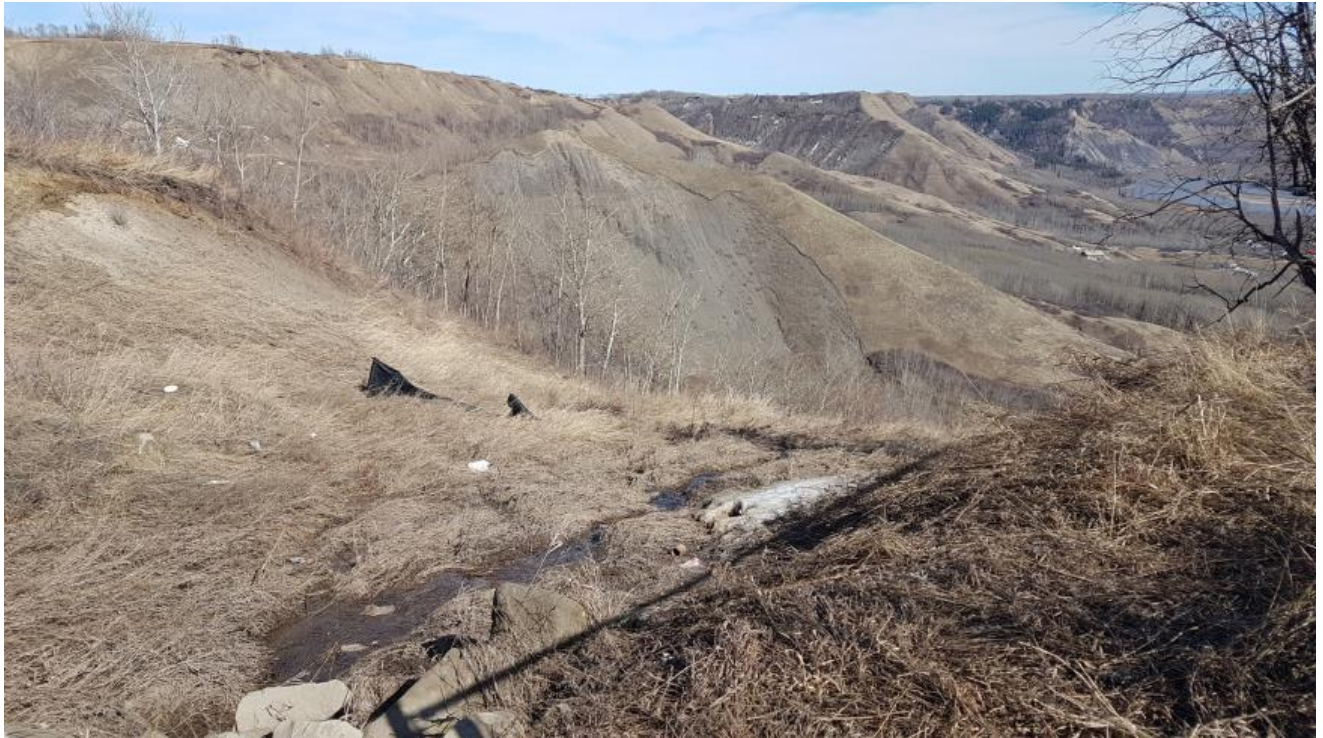
Figure 11. Erosion from the top of the east drainage as of April 2018.

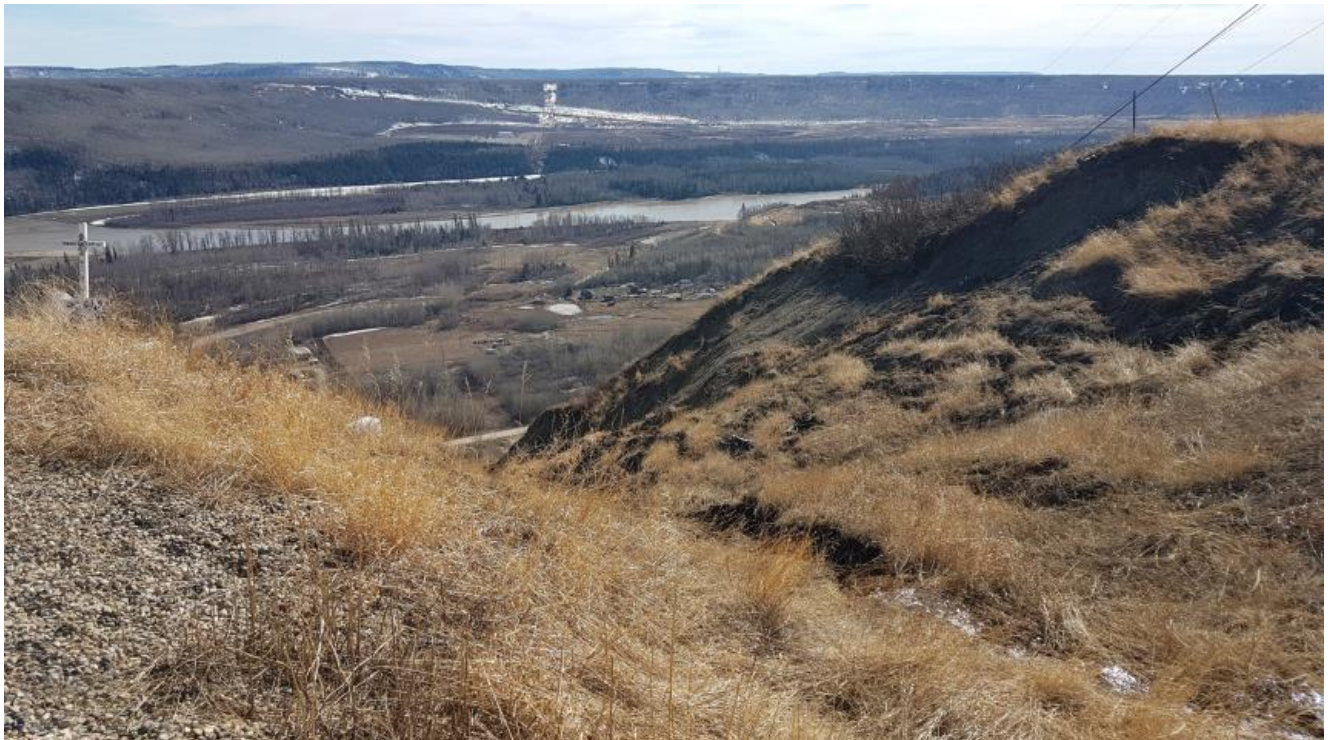
Figure 12. Erosion from the top of the west drainage as of April 2018.

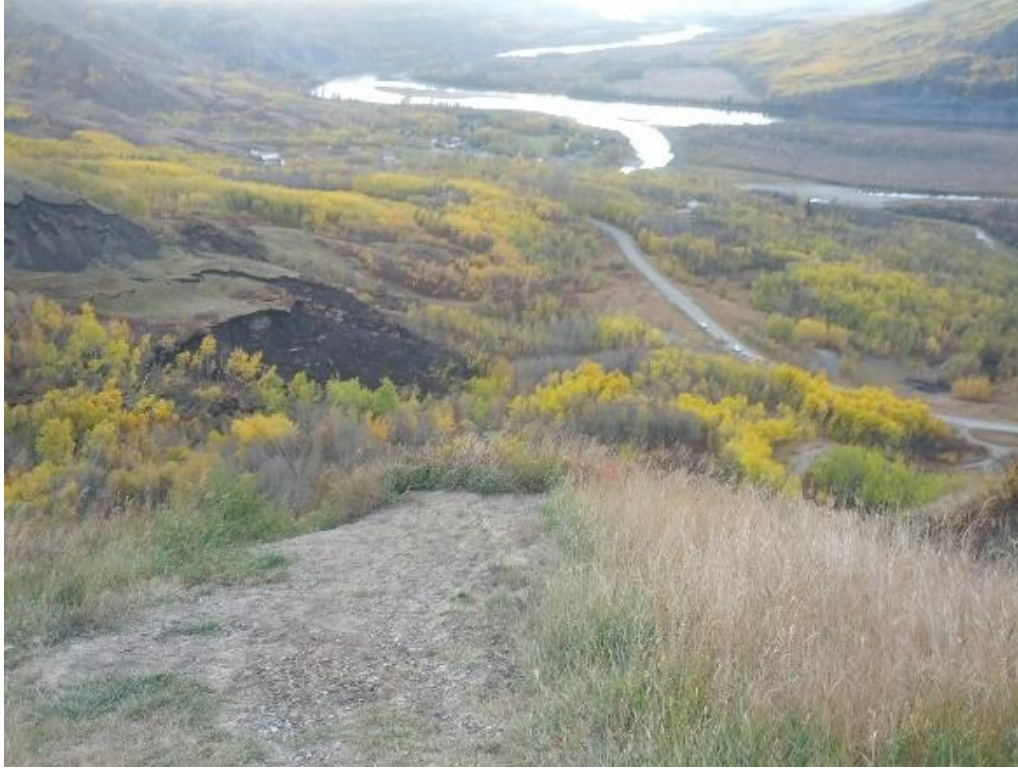
Figure 13. Landslide movement prior to the slide crossing Old Fort Road, as seen from Peace River Lookout (October 2018).

Over the course of several days a slow-moving landslide made its way down a hill adjacent to the Peace River Lookout. This slide eventually crossed Old Fort Road and cut off the community of Old Fort as this route provided the only method of travelling to and from the community. An evacuation of Old Fort commenced in October of 2018 as a result. Figures 13 to 16 show photos of the development of the creeping landslide making its way down the slope towards Peace River.

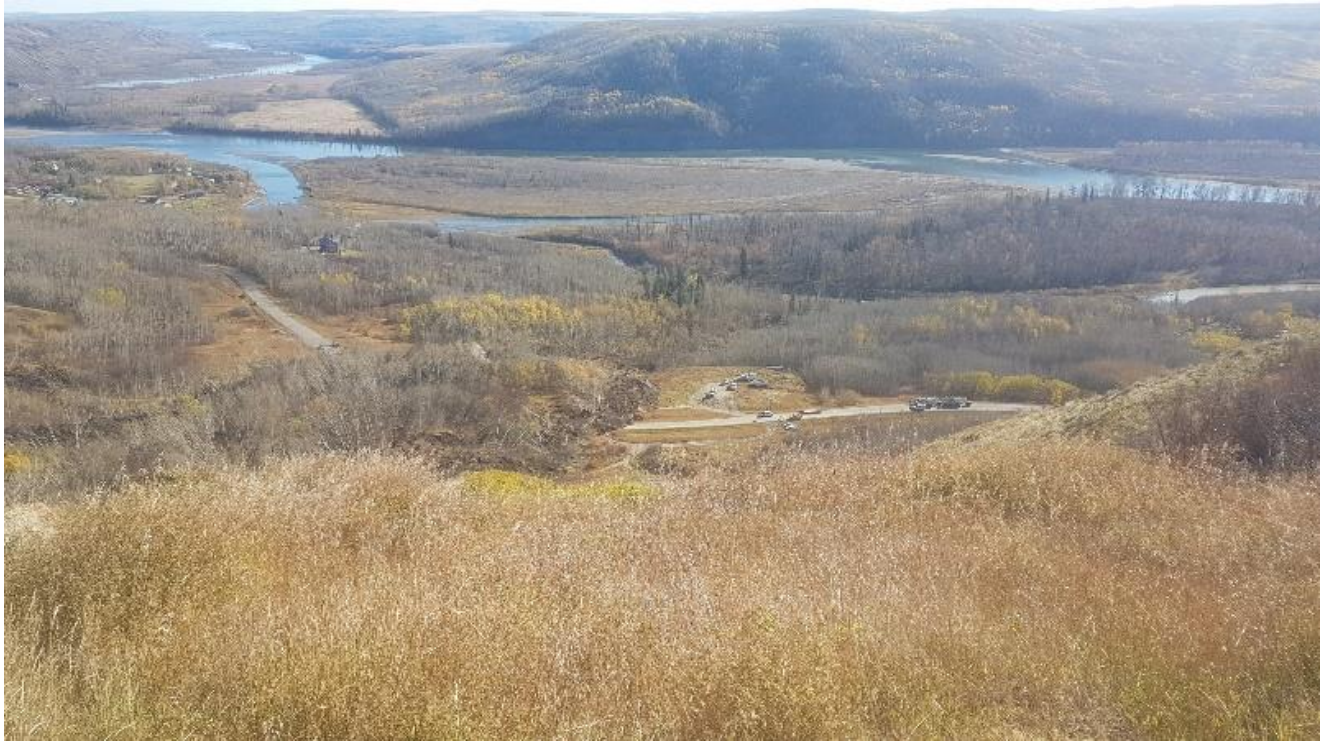
Figure 14. Landslide movement across Old Fort Road, as seen from Peace River Lookout (October 2018).

This slide was immediately adjacent to the Peace River Lookout and the area considered for development. There was no structural damage to the lookout area, but the down stream drainage courses were altered. We are unsure what effect continued runoff through the slide.

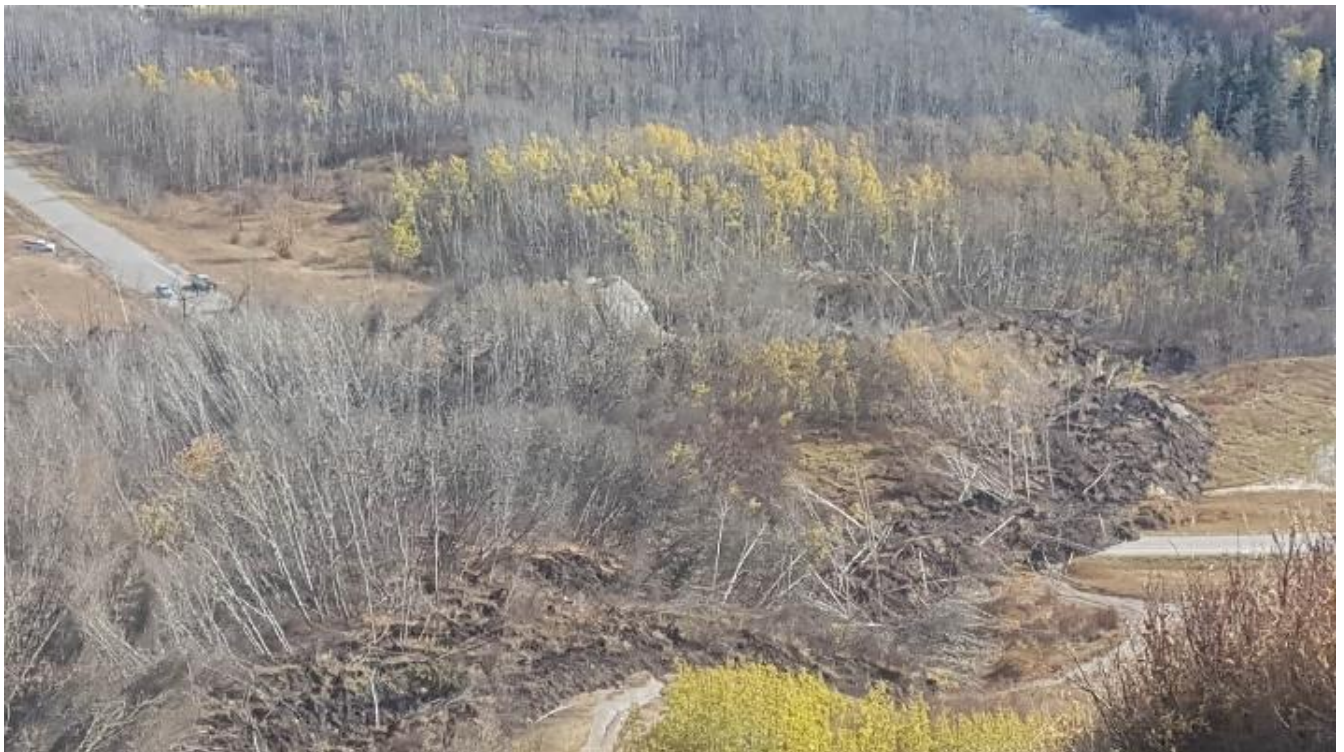
Figure 15. Zoomed image of landslide movement across Old Fort Road (October 2018).

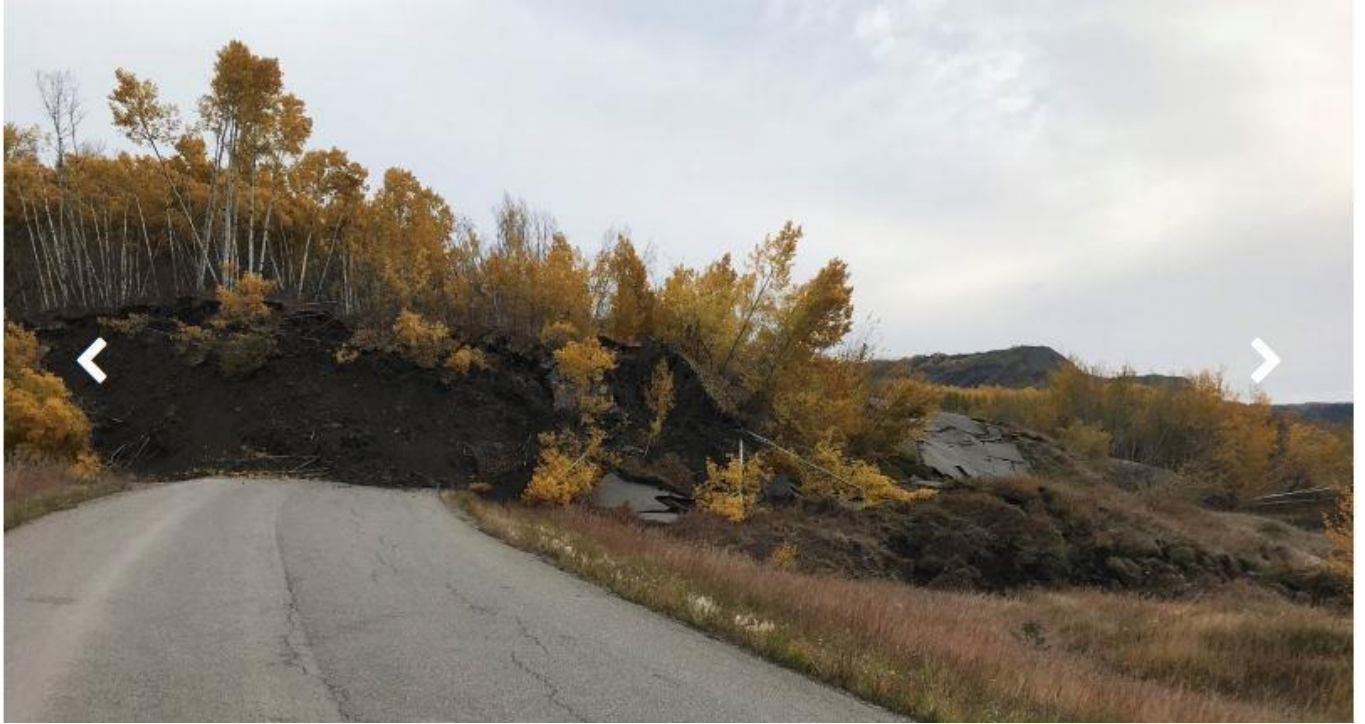
Figure 16. Photo showing the extent of the landslide blocking Old Fort Road (October 2018).

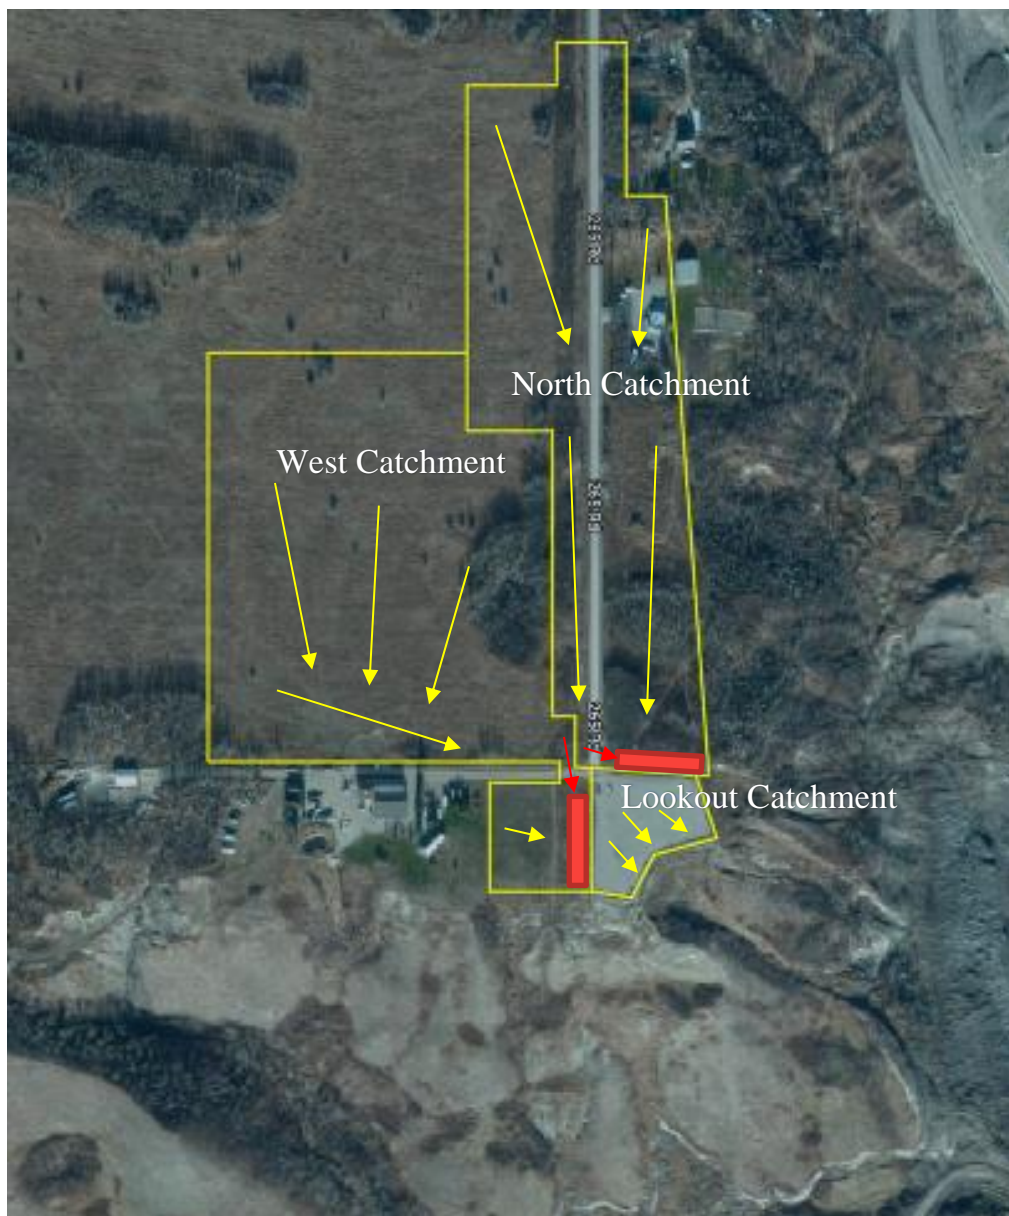
Figure 17 shows the catchment areas and Figure 18 indicates the location of the detention ditches and the drainage at the top of the slope. Yellow arrows represent overland flow within the catchment areas, while red arrows show culvert piping connecting the detention ditches. In Figure 18, green arrows represent existing drainage paths that convey stormwater off-site, while blue arrows show proposed new drainage paths.

Figure 17. Stormwater drainage site plan for Peace River Lookout, showing the 3 catchment areas.

Figures 17 and 18 provide a visual of the site drainage plan as it pertains to Peace River Lookout. There are three catchment areas, where the north and west catchments drain to the north and west detention ditches adjacent to Peace River Lookout. The lookout catchment drains out of the park site as overland flow retained during a storm event.

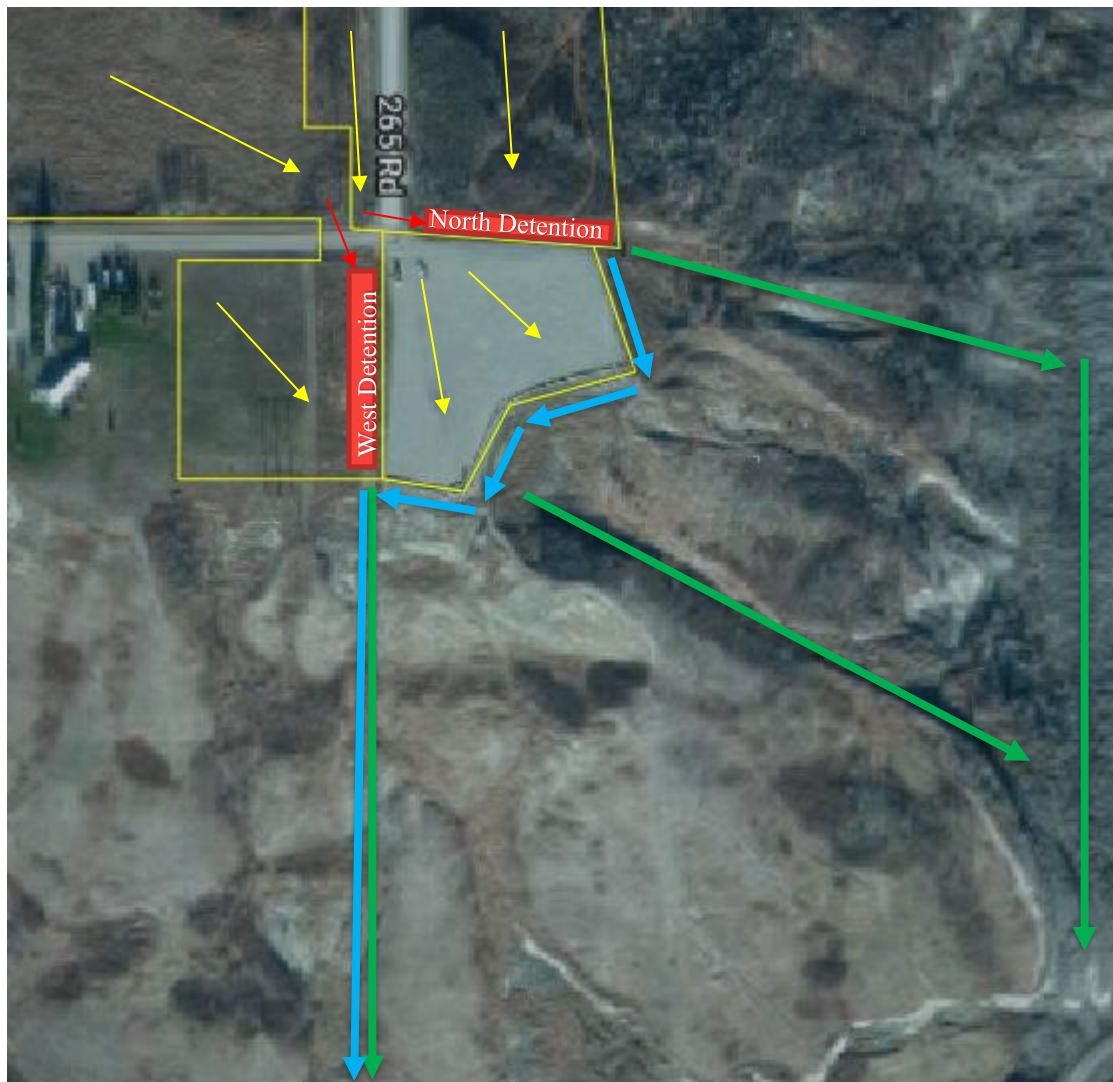
Figure 18. Stormwater drainage site plan for Peace River Lookout, showing proposed drainage paths and detention ditches.

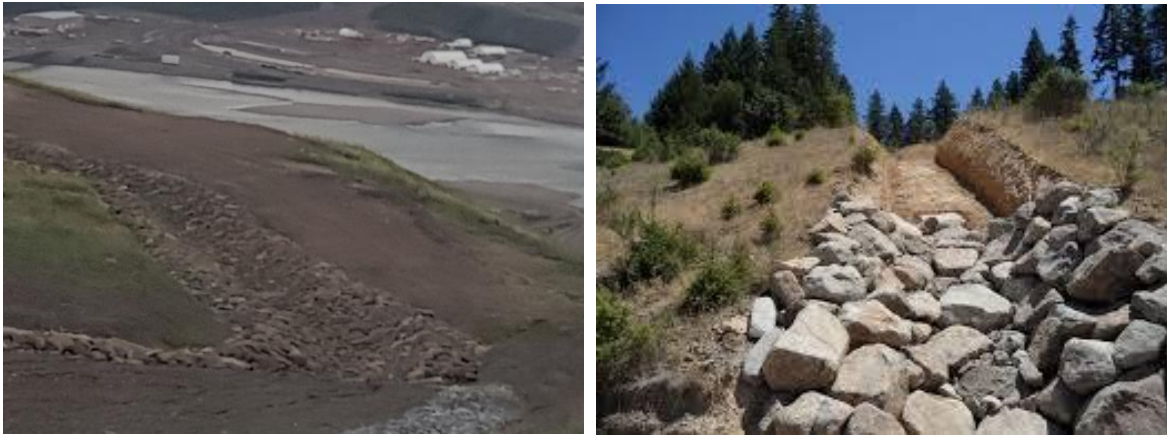
Pros:	Prevents erosion, Decreases water velocity, Benefits to water quality
Cons:	Expensive, Difficult to maintain, Difficult to access

Figure 20. Examples of a riprap drainage path.

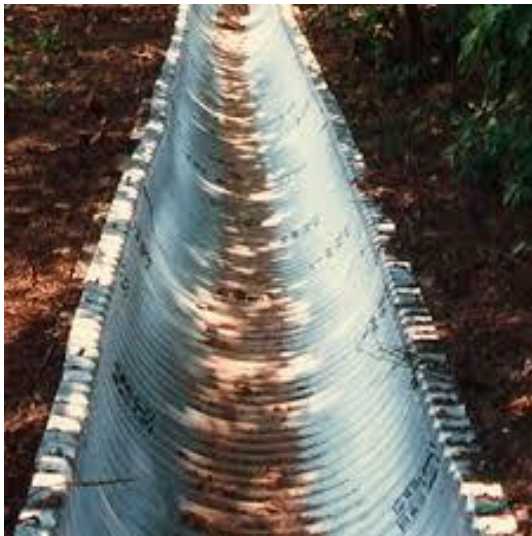
Pros: Prevents erosion, Easy to maintain

Cons: Visually displeasing

Figure 21. Example of a flume pipe drainage path.
