Buick Creek Arena (Rural)

Asset:
Clearview Arena (Rural)

Asset:
Fort St. John Curling Club

Asset:
North Peace Arena

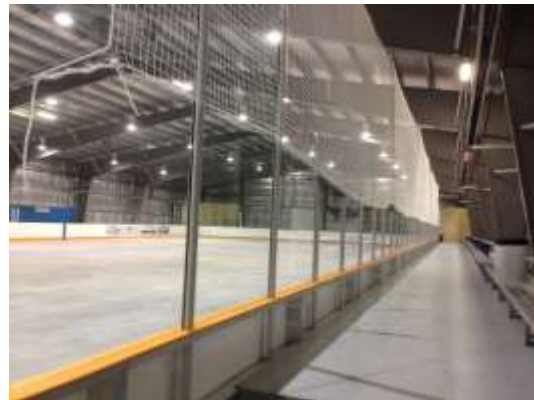
Interior: Foil film over insulation. Drywall and t-bar in team and public areas. Fair.

Interior finishes were economical choices that will show premature fatigue.

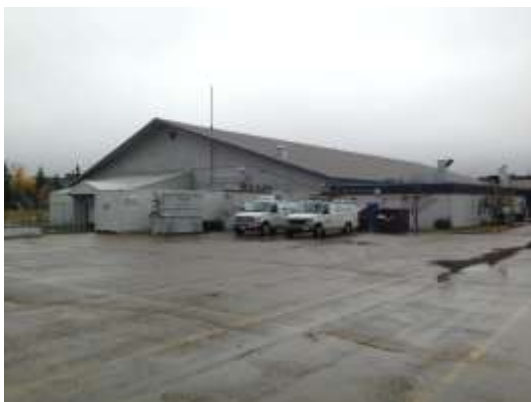
Exterior

Roof repaired but more envelope issues expected given facility age. Approaching 50 years of age, structural issues may be emerging (corrosion of rebar in concrete; stress and fatigue fractures).

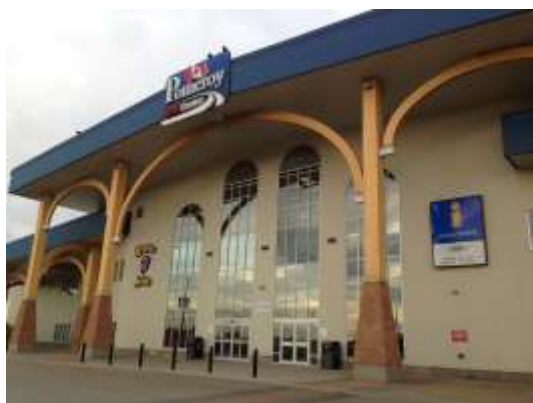
Exterior

Roof: Built-up roof with torch-on membrane. Poor.

Persistent roof issues may require premature replacement. Cosmetic improvements may be expected within 10 years, mechanical lifecycle issues not for at least 20 years.

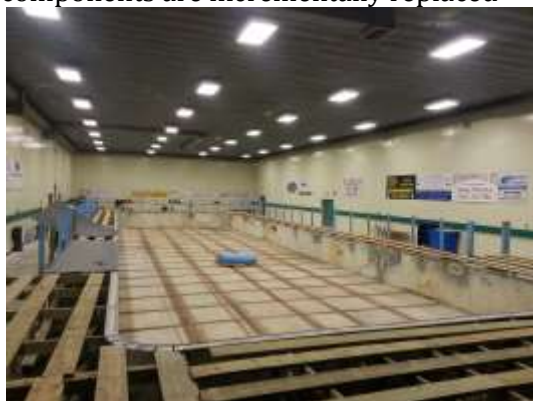
Pool being erected

Capital interventions anticipated: Building envelope, especially roof will soon begin showing its age. Interior finishes need sprucing-up. Portable pool components are incrementally replaced

each year so no large capital outlay needed.
