Asset:

Kids Arena Fieldhouse

Location: Fort St. John

Asset:
North Peace Gymnastics Club

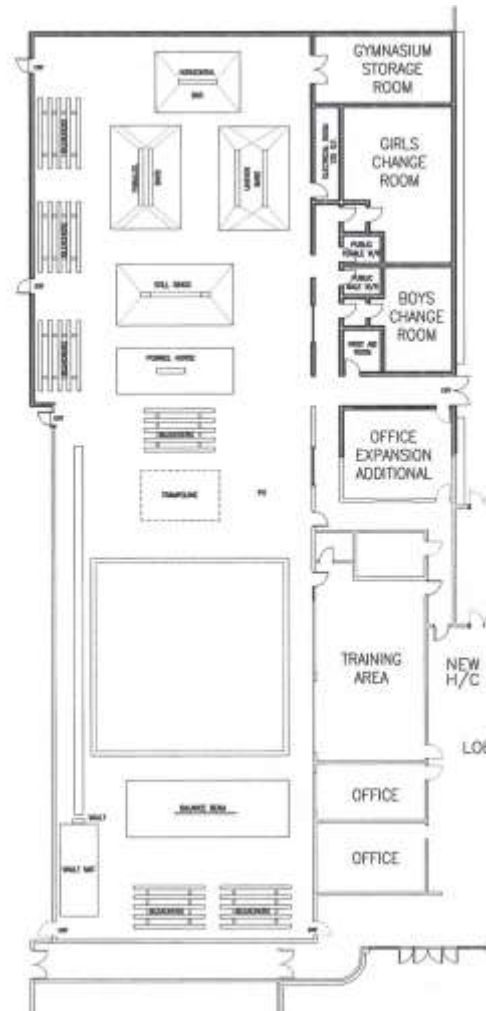
Equipment Layout

Functionality: Space converts for equipment; old pool tank allows for in-floor trampolines. Good.

Capital interventions anticipated:
Planning for a larger replacement facility has been initiated by the Club.
