## ELECTORAL AREA DIRECTORS COMMITTEE MEETING A G E N D A

### ELECTORAL AREA DIRECTORS COMMITTEE MEETING MINUTES

**Facility Condition Assessment Report  
Kelly Lake Community Centre**

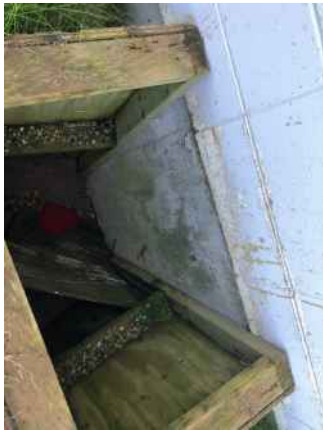
Kelly Lake Community Centre - A1010

No major deficiencies were observed or reported.

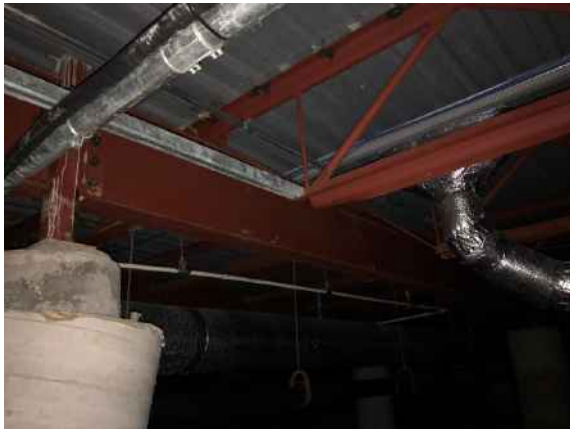
Kelly Lake Community Centre - B1010

No major deficiencies were observed or reported.

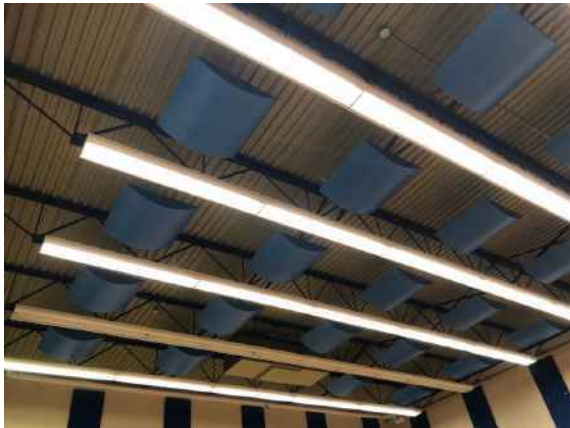
Kelly Lake Community Centre - B1020

No major deficiencies were observed or reported.

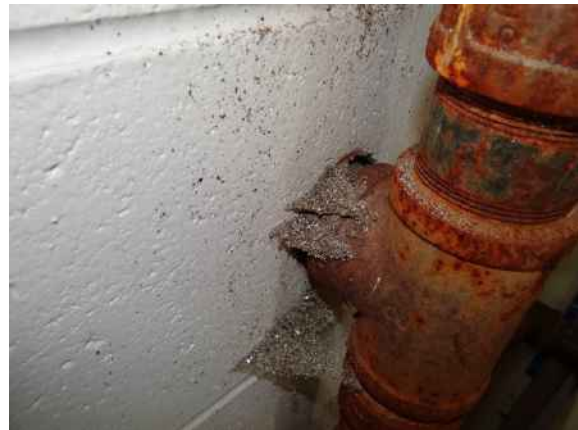
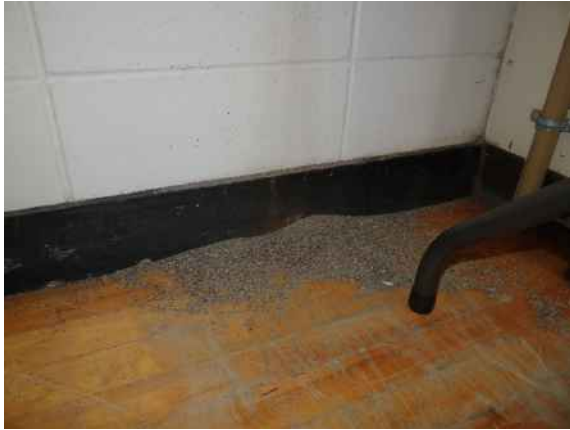
Kelly Lake Community Centre - B1030 Structure

No major deficiencies were observed or reported regarding the block masonry. However, a study to confirm the presence of asbestos containing vermiculite is recommended. The study, HazMat Assessment, should consider the facility entirely at the time of the assignment.

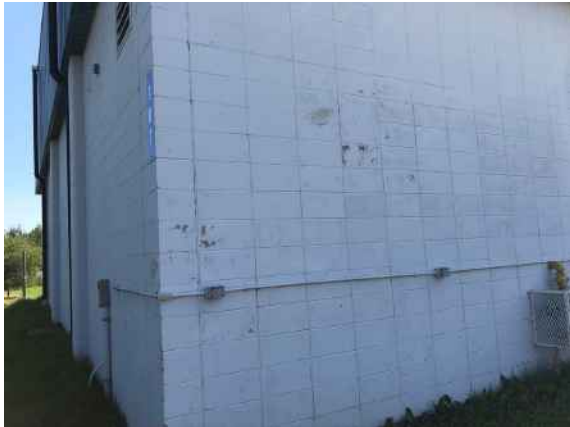
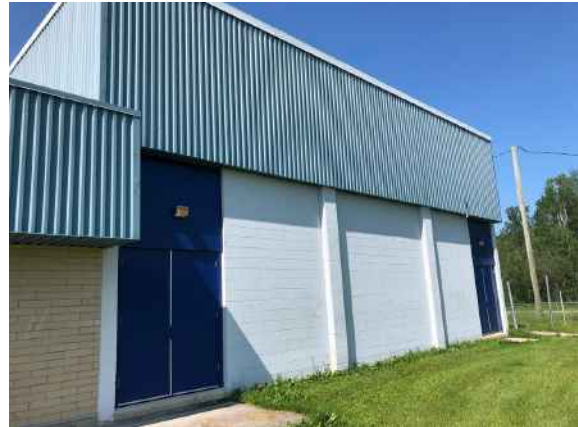
Kelly Lake Community Centre - B201010

Peeling and weathered paint was observed.

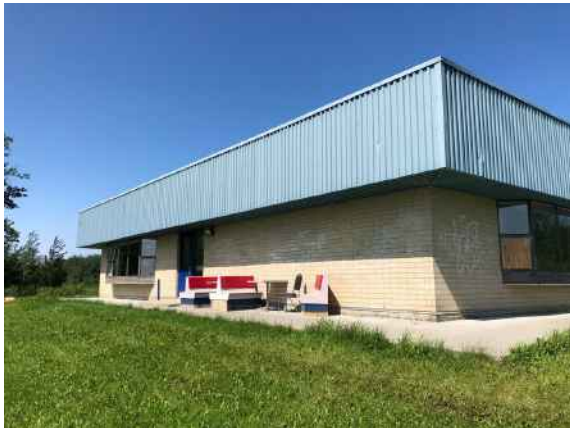
Kelly Lake Community Centre - B201021

No major deficiencies were observed or reported.

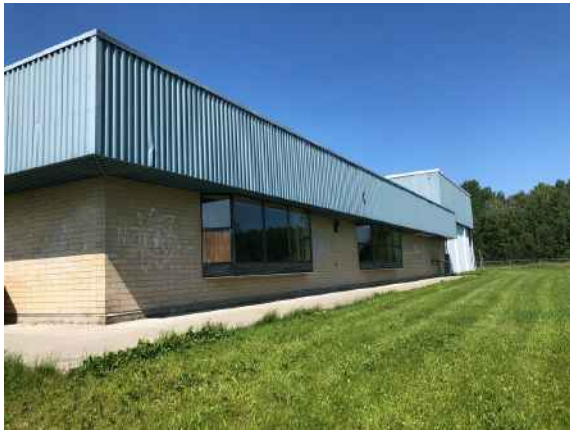
Kelly Lake Community Centre - B201024

No major deficiencies were observed or reported.

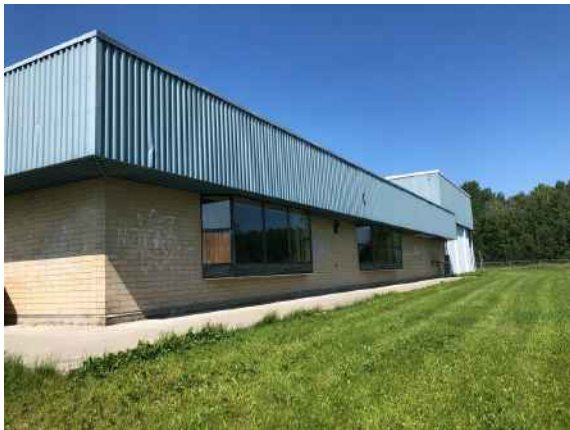
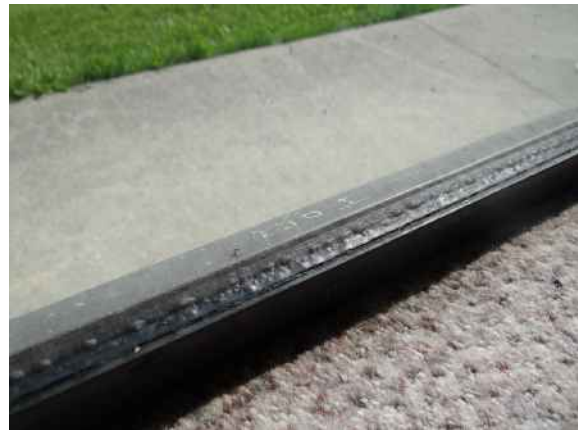
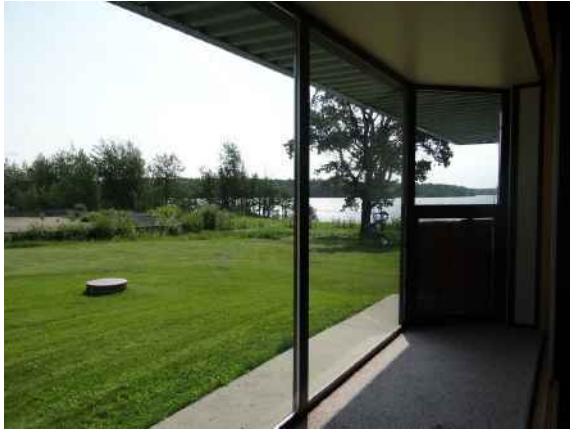
Kelly Lake Community Centre - B202001

No major deficiencies were observed or reported. Some separation and deterioration of the spacers between the panes was observed. It was reported that some operable windows are performing as designed.

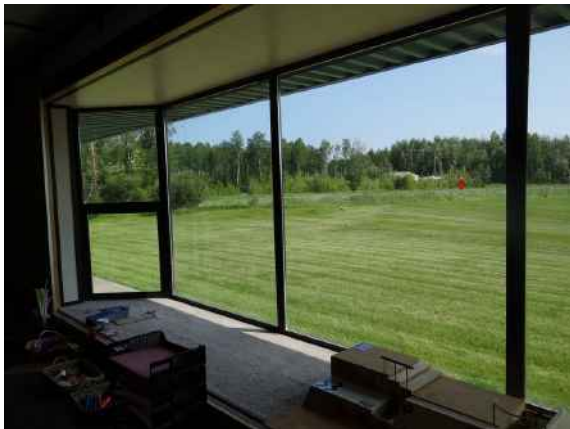
Kelly Lake Community Centre - B202001

No major deficiencies were observed or reported.

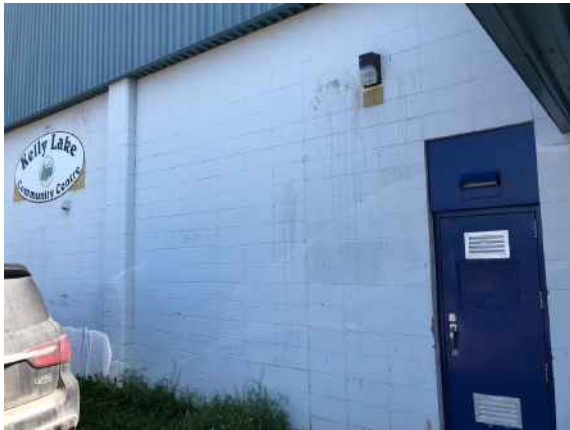
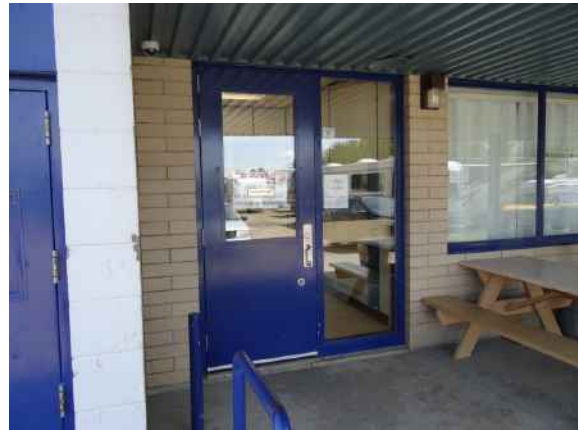
Kelly Lake Community Centre - B203002

No major deficiencies were observed or reported.

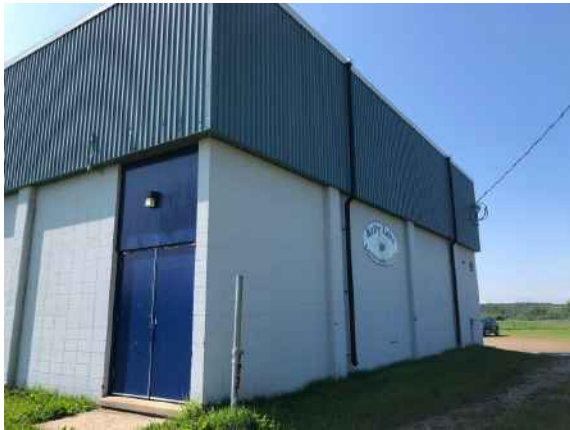
Kelly Lake Community Centre - B203003

No major deficiencies were observed or reported.

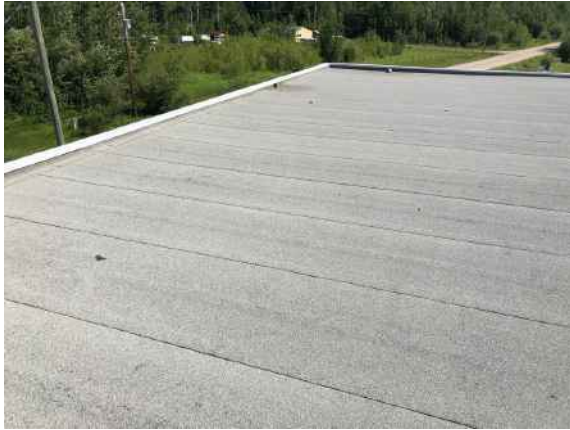
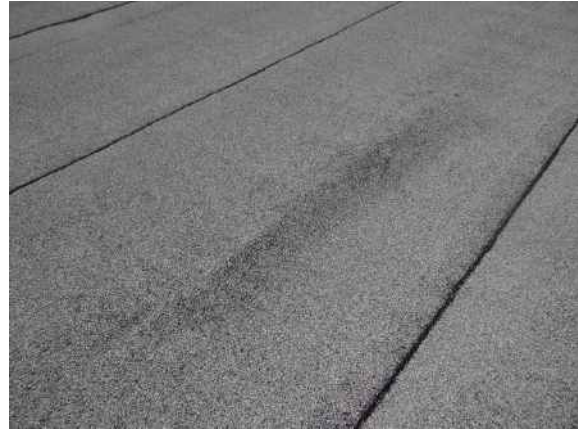
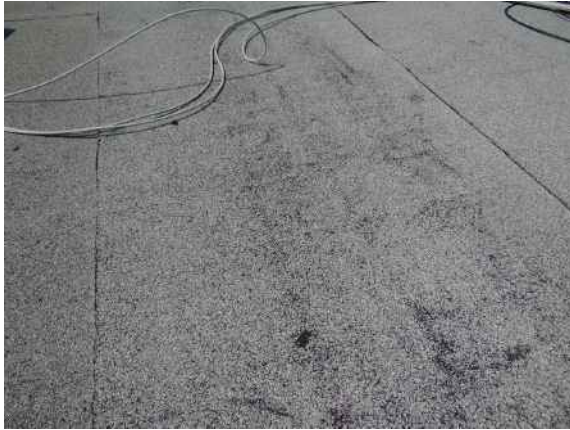
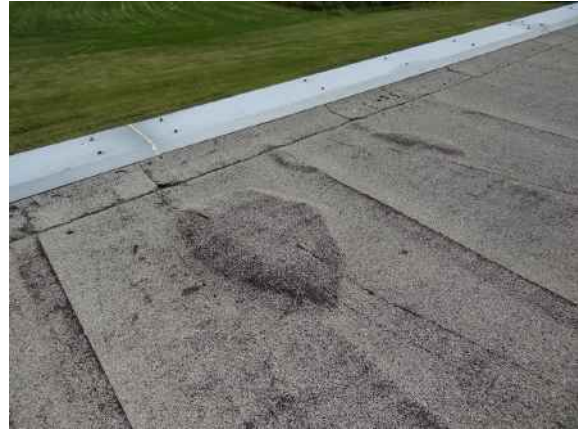
Kelly Lake Community Centre - B301022

Some ridging, surface wear, and cracking was observed. It was reported that some areas on the lower roof have been repaired. Water stains were observed on ceiling tiles suggesting possible previous leaks.

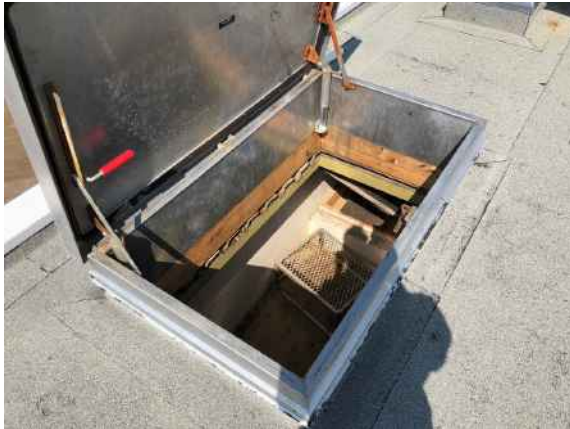
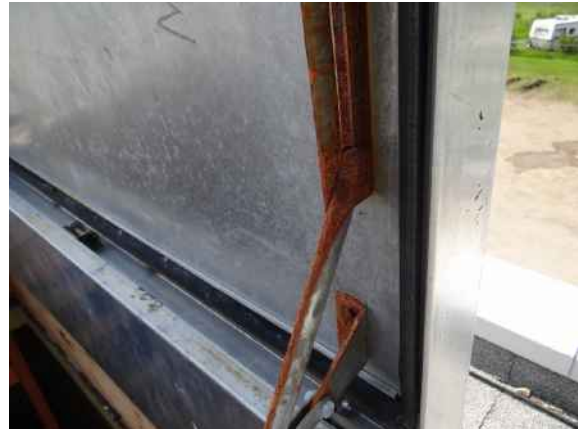
Kelly Lake Community Centre - B302022

The hatch was serviceable at the time of the assessment. However, corrosion was observed on the hinging mechanism.

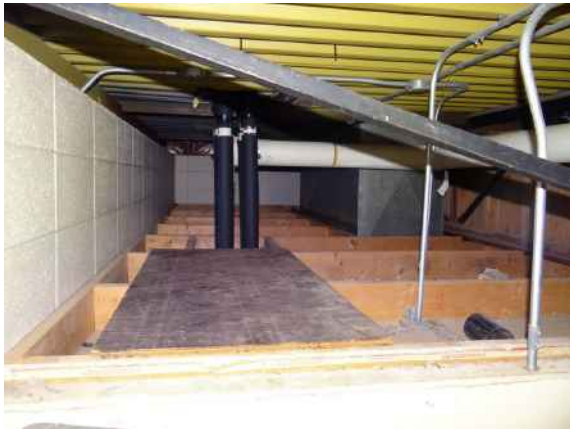
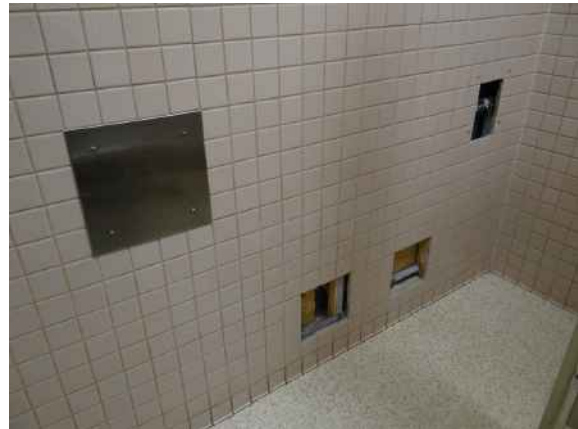
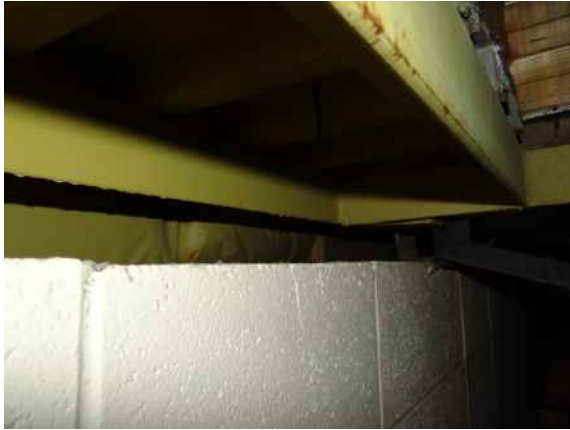
Kelly Lake Community Centre - C101001

No major deficiencies were observed or reported to the wall assemblies. However, unsealed penetrations in fire rated wall assemblies was observed and should be reviewed.

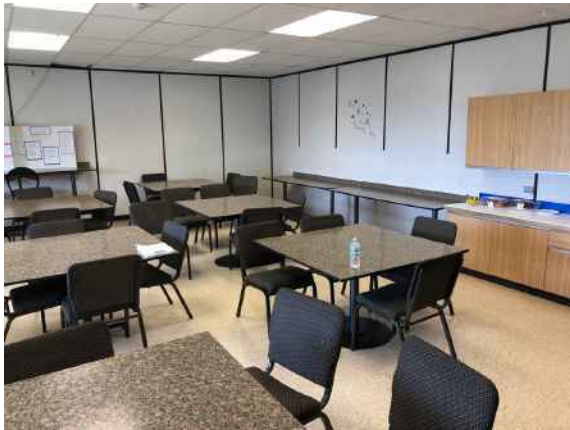
Kelly Lake Community Centre - C101002

No major deficiencies were observed or reported.

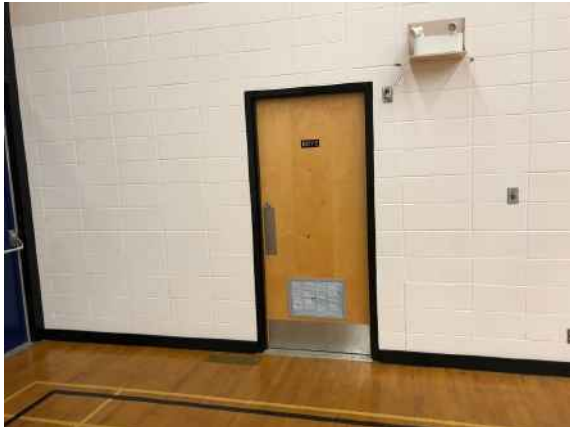
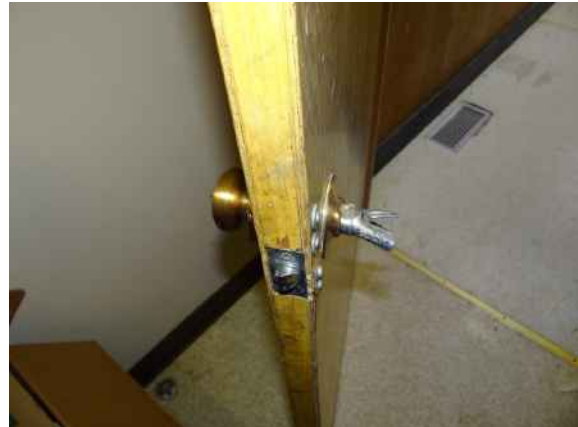
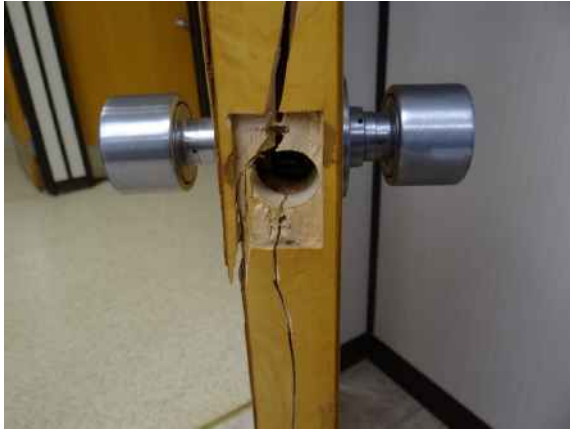
Kelly Lake Community Centre - C102002

No major deficiencies were observed or reported; however, damage to the office door was observed and should be repaired.

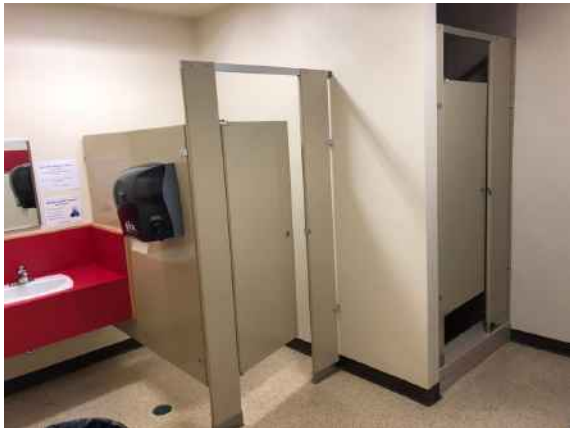
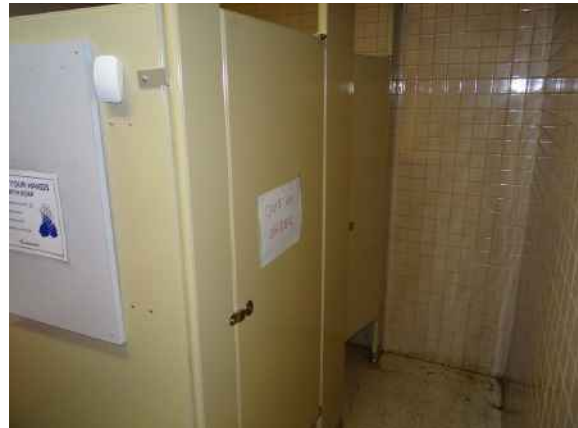
Kelly Lake Community Centre - C103001

No major deficiencies were observed or reported.

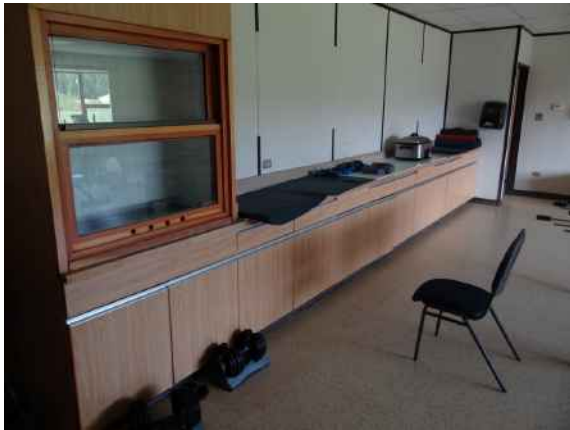
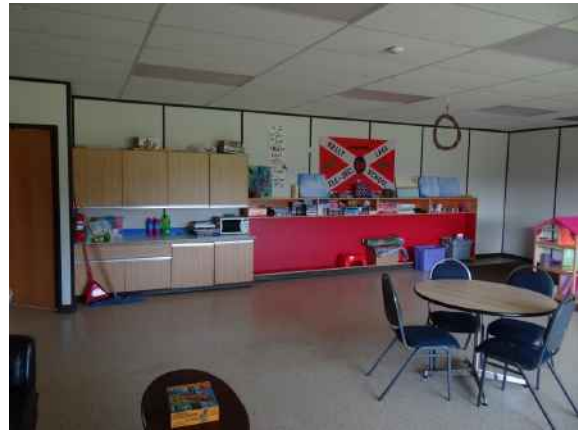
Kelly Lake Community Centre - C103009

No major deficiencies were observed or reported.

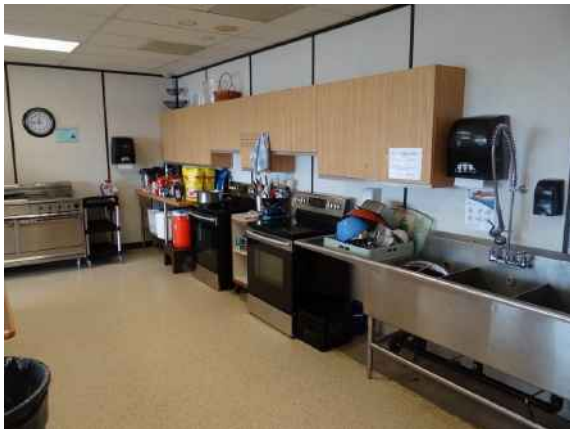
Kelly Lake Community Centre - C103010

No major deficiencies were observed or reported. Some misaligned door hinges were noted and should be addressed as part of maintenance activities.

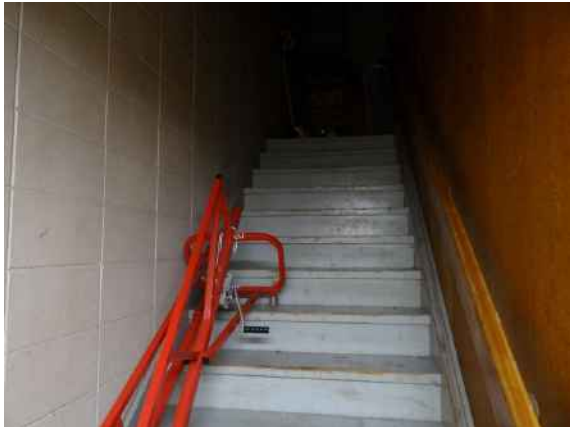
Kelly Lake Community Centre - C201001

No major deficiencies were observed or reported.

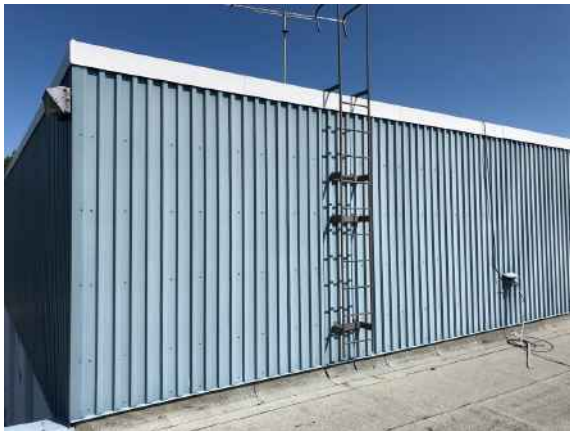
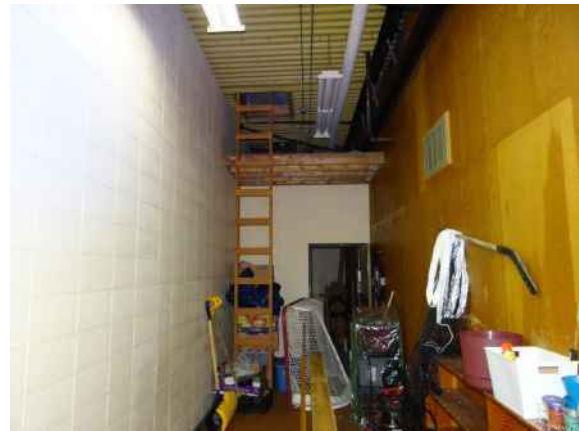
Kelly Lake Community Centre - C201027

No major deficiencies were observed or reported to the ladders. However, access to the mezzanine ladders is challenging and deemed unsafe.

Recommendation #1 - Improve Access to Roof Hatch	
Type	Major Repair
Year	2020
Cost	\$20,000.00

Recommendation #2 - Roof Access Ladders	
Type	Life Cycle Replacement
Year	2025
Cost	\$10,000.00

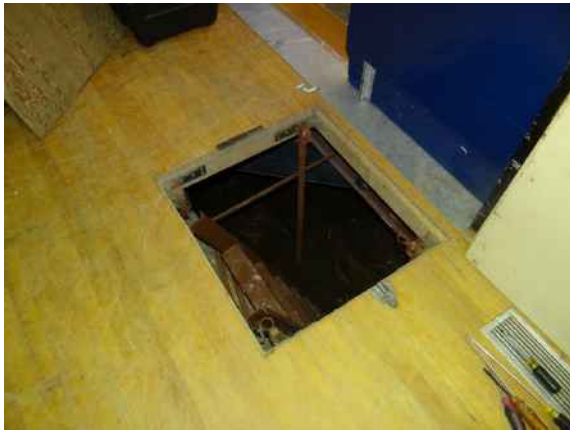
Kelly Lake Community Centre - C201099

No major deficiencies were observed or reported.

Recommendation #1 - Other Stair Construction	
Type	Life Cycle Replacement
Year	2027
Cost	\$20,000.00

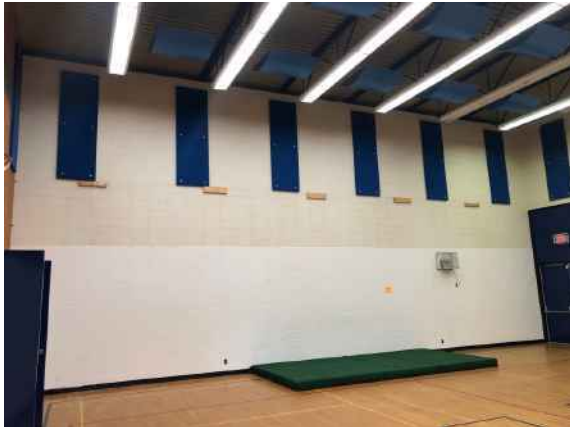
Kelly Lake Community Centre - C301005

No major deficiencies were observed or reported.

Recommendation #1 - Painted Wall Covering	
Type	Life Cycle Replacement
Year	2025
Cost	\$14,400.00

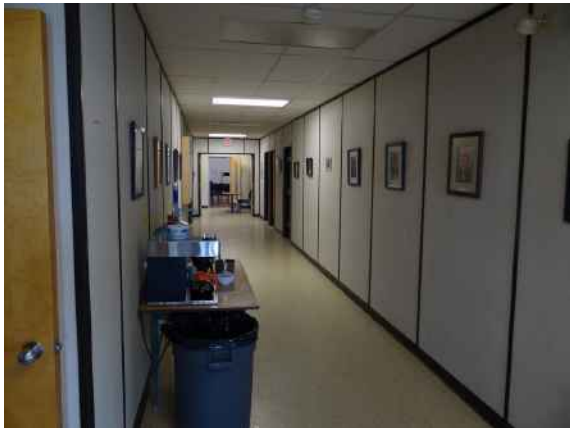
Kelly Lake Community Centre - C301021

No major deficiencies were observed or reported.

Recommendation #1 - Wall Paper	
Type	Life Cycle Replacement
Year	2025
Cost	\$31,500.00

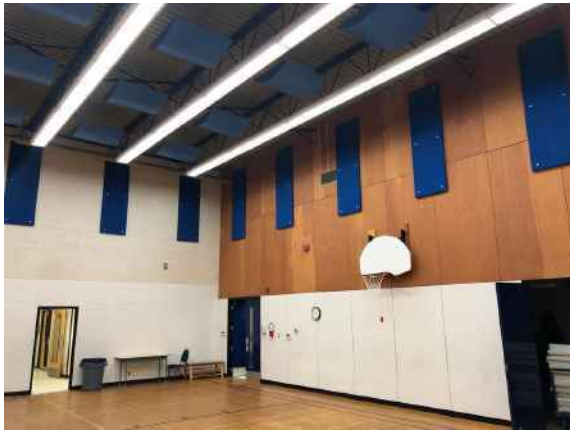
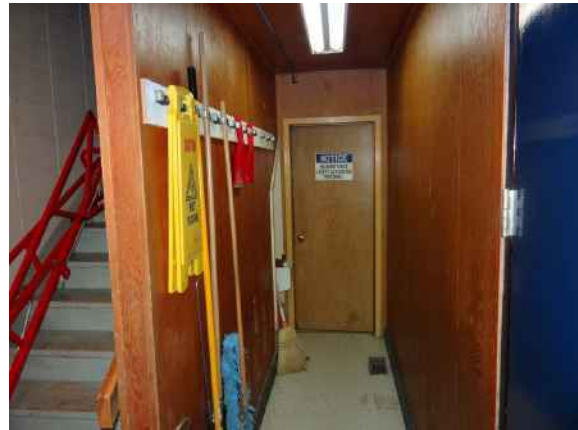
Kelly Lake Community Centre - C301022

No major deficiencies were observed or reported.

Recommendation #1 - Wood Panel	
Type	Life Cycle Replacement
Year	2025
Cost	\$28,080.00

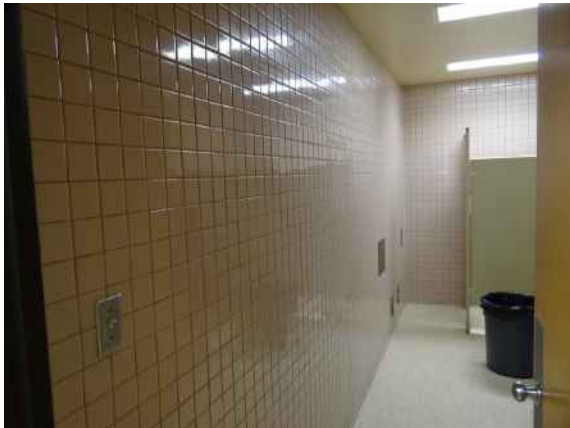
Kelly Lake Community Centre - C301023

No major deficiencies were observed or reported.

Recommendation #1 - Ceramic Tile	
Type	Life Cycle Replacement
Year	2025
Cost	\$39,150.00

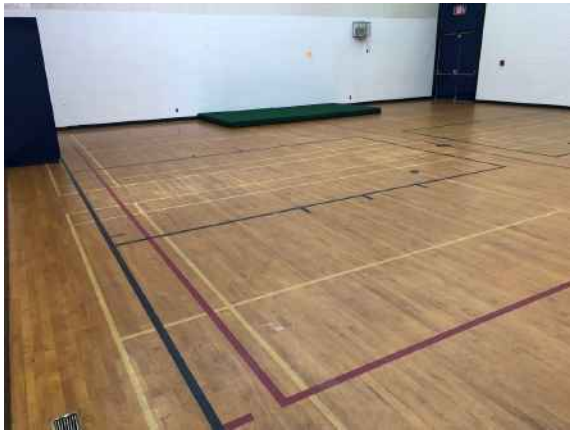
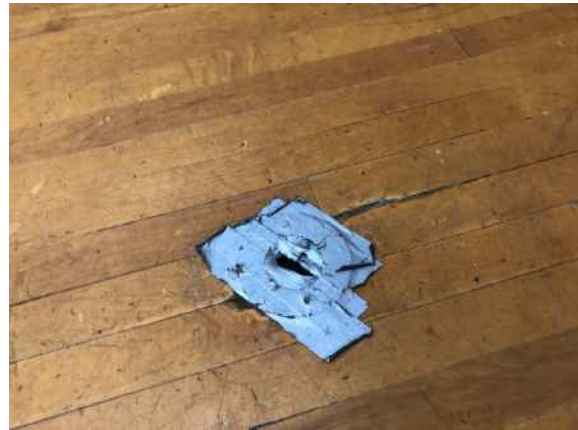
Kelly Lake Community Centre - C302003

Physical damage, uneven floor surface and general wear was observed.

Recommendation #1 - Wood Flooring	
Type	Life Cycle Replacement
Year	2021
Cost	\$75,140.00

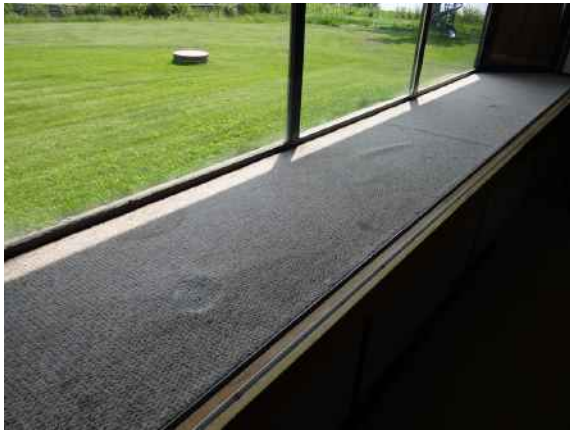
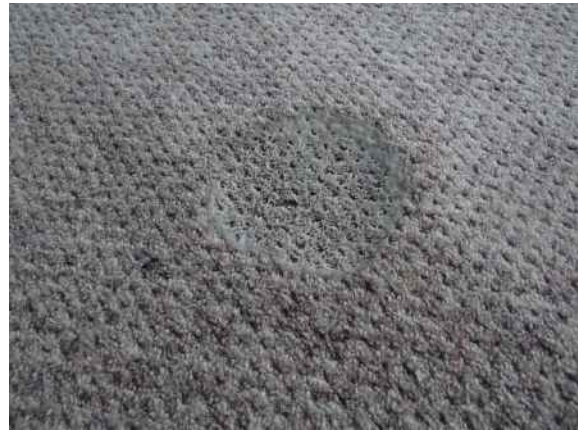
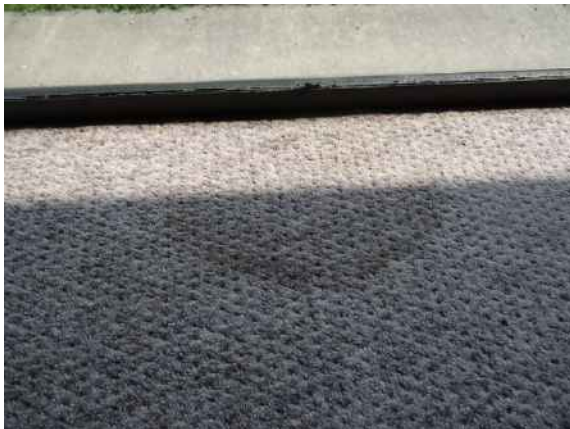
Kelly Lake Community Centre - C302005

Localized stains, wrinkles and general wear were observed.

Recommendation #1 - Carpet	
Type	Life Cycle Replacement
Year	2022
Cost	\$2,160.00

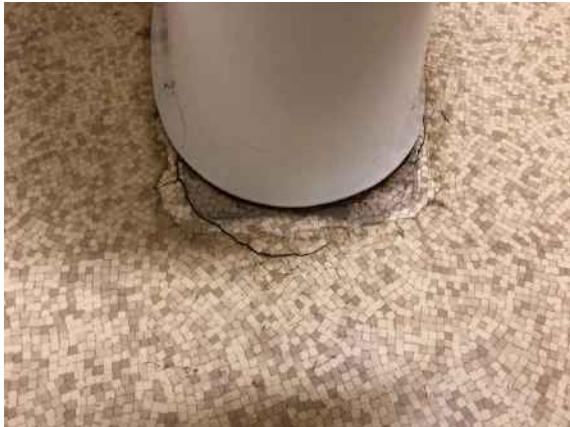
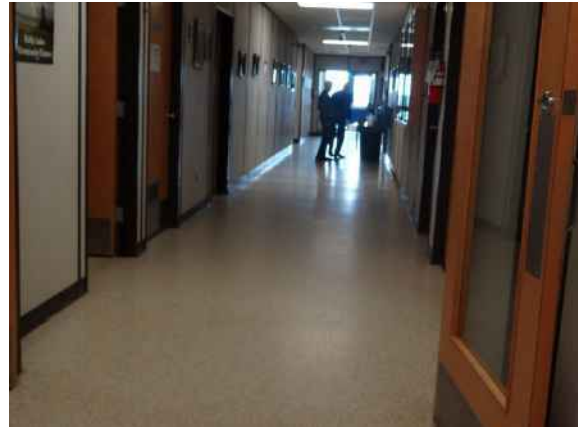
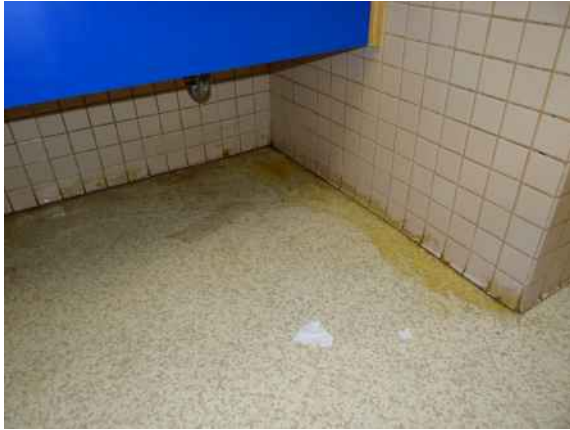
Kelly Lake Community Centre - C302006

Localized damage was observed in washrooms, under sinks and around toilets. Material may contain asbestos and should be considered as part of the recommended HazMat assessment.

Recommendation #1 - Vinyl Sheet	
Type	Life Cycle Replacement
Year	2022
Cost	\$48,720.00

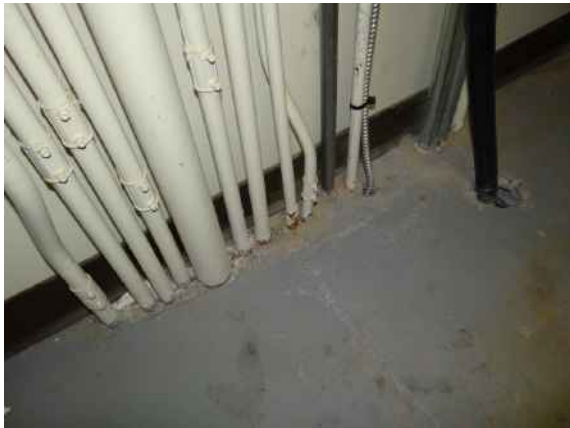
Kelly Lake Community Centre - C302007

Staining and wear were observed.

Recommendation #1 - Painted / Sealed Concrete Floor	
Type	Life Cycle Replacement
Year	2022
Cost	\$1,040.00

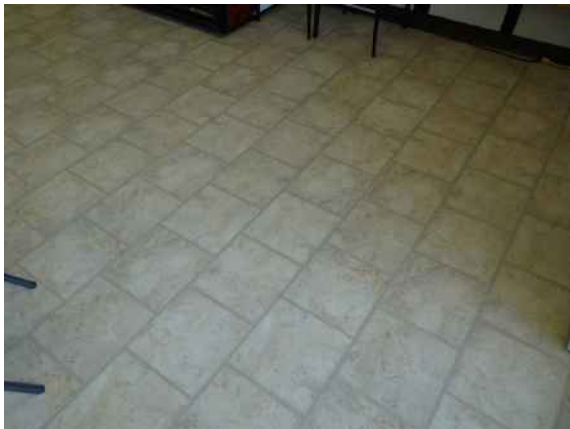
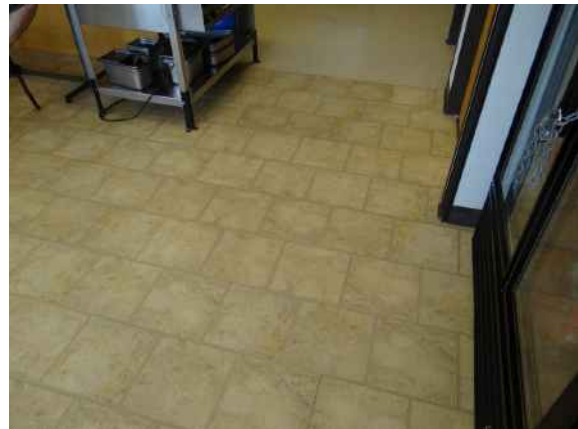
Kelly Lake Community Centre - C302099

No major deficiencies were observed or reported.

Recommendation #1 - Other Floor Finishes	
Type	Life Cycle Replacement
Year	2030
Cost	\$15,000.00

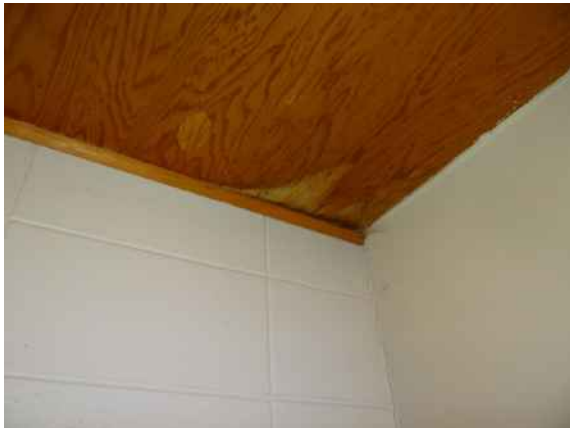
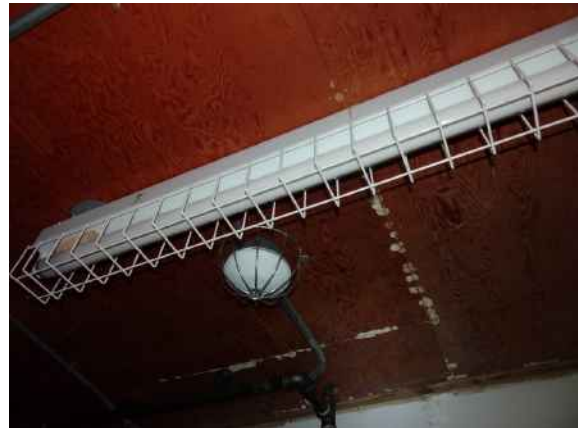
Kelly Lake Community Centre - C303005

No major deficiencies were observed or reported.

Recommendation #1 - Wood Ceiling	
Type	Life Cycle Replacement
Year	2025
Cost	\$8,710.00

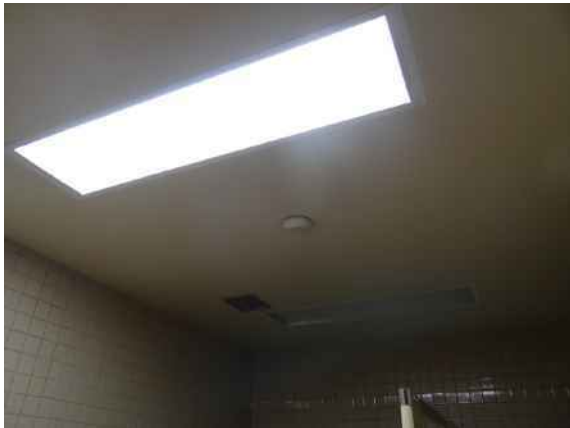
Kelly Lake Community Centre - C303006

No major deficiencies were observed or reported.

Recommendation #1 - Painted Ceiling Structures	
Type	Life Cycle Replacement
Year	2025
Cost	\$1,000.00

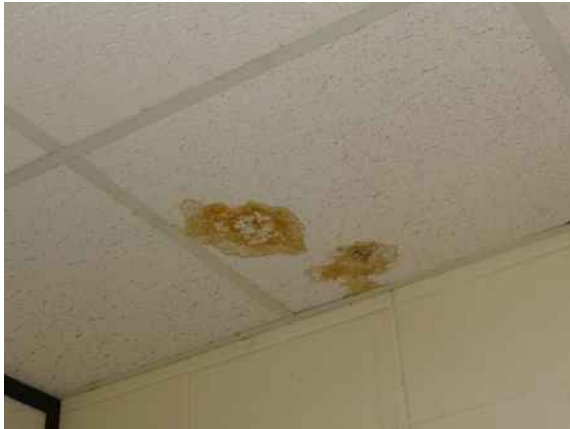
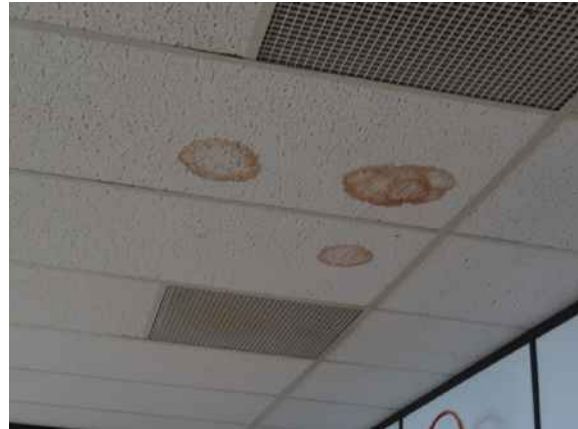
Kelly Lake Community Centre - C303007

Damage and staining was observed in localized areas, which should be addressed as part of maintenance activities. Otherwise, no major issues noted or reported.

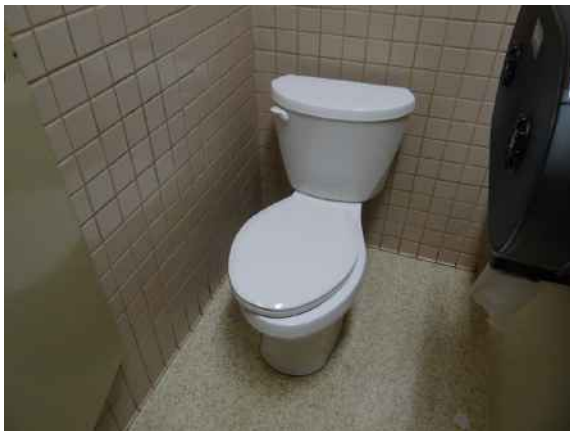
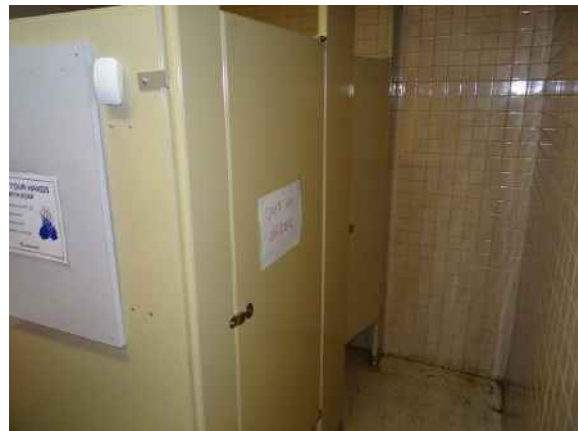
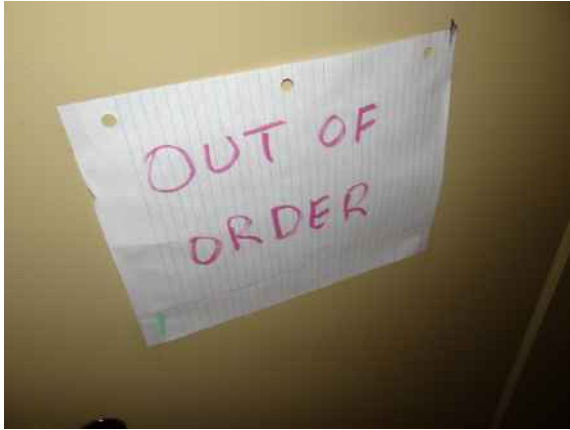
Kelly Lake Community Centre - D201001

It was observed that one toilet was out of order at the time of inspection and should be repaired as part of maintenance. Otherwise, no major deficiencies were observed or reported.

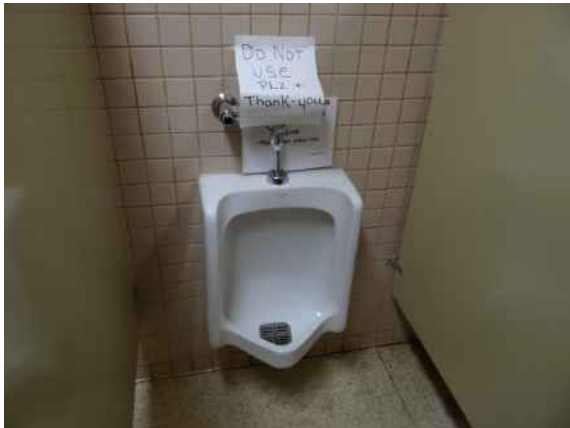
Kelly Lake Community Centre - D201002

It was observed that the urinal was out of order at the time of inspection.

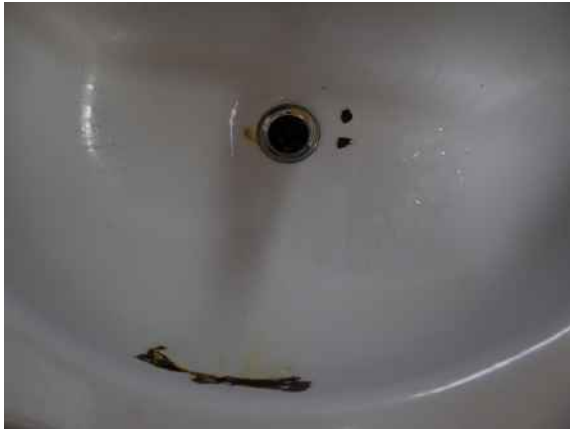
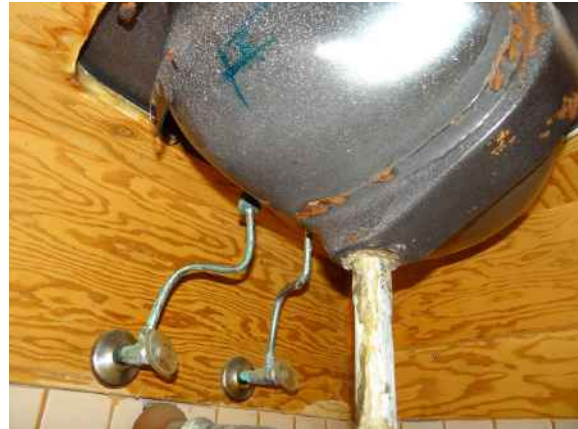
Kelly Lake Community Centre - D201003

It was observed that the enamelled sinks are chipped and corroded.

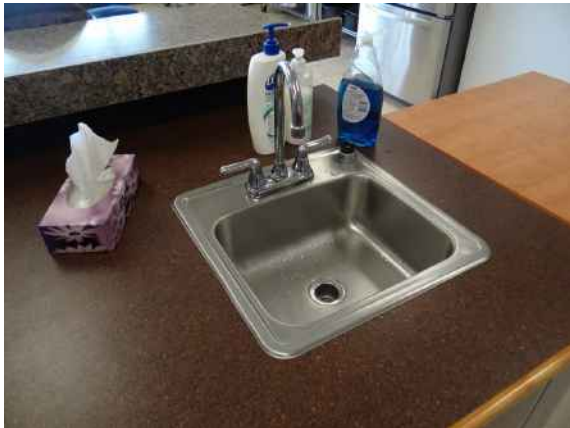
Kelly Lake Community Centre - D201004

No major deficiencies were observed or reported.

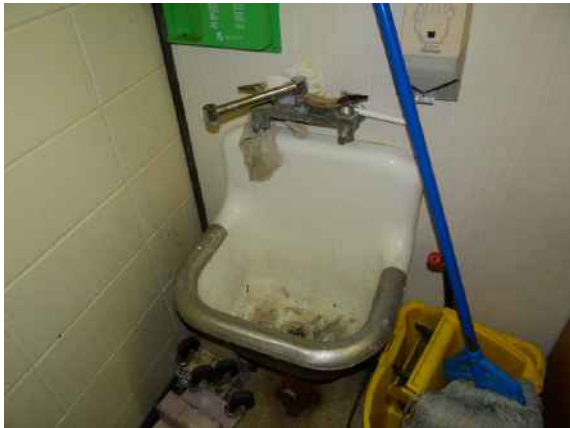
Kelly Lake Community Centre - D201024

Some staining and corrosion was observed but is understood to be in serviceable condition.

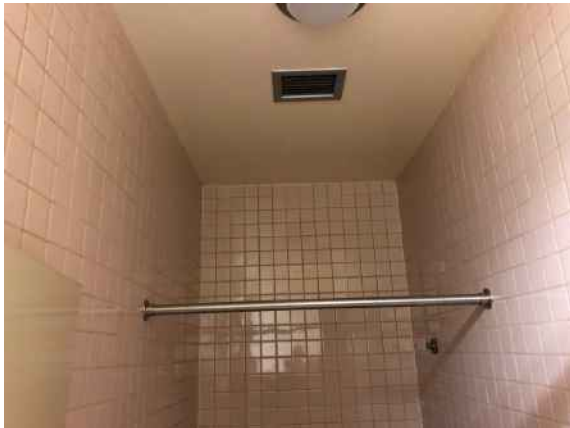
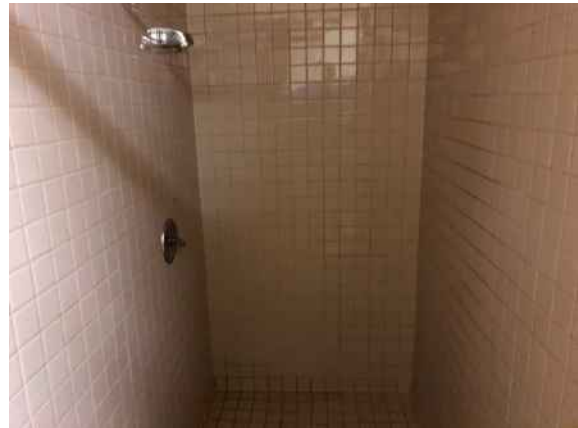
Kelly Lake Community Centre - D201025

No major deficiencies were observed or reported.

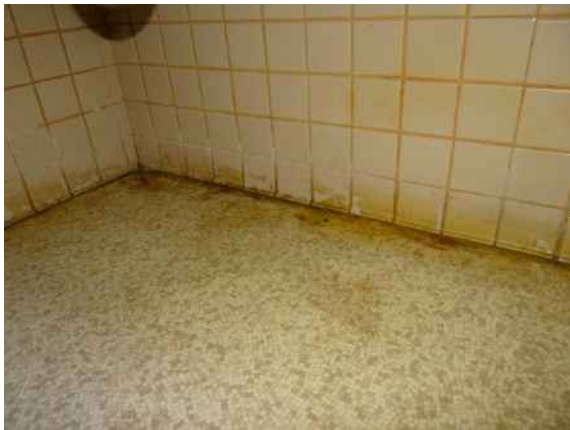
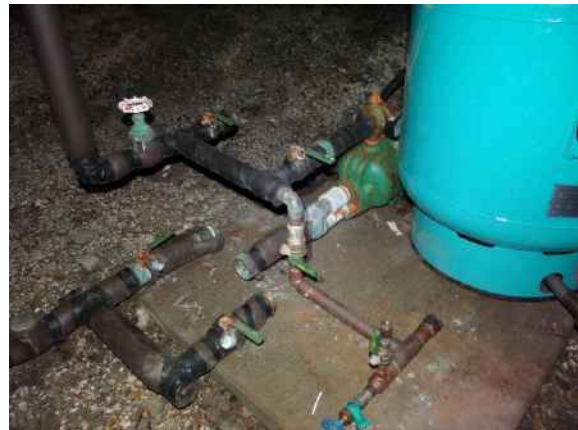
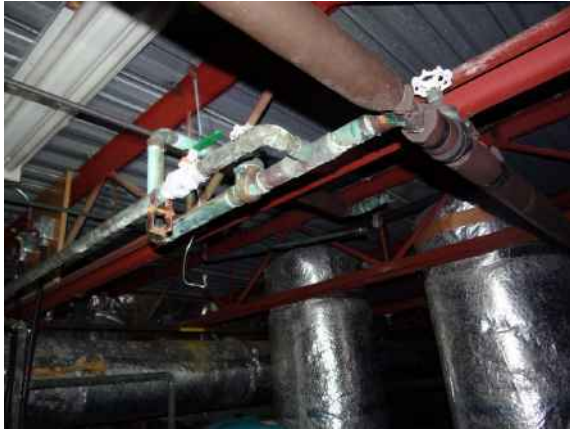
Kelly Lake Community Centre - D202001

Corrosion and evidence of leaking was observed in the crawlspaces, washrooms and other locations. A detailed review of the plumbing is recommended to confirm its remaining useful life.

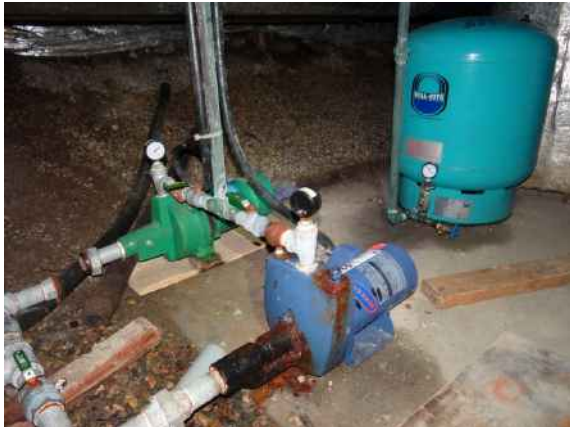
Kelly Lake Community Centre - D202006

Corrosion and evidence of leakage was observed.

Recommendation #1 - Domestic Water Equipment - Booster Systems	
Type	Life Cycle Replacement
Year	2020
Cost	\$10,000.00

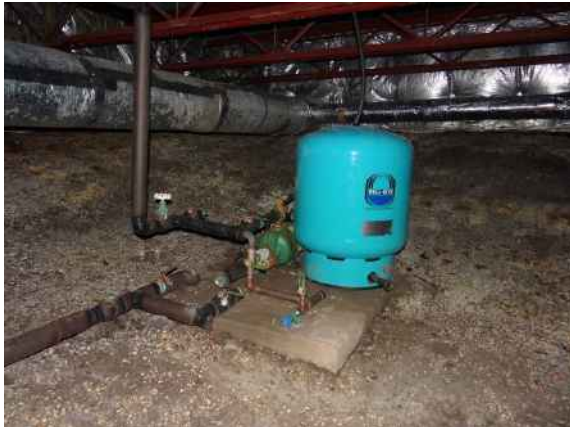
Kelly Lake Community Centre - D202009

The associated plumbing for one tank appeared to be under repair at the time of inspection.

Recommendation #1 - D202009 - Domestic Water Storage Tanks	
Type	Life Cycle Replacement
Year	2030
Cost	\$4,500.00

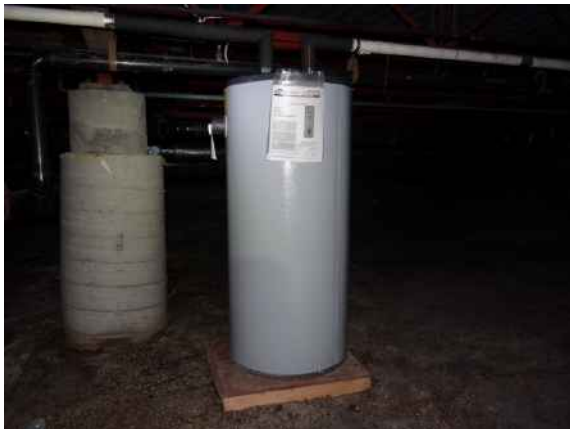
Kelly Lake Community Centre - D202009

No major deficiencies were observed or reported.

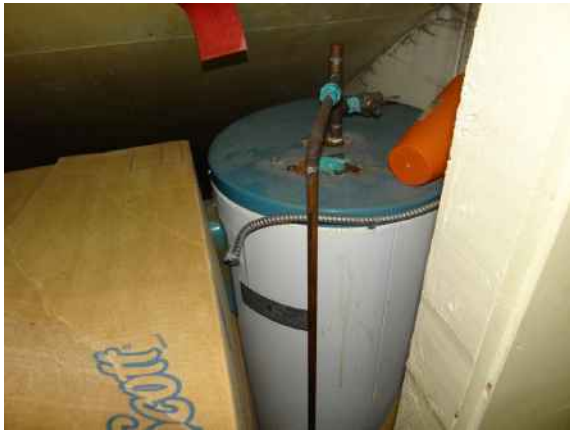
Kelly Lake Community Centre - D202021

Corrosion was observed. Tank is beyond service life and could not be confirmed if it was in service.

Recommendation #1 - Domestic Water Tank Heaters	
Type	Life Cycle Replacement
Year	2020
Cost	\$3,375.00

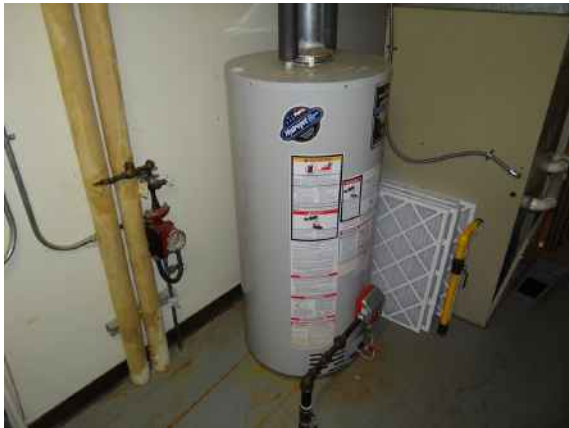
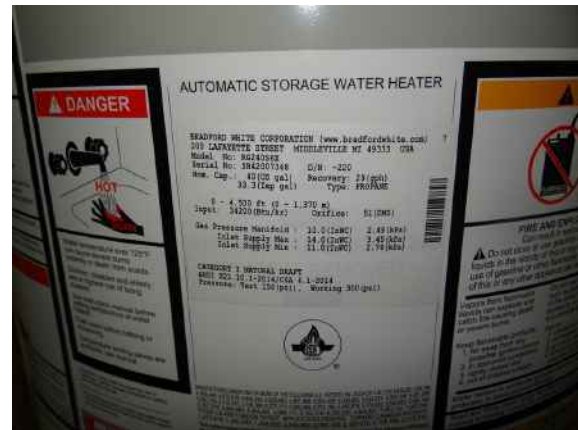
Kelly Lake Community Centre - D202021

No major deficiencies were observed or reported.

Recommendation #1 - Domestic Water Tank Heaters	
Type	Life Cycle Replacement
Year	2025
Cost	\$6,750.00

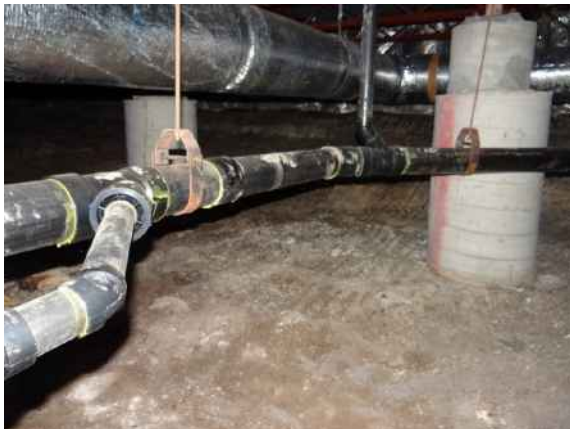
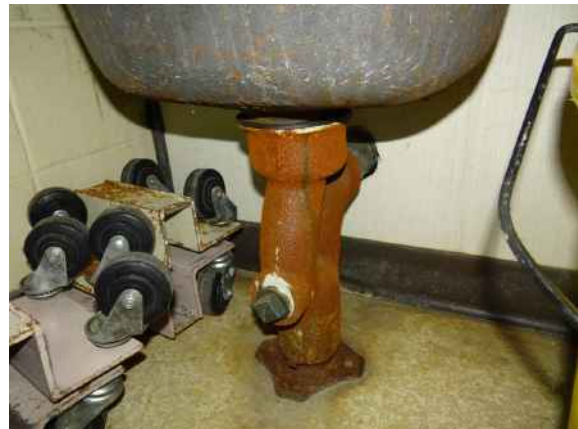
Kelly Lake Community Centre - D203001

Corrosion on metal piping was observed in localized areas. Evidence of sewage odors in the vicinity of the gymnasium washrooms was noted at the time of the site assessment, and should be further investigated.

Recommendation #1 - Investigate Potential Sanitary Leak	
Type	Engineering Study
Year	2020
Cost	\$10,000.00

Recommendation #2 - Repair Allowance - Sanitary Drainage System	
Type	Major Repair
Year	2020
Cost	\$8,000.00

Recommendation #3 - Sanitary Waste and Vent Piping	
Type	Life Cycle Replacement
Year	2027
Cost	\$29,925.00

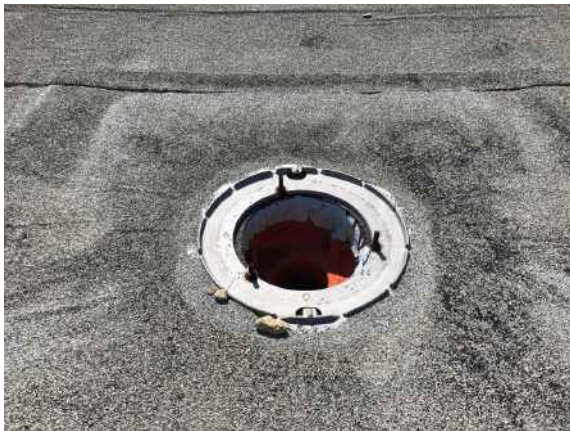
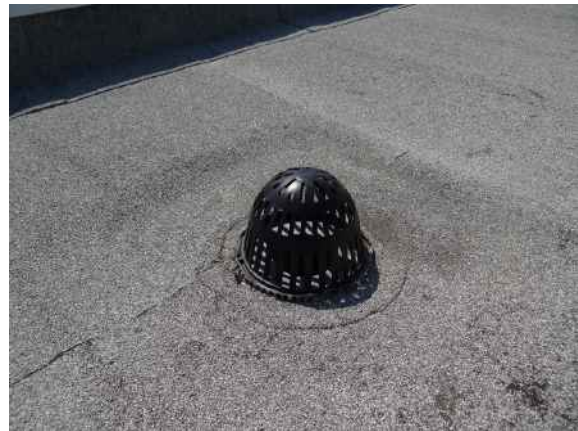
Kelly Lake Community Centre - D204001

Roof drainage appears to be performing as intended. Missing grills or strainers at roof drains were observed and should be replaced as part of maintenance.

Recommendation #1 - Rain Water Drainage Piping and Fittings	
Type	Life Cycle Replacement
Year	2027
Cost	\$19,950.00

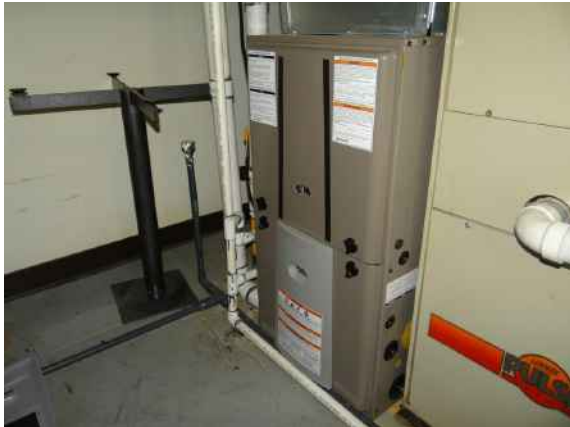
Kelly Lake Community Centre - D302008

No major deficiencies were observed or reported. Therefore the lifecycle replacement has been deferred.

Recommendation #1 - Fuel Fired Forced Air Furnace	
Type	Life Cycle Replacement
Year	2025
Cost	\$9,600.00

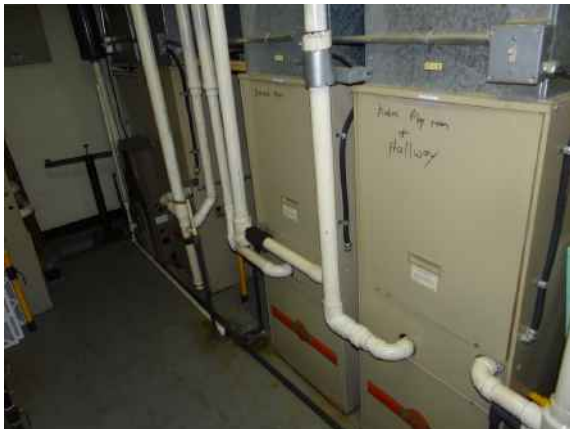
Kelly Lake Community Centre - D302008

No major deficiencies were observed or reported. Therefore the lifecycle replacement has been deferred.

Recommendation #1 - Fuel Fired Forced Air Furnace	
Type	Life Cycle Replacement
Year	2023
Cost	\$12,800.00
