## ELECTORAL AREA DIRECTORS COMMITTEE MEETING A G E N D A

### ELECTORAL AREA DIRECTORS COMMITTEE MEETING MINUTES

**Facility Condition Assessment Report  
Kelly Lake Community Centre**

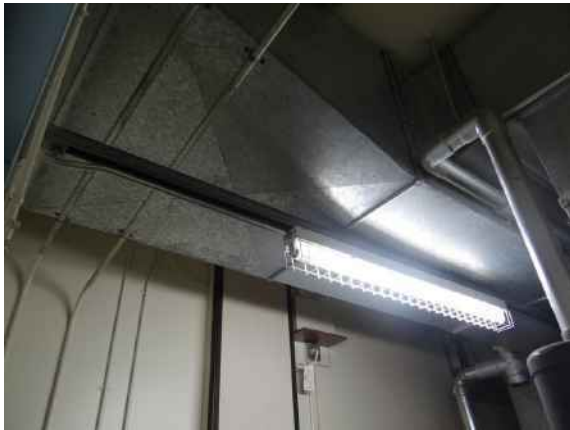
Kelly Lake Community Centre - D304001

No major deficiencies were observed or reported.

Recommendation #1 - Air Distribution Systems	
Type	Life Cycle Replacement
Year	2025
Cost	\$79,800.00

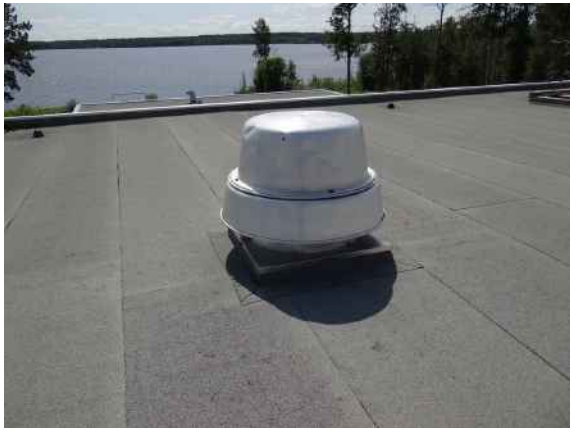
Kelly Lake Community Centre - D304007

No major deficiencies were observed or reported. Some mechanical damage was noted.

Recommendation #1 - Exhaust Fans	
Type	Life Cycle Replacement
Year	2025
Cost	\$9,000.00

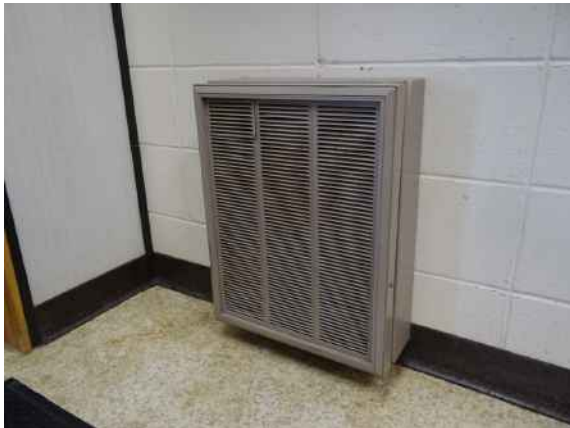
Kelly Lake Community Centre - D305006

No major deficiencies were observed or reported.

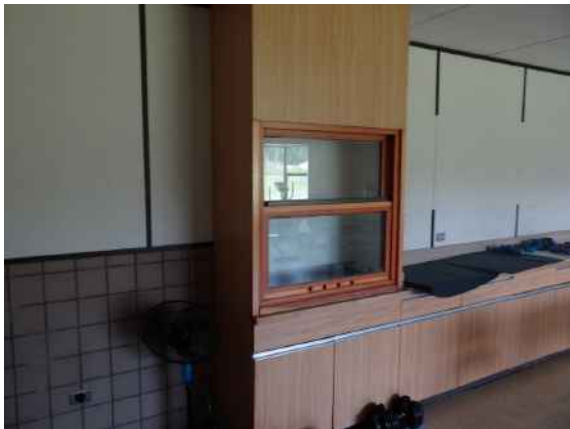
Kelly Lake Community Centre - D309021

The fume hood system is understood to be decommissioned. It is recommended that it be inspected prior to being put into service.

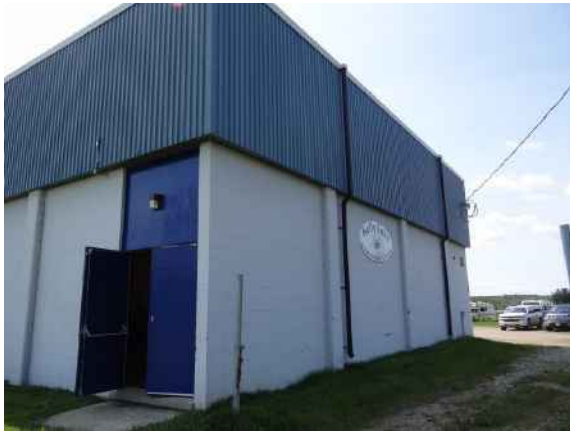
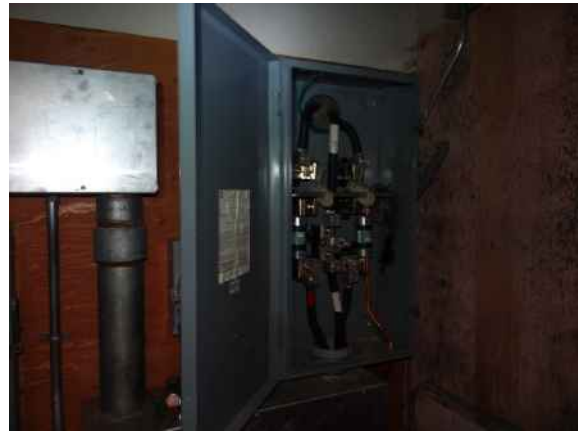
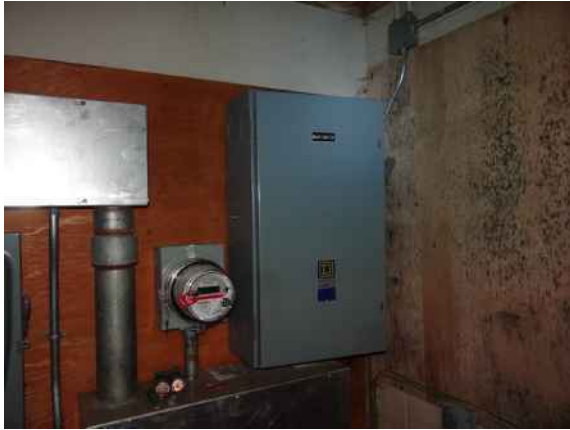
Kelly Lake Community Centre - D501022

No major deficiencies were observed or reported.

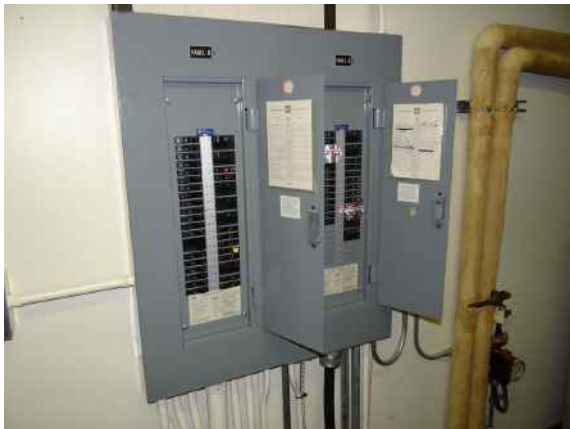
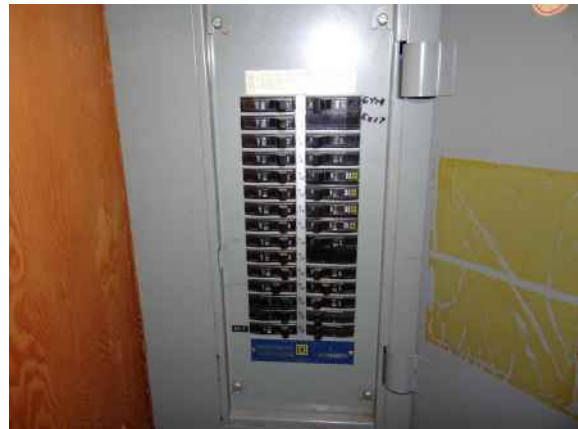
Kelly Lake Community Centre - D501023

No major deficiencies were observed or reported.

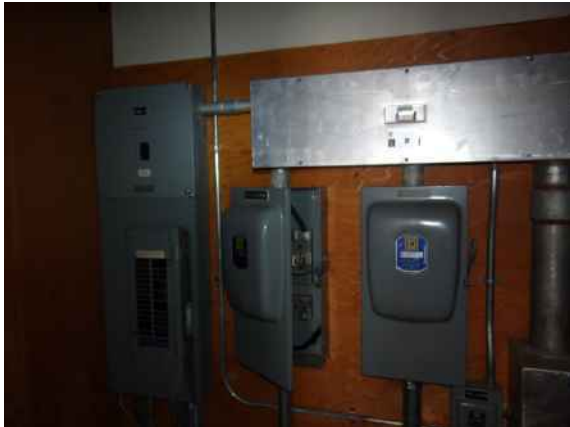
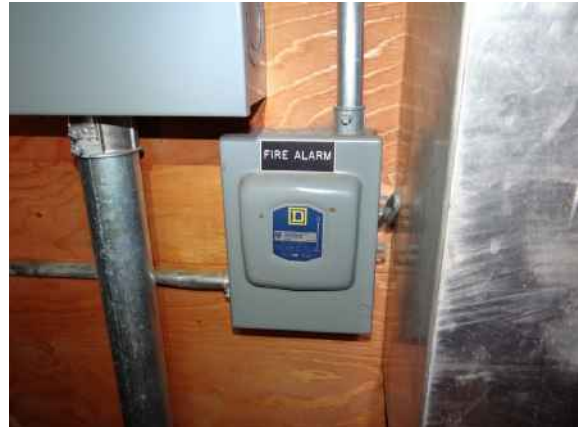
Kelly Lake Community Centre - D502001

No major deficiencies were observed or reported.

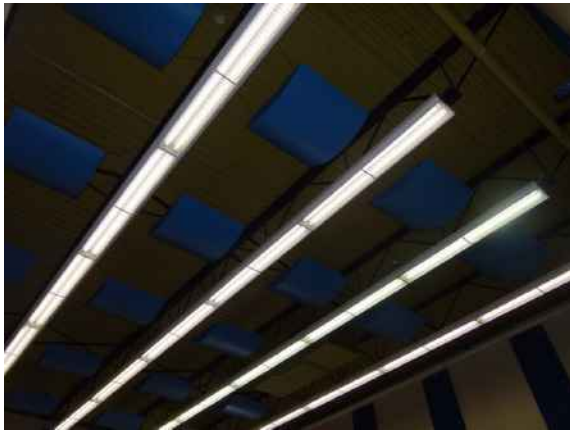
Kelly Lake Community Centre - D502002

No major deficiencies were observed or reported.

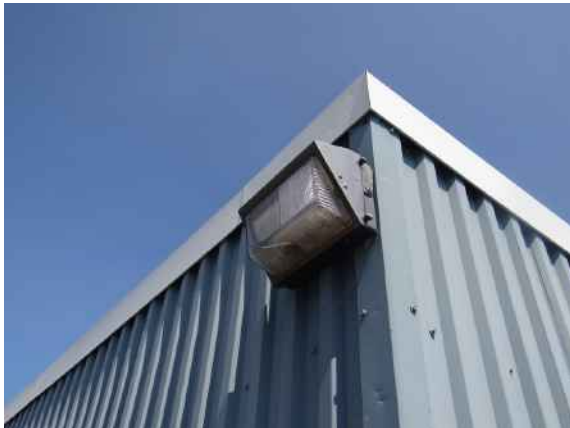
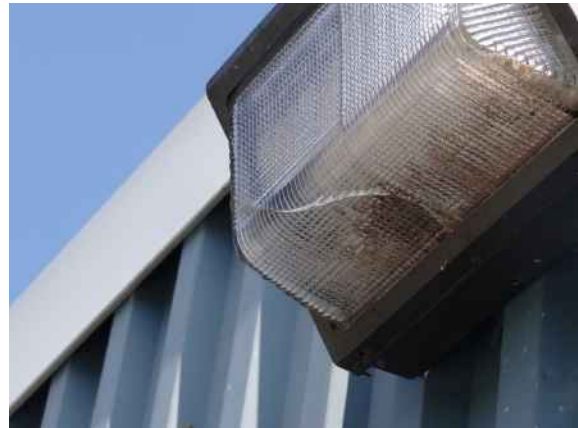
Kelly Lake Community Centre - D502021

Fixtures understood to be functional. Some damage was noted. fixtures are outdated.

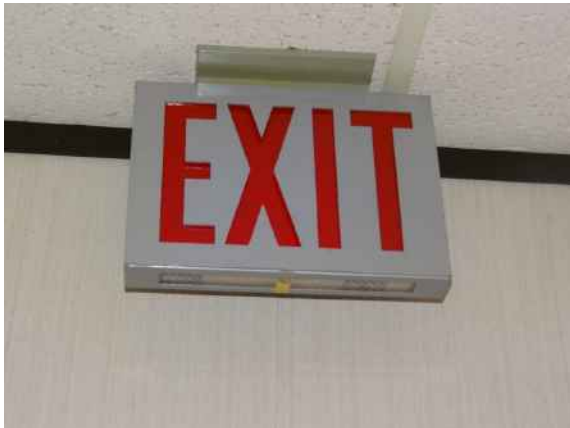
Kelly Lake Community Centre - D502022

No major deficiencies were observed or reported. However, the fixtures are outdated.

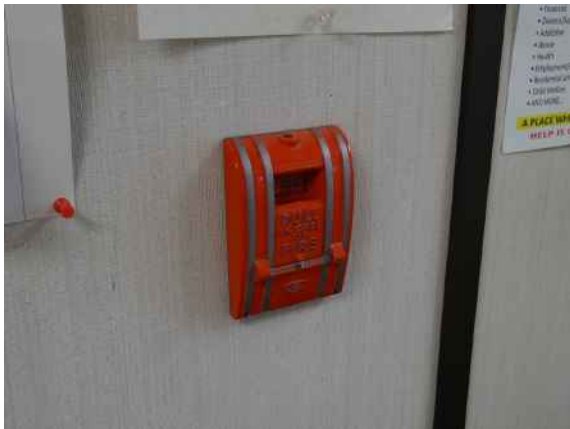
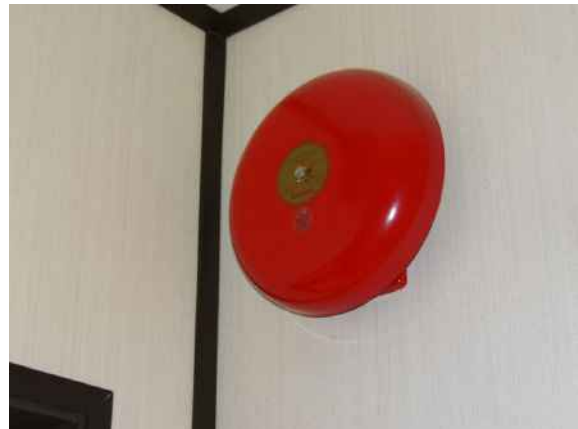
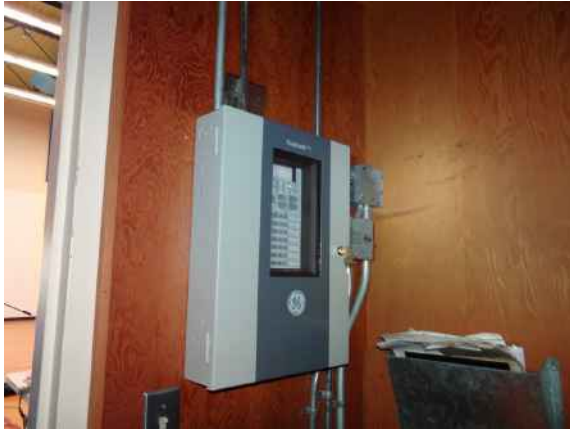
Kelly Lake Community Centre - D503001

It was observed that the fire alarm system has not been inspected since 2013. Annual inspection is recommended. Remaining service life to be confirmed by inspection.

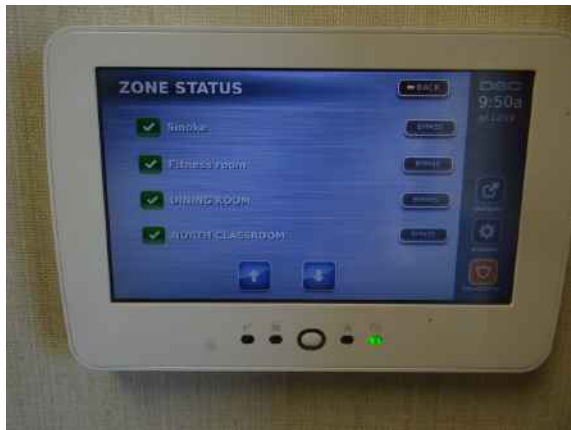
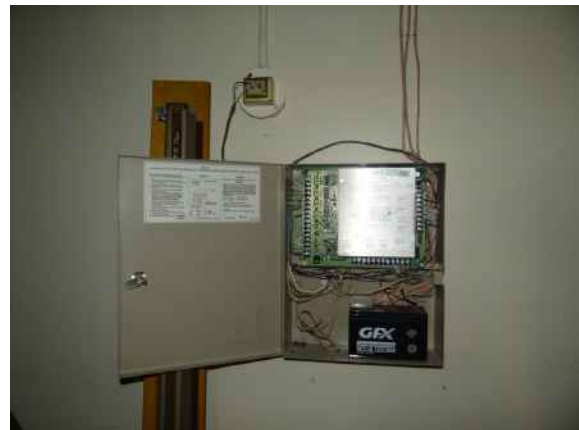
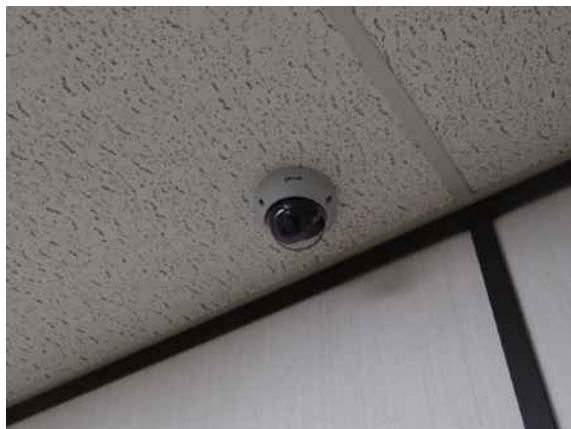
Kelly Lake Community Centre - D503008

No major deficiencies were observed or reported.

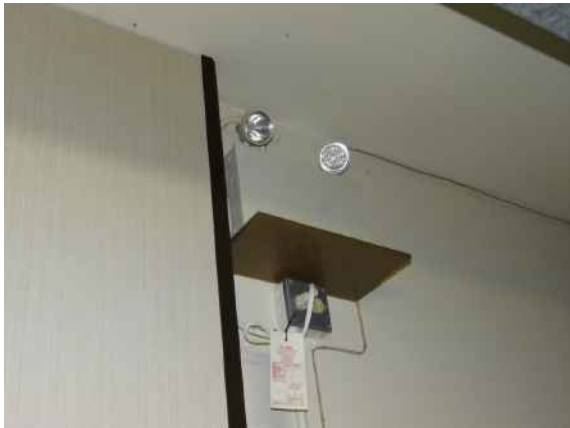
Kelly Lake Community Centre - D509003

No major deficiencies were observed or reported but the fixtures are outdated.

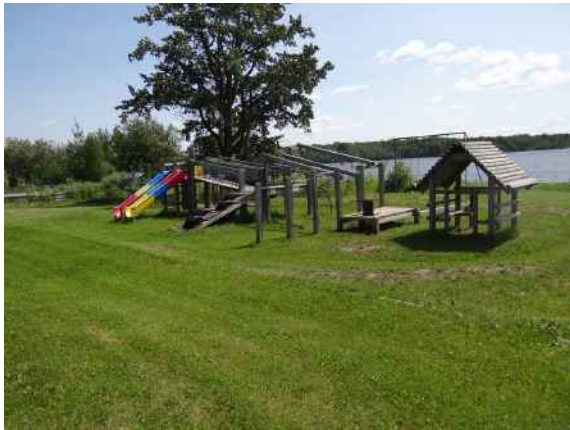
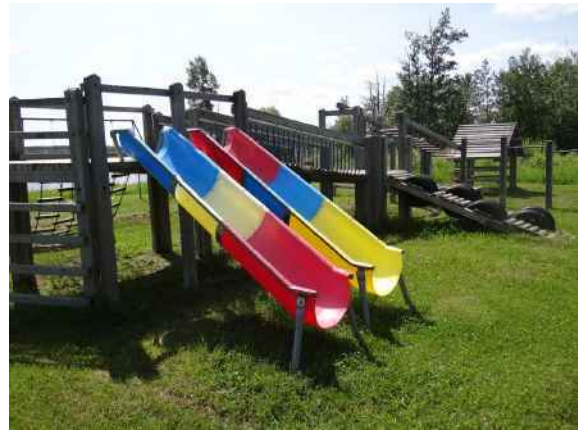
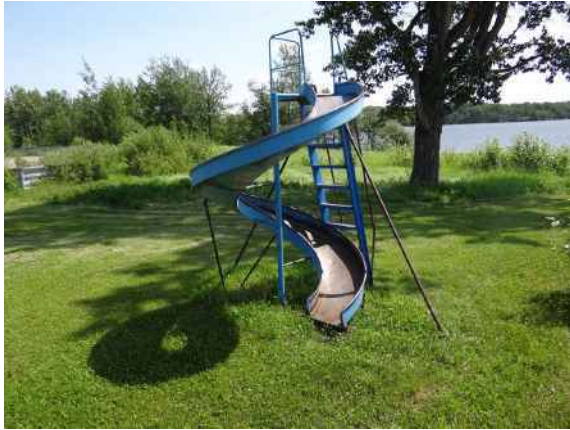
Kelly Lake Community Centre - F101001

Equipment was observed and reported to be in need of repair or replacement.

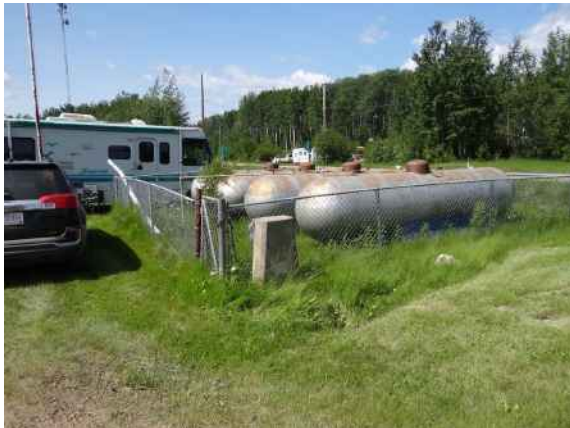
Kelly Lake Community Centre - F101004

No major issues observed or reported.

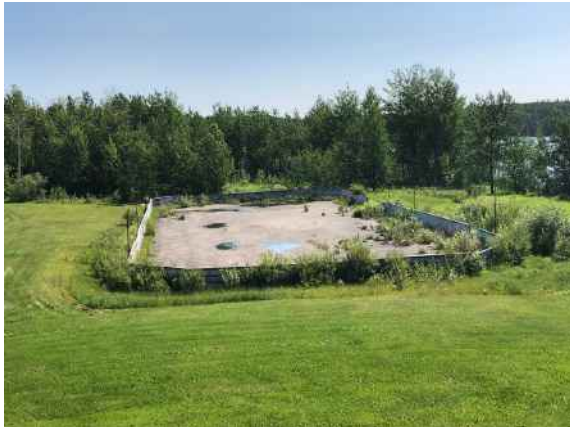
Kelly Lake Community Centre - F101005

It was observed that this feature has not been maintained, vegetation is overgrown and the wood fencing is deteriorated.

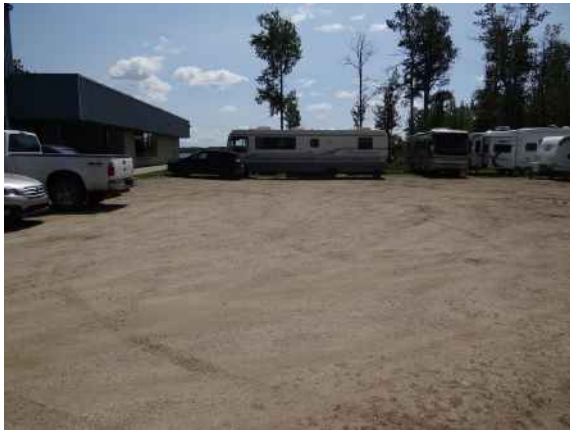
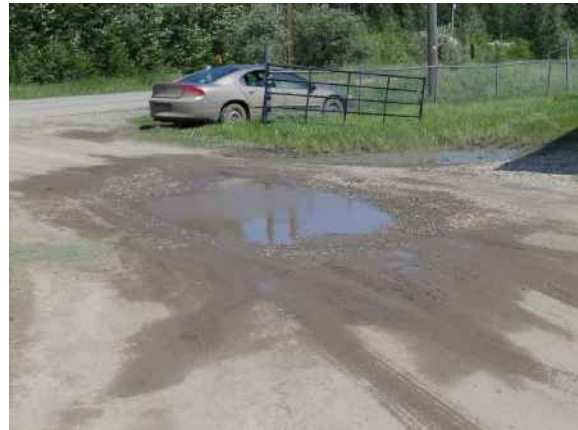
Kelly Lake Community Centre - G202024

Pot holes and ponding were observed. Releveling and resurfacing is recommended.

Recommendation #1 - Gravel Paved Surface - Parking Area	
Type	Life Cycle Replacement
Year	2021
Cost	\$10,000.00

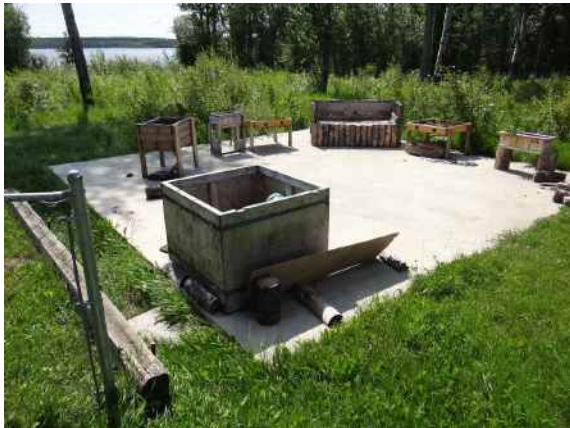
Kelly Lake Community Centre - G203022

No major deficiencies were observed or reported.

Recommendation #1 - Concrete Paved Surfaces	
Type	Life Cycle Replacement
Year	2025
Cost	\$2,400.00

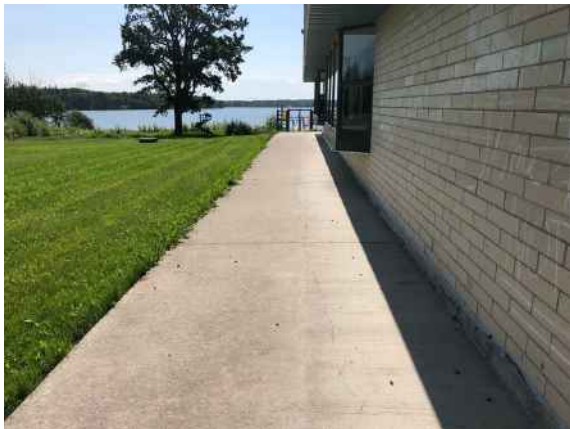
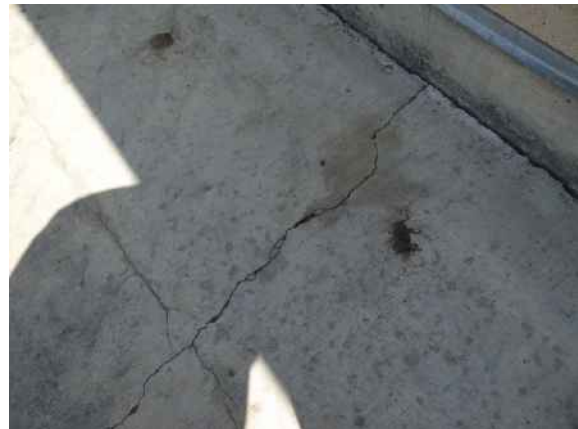
Kelly Lake Community Centre - G203022

No major deficiencies were observed or reported. Some settlement away from the building and some cracking was observed.

Recommendation #1 - Concrete Paved Surfaces	
Type	Life Cycle Replacement
Year	2025
Cost	\$18,000.00

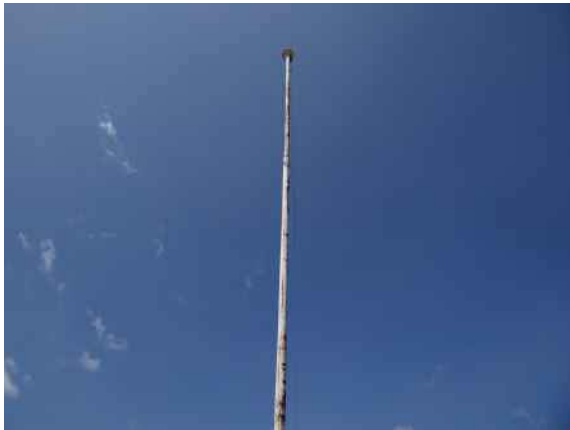
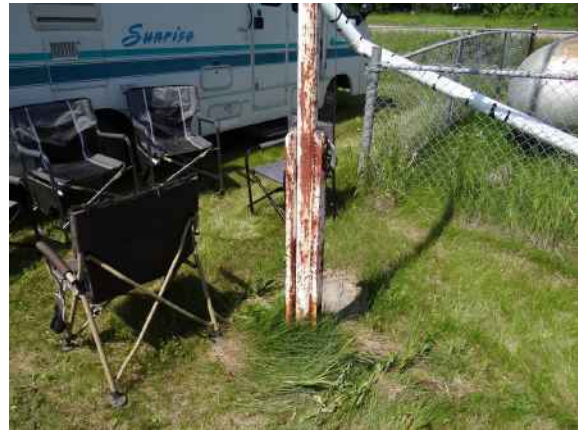
Kelly Lake Community Centre - G204009

Corrosion was observed.

Recommendation #1 - Flagpoles	
Type	Life Cycle Replacement
Year	2022
Cost	\$5,000.00

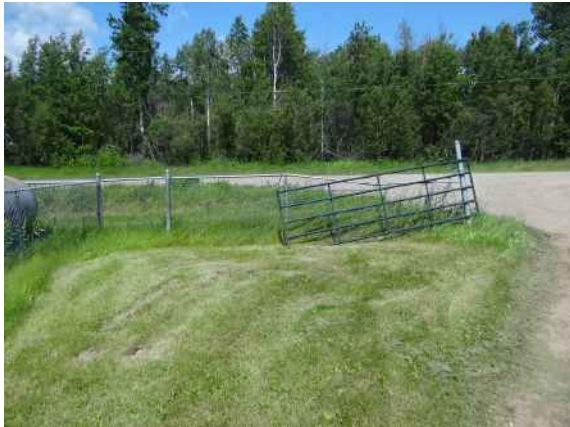
Kelly Lake Community Centre - G204021

No major deficiencies were observed or reported. However, localized wearing and poor gate operation was noted and should be repaired as part of maintenance activities.

Recommendation #1 - Fencing and Gates - Chain Link Fence	
Type	Life Cycle Replacement
Year	2024
Cost	\$162,500.00

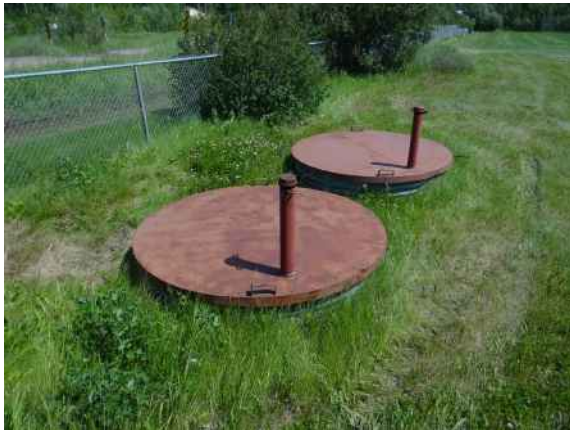
Kelly Lake Community Centre - G3010

Domestic water is supplied by a cistern located on the property consisting of two tanks installed below grade. Little information was available regarding the condition of the cisterns.

No major deficiencies were observed or reported.

Recommendation #1 - Water Supply	
Type	Life Cycle Replacement
Year	2024
Cost	\$99,750.00

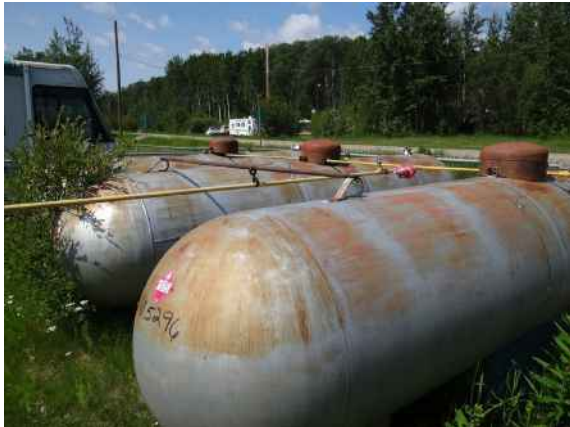
Kelly Lake Community Centre - G306021

The tanks are past their typical useful life with corrosion. Tanks should be inspected if intended to remain in service.

Recommendation #1 - Fuel Storage Tanks - Aboveground	
Type	Life Cycle Replacement
Year	2020
Cost	\$40,000.00

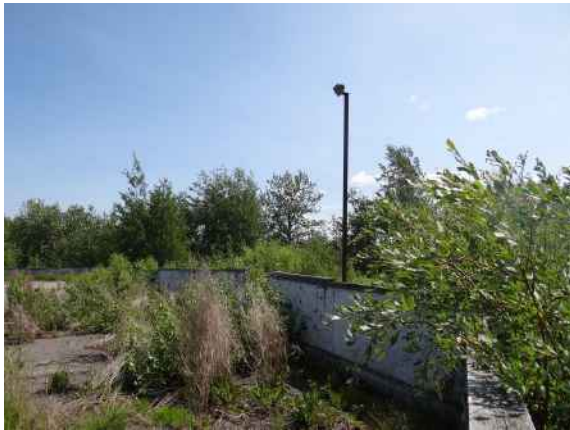
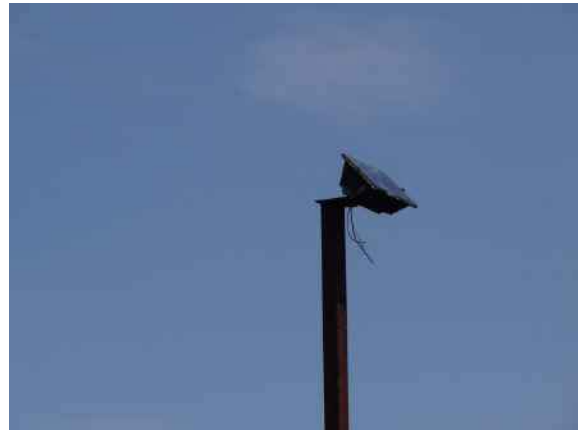
Kelly Lake Community Centre - G402013

Fixtures do not appear to be in service and evidence of damage.

Recommendation #1 - Exterior Pole Light Fixture	
Type	Life Cycle Replacement
Year	2020
Cost	\$3,000.00

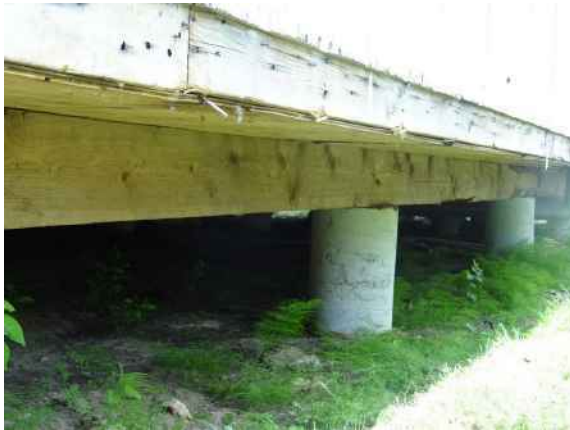
Osborn Hall - A1020

No major deficiencies were observed or reported.

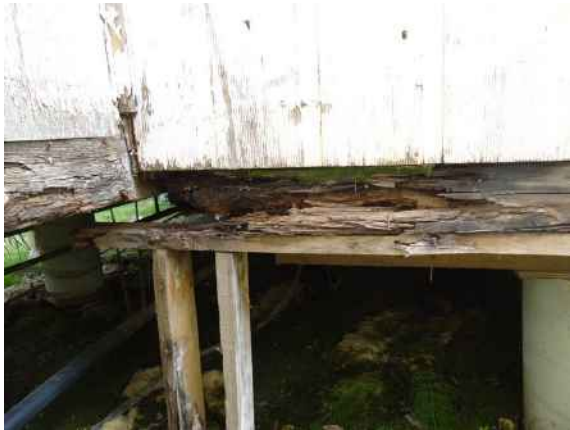
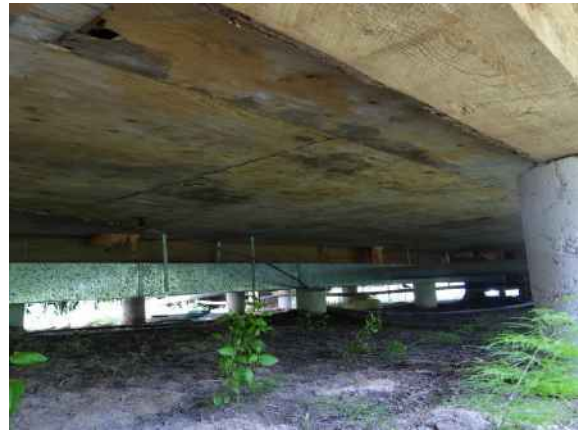
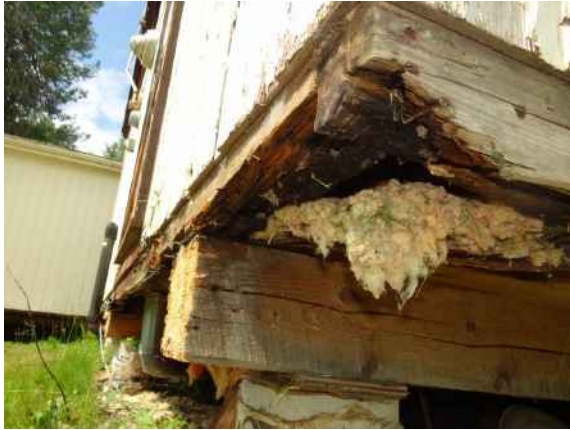
Osborn Hall - B1030

Decay and rot to supporting wood members was observed along the exterior of the building.

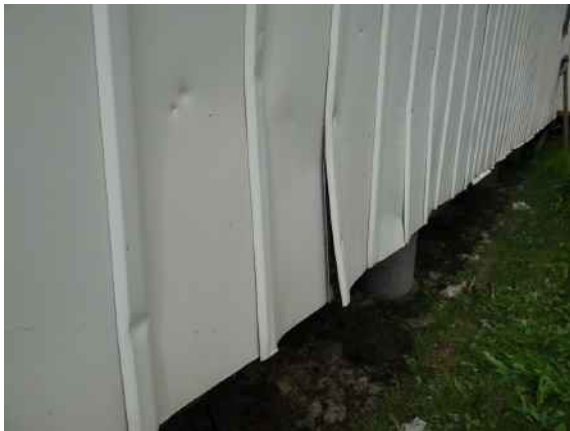
Osborn Hall - B201024

Mechanical damage and detached siding was observed. Building envelope components generally observed to be deficient. Detailed review is recommended to confirm remaining service life and establish scope of renewal work.

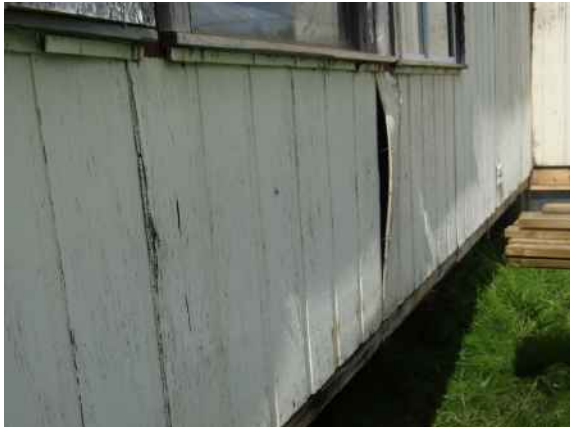
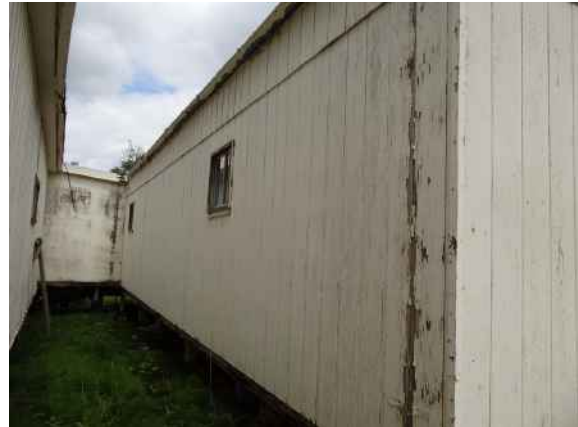
Osborn Hall - B201026

Extensive deterioration was observed throughout the exterior elevations. Deterioration includes physical damage, unsealed penetrations, water ingress, moisture staining, and associated decay.

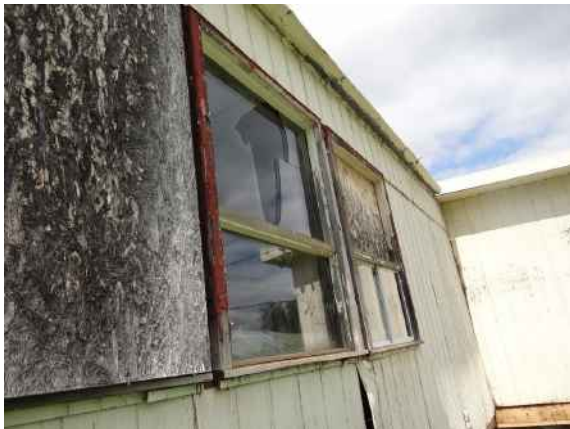
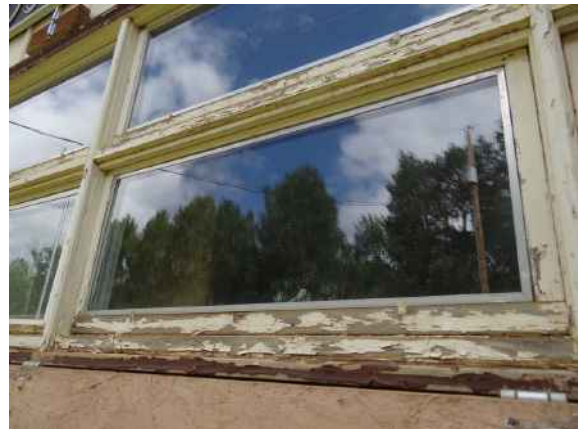
Osborn Hall - B202001

Some windows appear damaged and inoperable. Broken glass panes were observed.

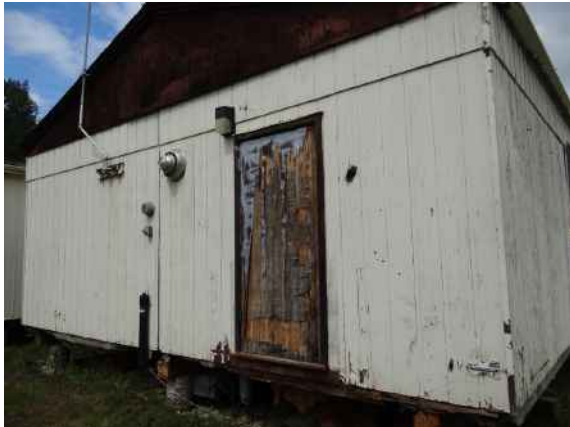
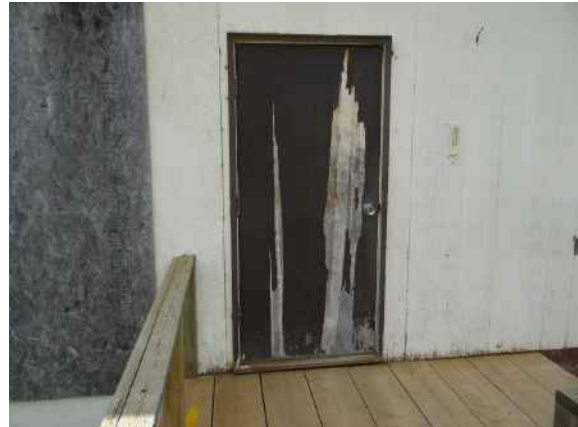
Osborn Hall - B203002

Extensive deterioration was observed. Doors do not appear to seal properly. This may result in heat loss and drafts.

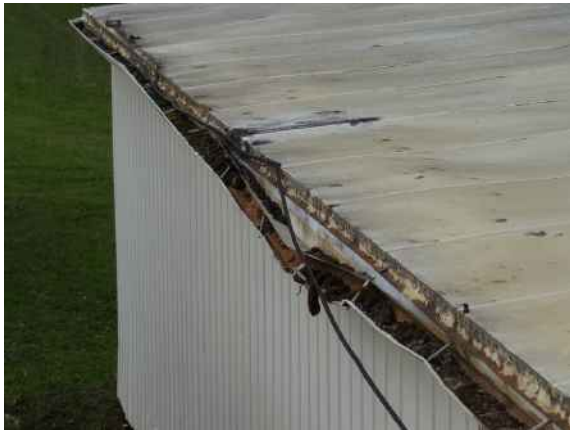
Osborn Hall - B301005

Significant damage, corrosion, and detached gutters were observed. The gutters are currently considered unserviceable.

Recommendation #1 - Gutters and Downspouts	
Type	Life Cycle Replacement
Year	2020
Cost	\$2,400.00

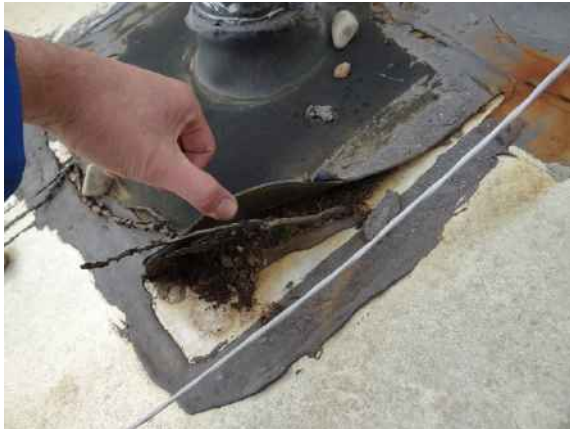
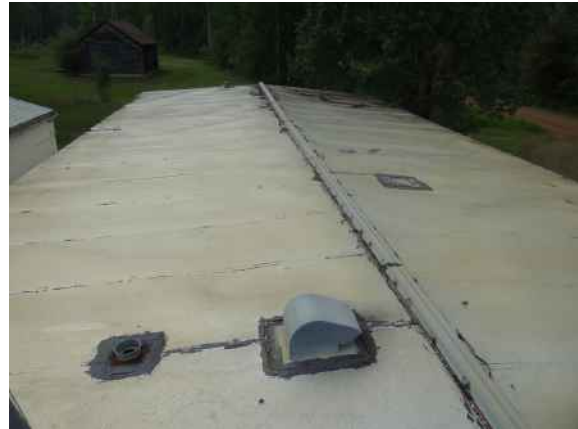
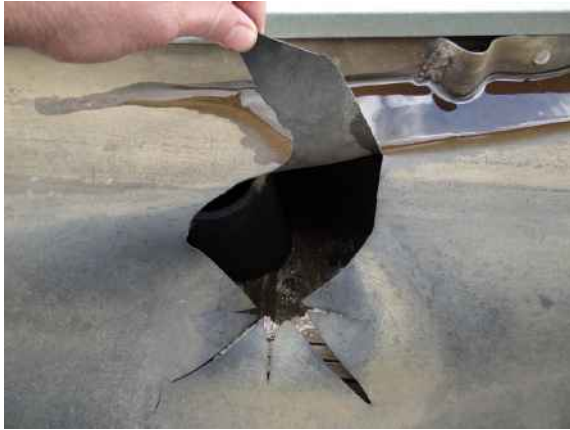
Osborn Hall - B301023

Significant physical damage, unsealed penetrations, and deterioration were observed. The roof is not considered to be in serviceable condition.

Recommendation #1 - Conventional - Single Ply Membrane	
Type	Life Cycle Replacement
Year	2020
Cost	\$35,100.00

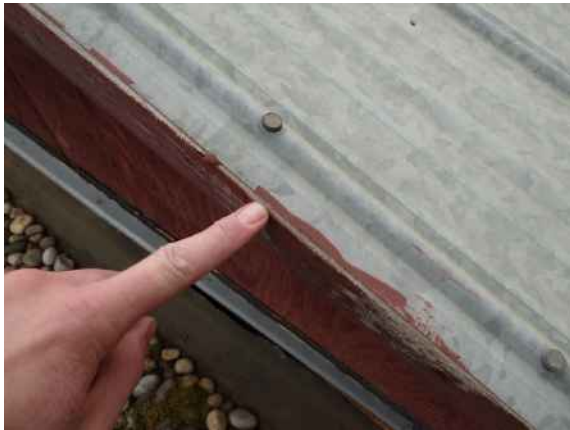
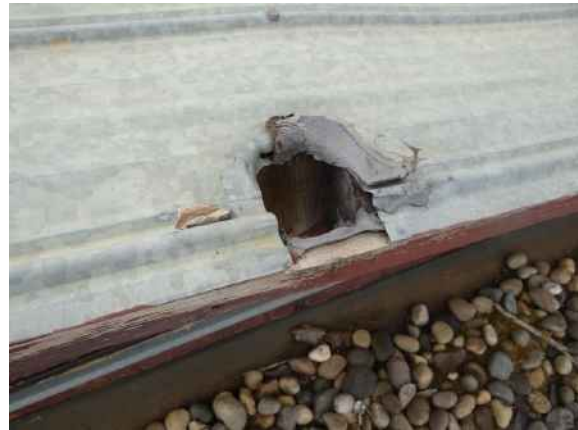
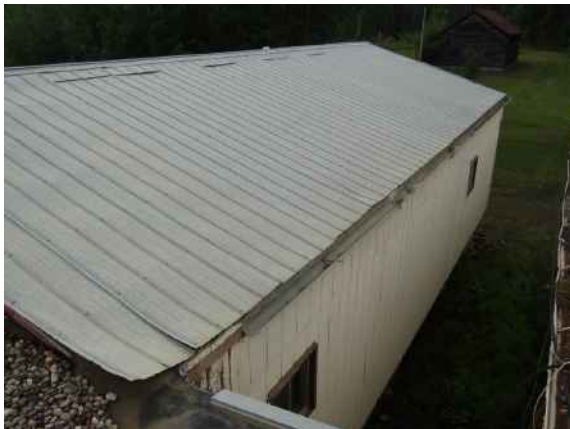
Osborn Hall - B301028

Mechanical damage and unsealed openings in the roof covering were observed.

Recommendation #1 - Metal Roofing	
Type	Life Cycle Replacement
Year	2020
Cost	\$36,400.00

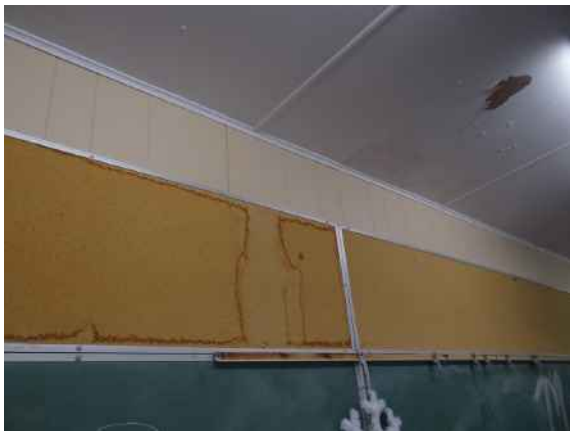
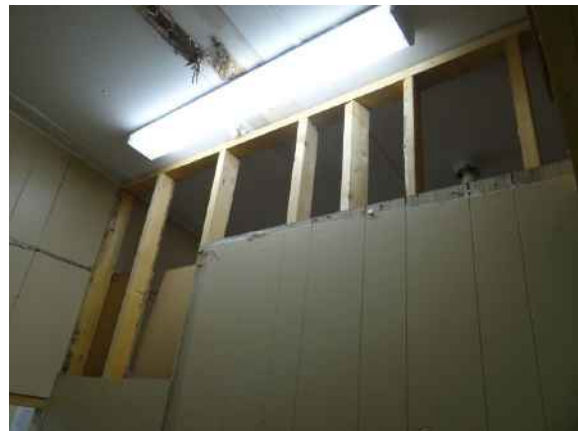
Osborn Hall - C101001

Visible water damage was observed on wall surfaces. Wall covering was missing or damaged. Affected areas should be repaired.

Recommendation #1 - Repair Allowance - Interior Partitions	
Type	Major Repair
Year	2020
Cost	\$4,750.00

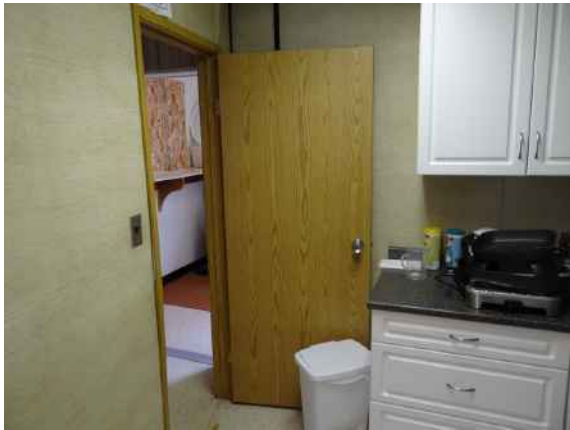
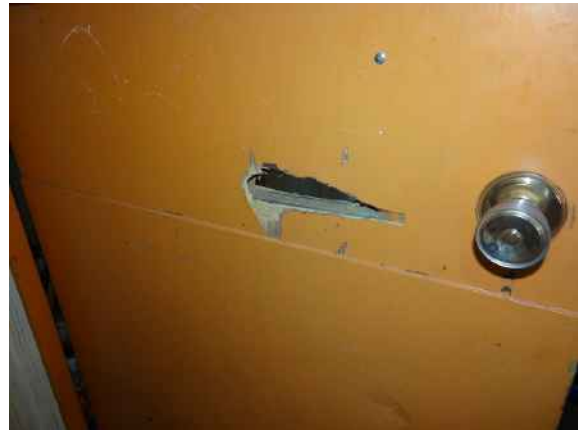
Osborn Hall - C102002

Mechanical damage and wear were observed.

Recommendation #1 - Solid Interior Door - Single	
Type	Life Cycle Replacement
Year	2023
Cost	\$12,000.00

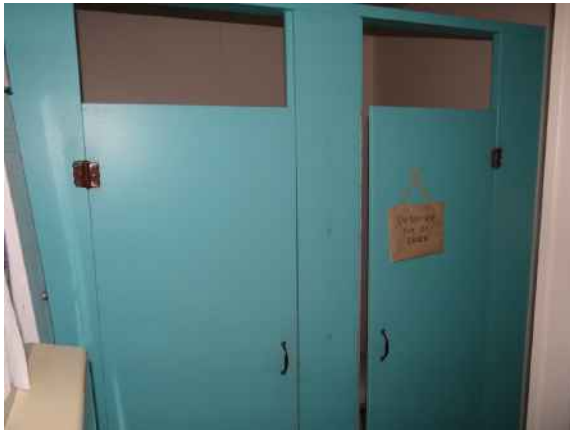
Osborn Hall - C103001

Mechanical and water damage were observed.

Recommendation #1 - Washroom Partitions	
Type	Life Cycle Replacement
Year	2022
Cost	\$4,500.00

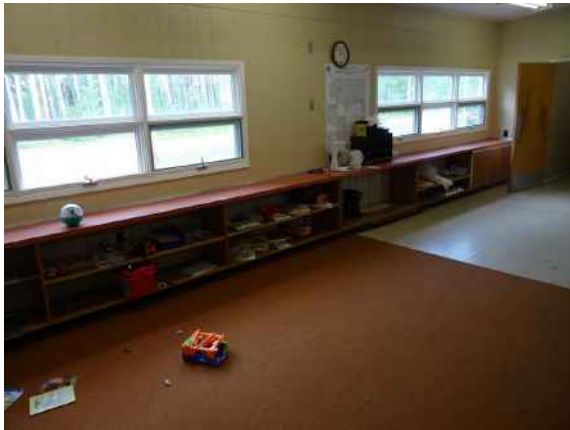
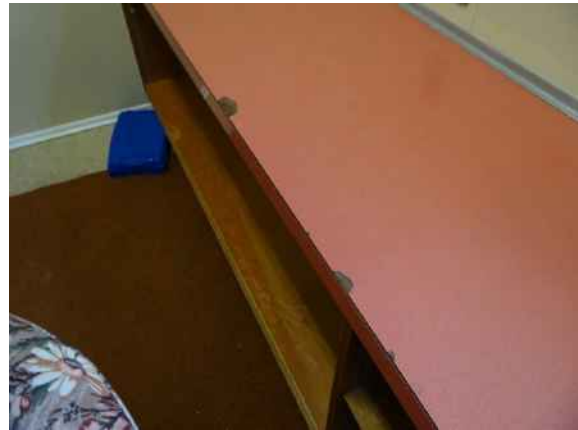
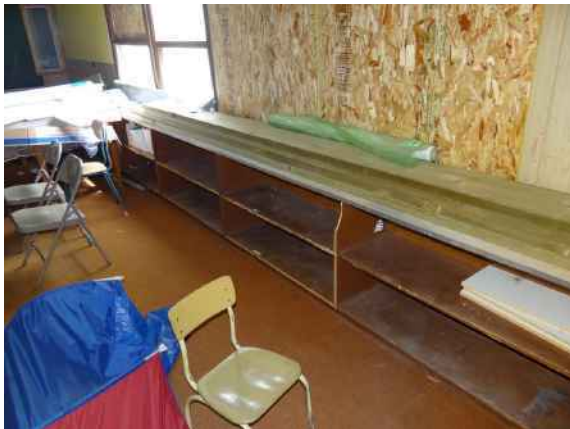
Osborn Hall - C103009

Mechanical damage and wear were observed.

Recommendation #1 - Cabinets - Millwork	
Type	Life Cycle Replacement
Year	2022
Cost	\$15,000.00

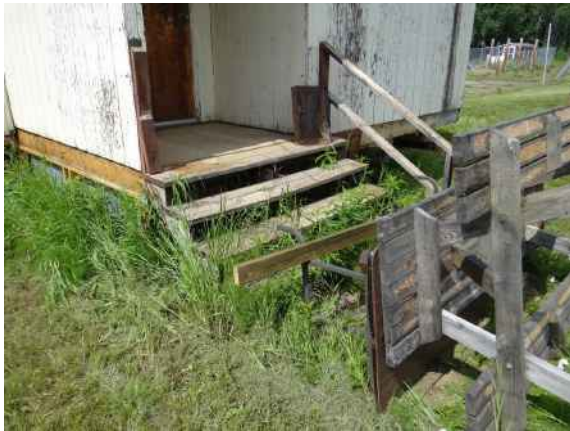
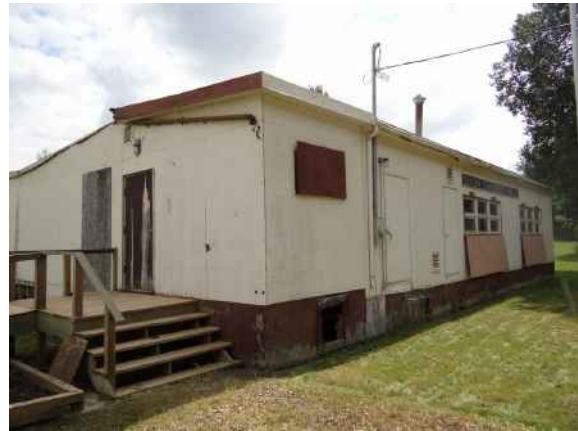
Osborn Hall - C201002

North stairs and ramps were in good condition. Some deterioration was observed along eastern stairs. Installation of a handrails on both sides is recommended. It was observed that some exits do not have steps, which is a safety hazard. Installation of steps is recommended.

Recommendation #1 - Repair Allowance - Exterior Stairs	
Type	Condition-Based
Year	2019
Cost	\$7,000.00

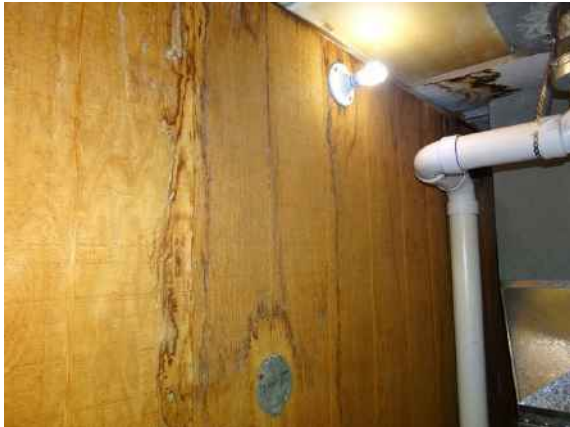
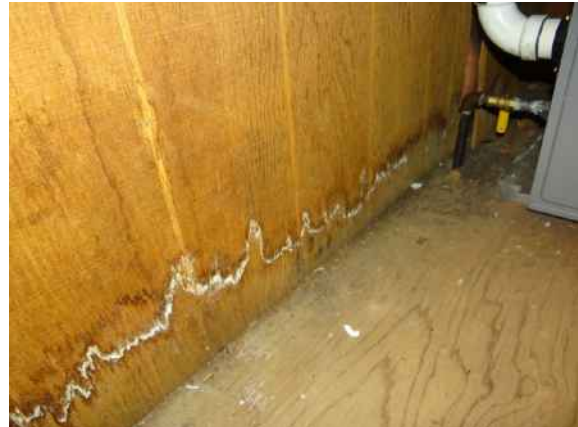
Osborn Hall - C301022

Water damage was observed in areas and should be repaired. Overall condition should be considered in conjunction with the Building Envelope Condition Assessment.

Recommendation #1 - Repair Allowance - Wood Panel Finishes	
Type	Major Repair
Year	2020
Cost	\$3,510.00

Recommendation #2 - Wood Panel	
Type	Life Cycle Replacement
Year	2022
Cost	\$70,200.00

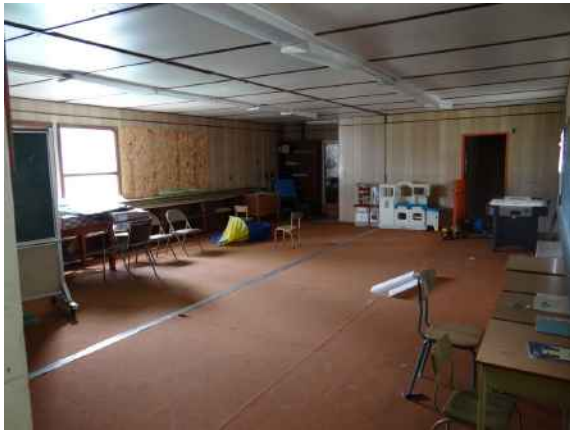
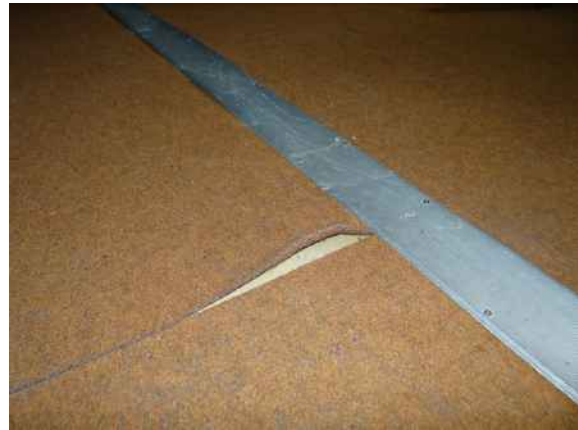
Osborn Hall - C302005

Wear, staining and buckling were observed

Recommendation #1 - Carpet	
Type	Life Cycle Replacement
Year	2020
Cost	\$10,320.00

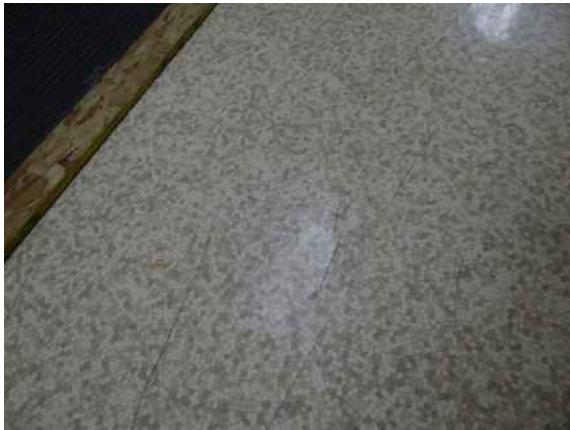
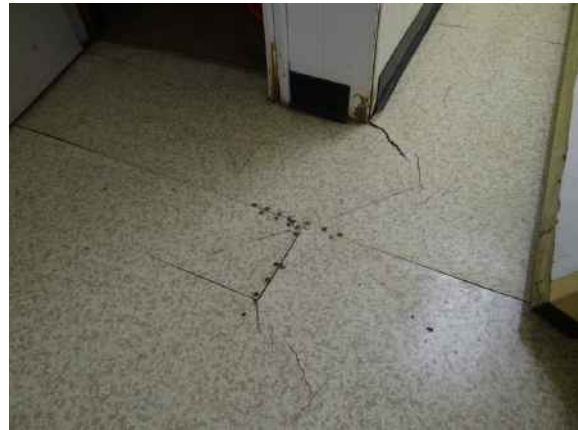
Osborn Hall - C302006

Cracks, delamination and staining were observed.

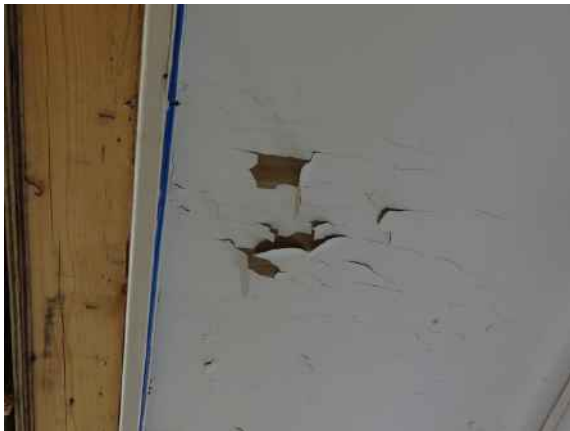
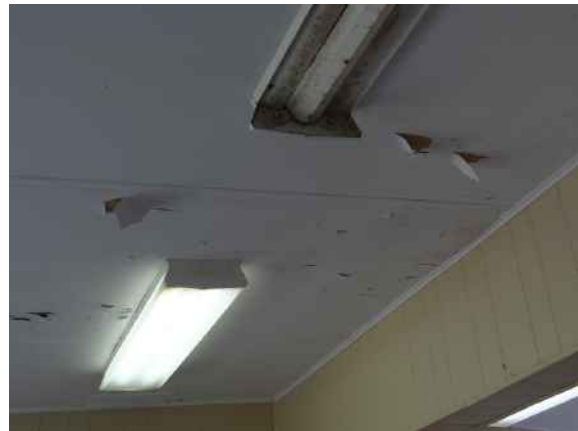
Osborn Hall - C303006

Water damage / peeling was observed. A Hazardous Materials (HazMat) assessment to determine the presence of lead in the paint, and to make recommendations for abatement if it is found to be present is recommended. The assessment should attempt to identify all hazardous materials present on-site.

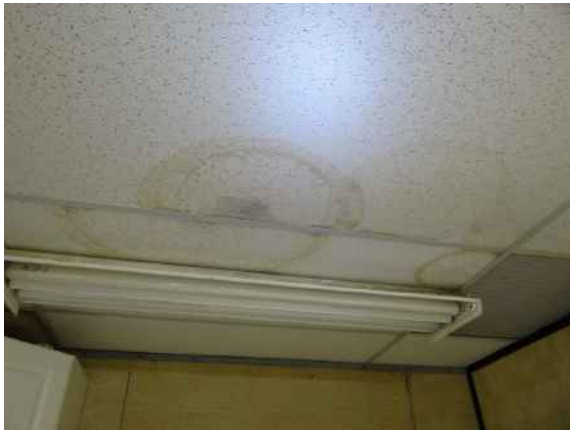
Osborn Hall - C303007

Water damage was observed in localized areas and should be addressed as part of maintenance.

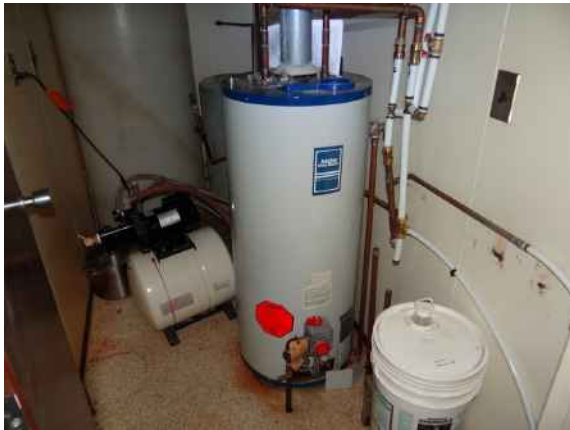
Osborn Hall - D202021

Corrosion was observed, operation of the equipment could not be confirmed.

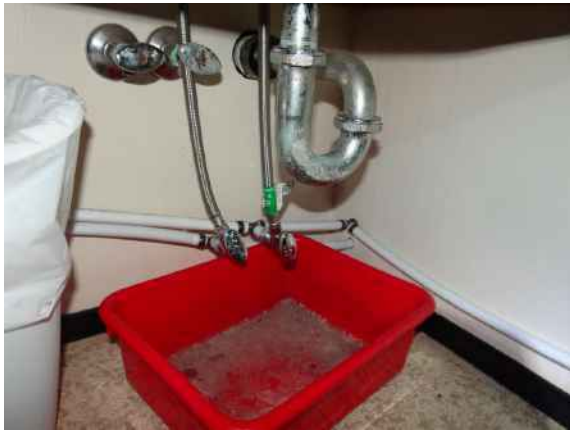
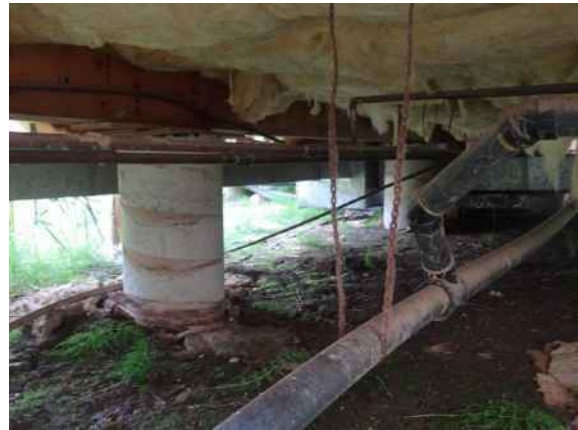
Osborn Hall - D203001

Some drains under the sinks appears to be leaking and should be repaired as part of maintenance.

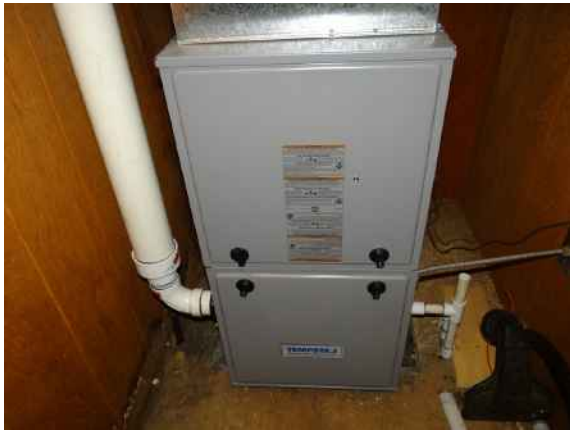
Osborn Hall - D302008

Heat is supplied by two fuel burning forced air furnaces. Unit 1 was installed in 2016

No major deficiencies were observed or reported.

Recommendation #1 - Fuel Fired Forced Air Furnace	
Type	Life Cycle Replacement
Year	2034
Cost	\$3,200.00

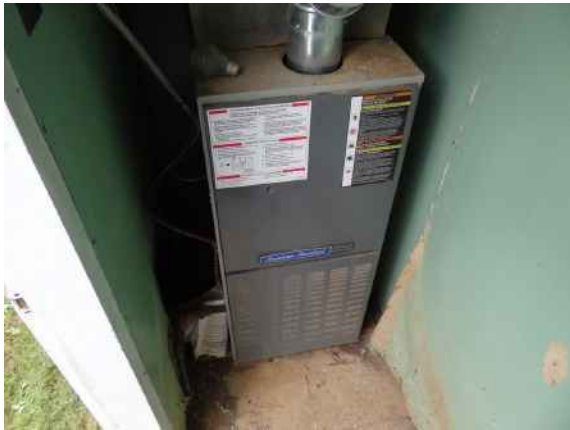
Osborn Hall - D302008

Heat is provided by two fuel burning forced air furnaces. Unit 2 was installed in 2009.

No major deficiencies were observed or reported.

Recommendation #1 - Fuel Fired Forced Air Furnace	
Type	Life Cycle Replacement
Year	2027
Cost	\$4,000.00

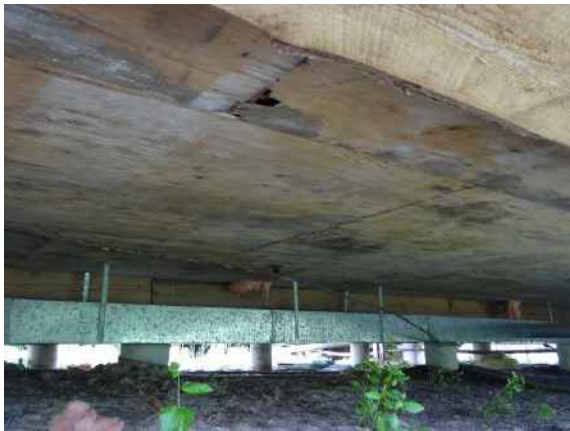
Osborn Hall - D304001

The ducting installed under the building does not appear to be insulated. This may result in heat loss, condensation and possible water damage. Ducting should be reviewed if intended to remain in service. The overall system condition to be confirmed based on the findings of the study.

Recommendation #1 - Inspect heat distribution system	
Type	Engineering Study
Year	2020
Cost	\$6,000.00

Recommendation #2 - Air Distribution Systems	
Type	Life Cycle Replacement
Year	2021
Cost	\$31,200.00

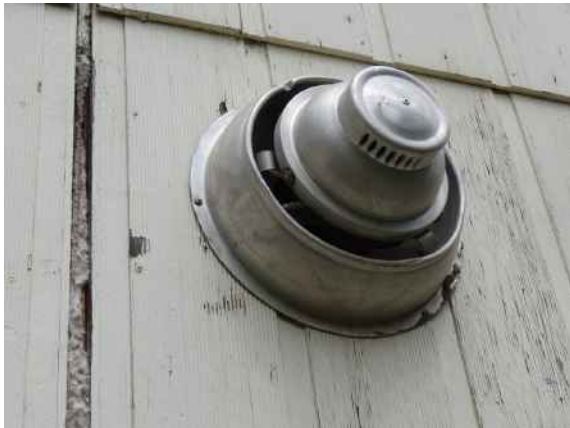
Osborn Hall - D304007

No major deficiencies were observed or reported.

Recommendation #1 - Exhaust Fans	
Type	Life Cycle Replacement
Year	2022
Cost	\$3,150.00
