## ELECTORAL AREA DIRECTORS COMMITTEE MEETING A G E N D A

### ELECTORAL AREA DIRECTORS COMMITTEE MEETING MINUTES

**Facility Condition Assessment Report  
Kelly Lake Community Centre**

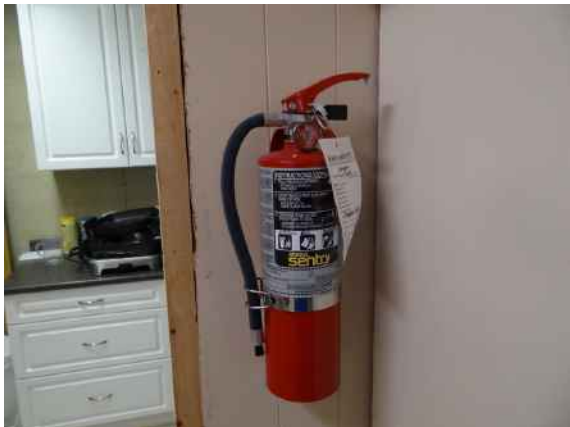
Osborn Hall - D409099

No major deficiencies were observed or reported.

Recommendation #1 - Other Fire Protection Systems	
Type	Life Cycle Replacement
Year	2026
Cost	\$200.00

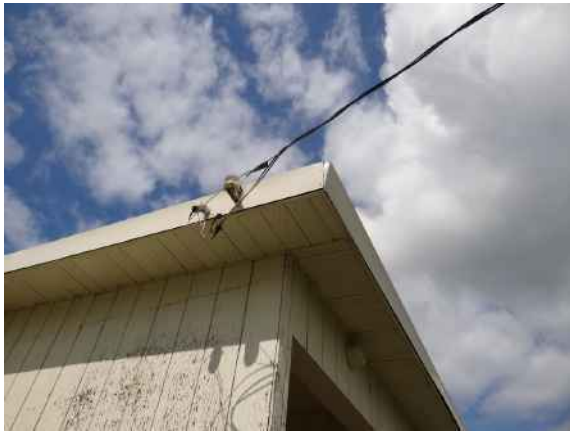
Osborn Hall - D501022

No major deficiencies were observed or reported.

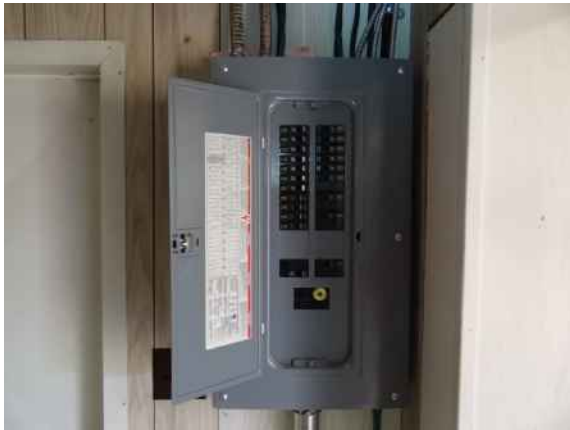
Osborn Hall - D501023

No major deficiencies were observed or reported.

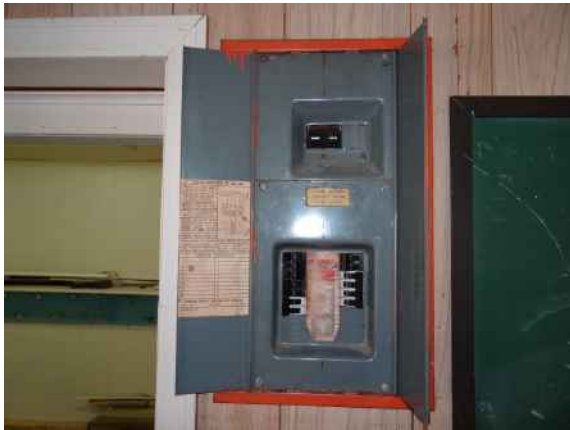
Osborn Hall - D501023

Electrical systems understood to trip breakers regularly.

Recommendation #1 - Electrical Panels	
Type	Life Cycle Replacement
Year	2020
Cost	\$4,000.00

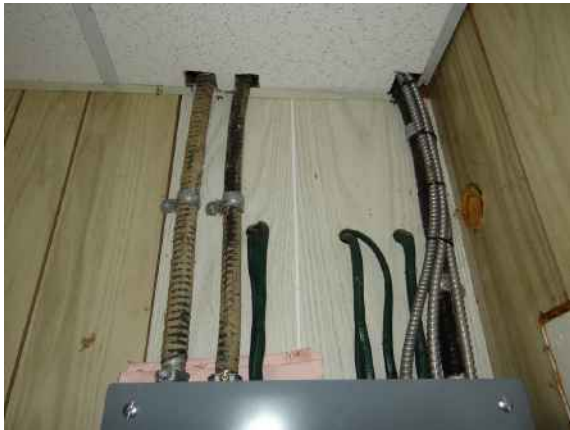
Osborn Hall - D502001

No major deficiencies were observed or reported; however, wiring is outdated.

Recommendation #1 - Branch Wiring and Devices	
Type	Life Cycle Replacement
Year	2022
Cost	\$24,700.00

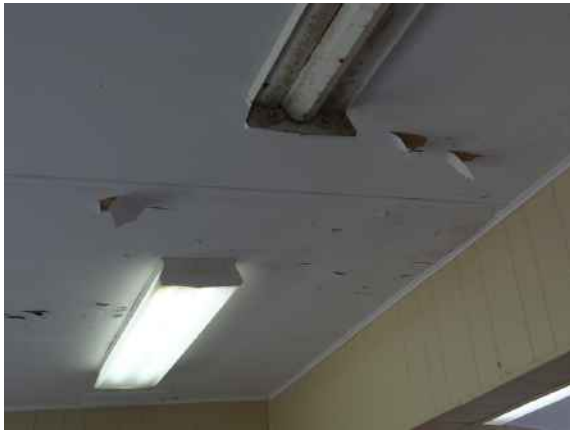
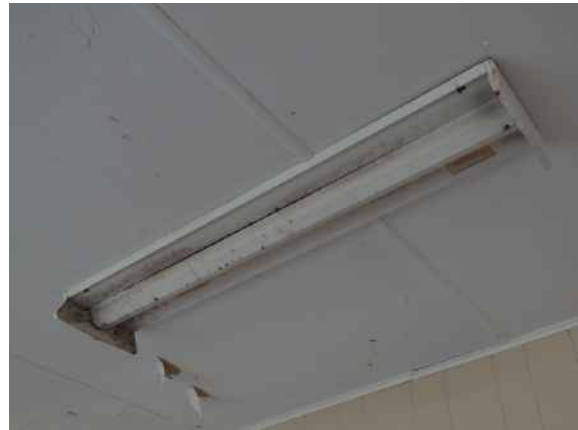
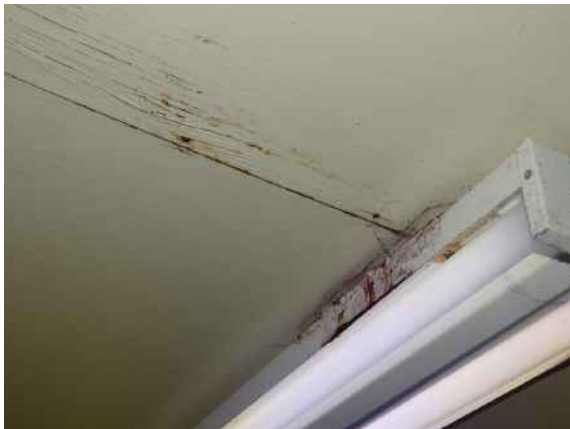
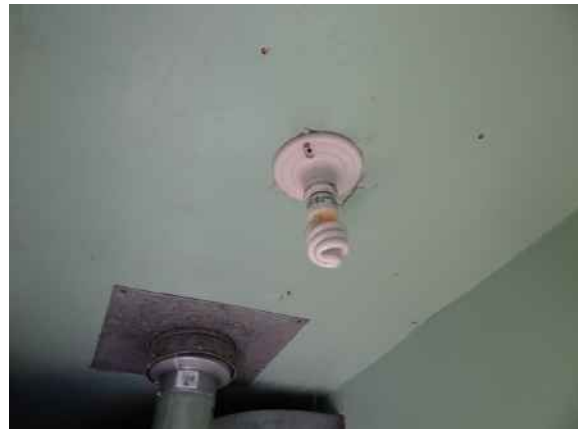
Water damage and corrosion was observed.

Recommendation #1 - Interior Lighting	
Type	Life Cycle Replacement
Year	2021
Cost	\$22,100.00

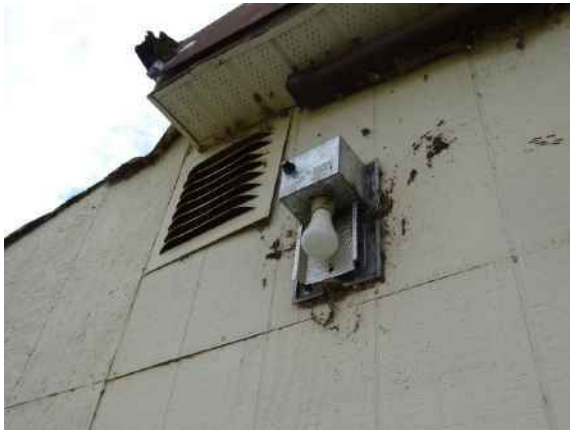
Osborn Hall - D502021

Mechanical damage was noted. Fixtures are outdated.

Recommendation #1 - Exterior Lighting	
Type	Life Cycle Replacement
Year	2021
Cost	\$4,800.00

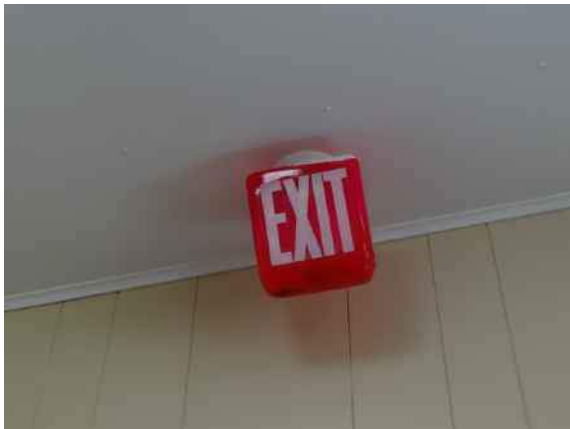
Osborn Hall - D502022

Exit lighting appears inadequate. Exit lighting should be installed at each exit. Fixtures are outdated. Emergency lighting and escape plan not observed.

Recommendation #1 - Install emergency lighting & Fire Escape Plan	
Type	Major Repair
Year	2020
Cost	\$3,900.00

Recommendation #2 - Exit Lighting	
Type	Life Cycle Replacement
Year	2020
Cost	\$3,120.00

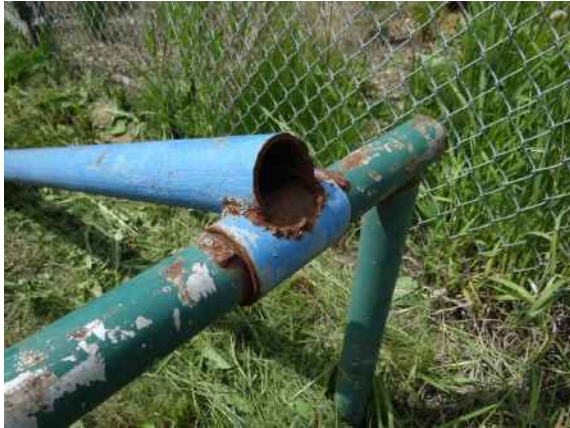
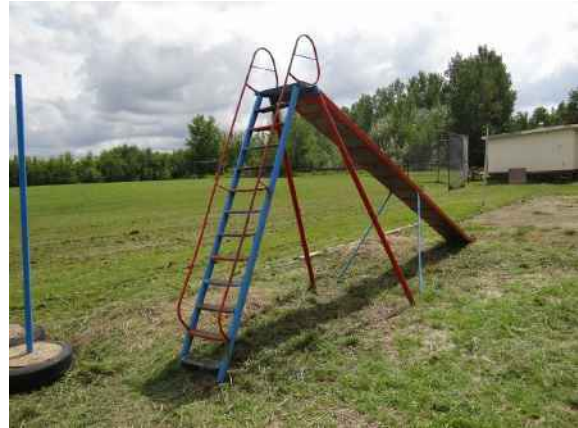
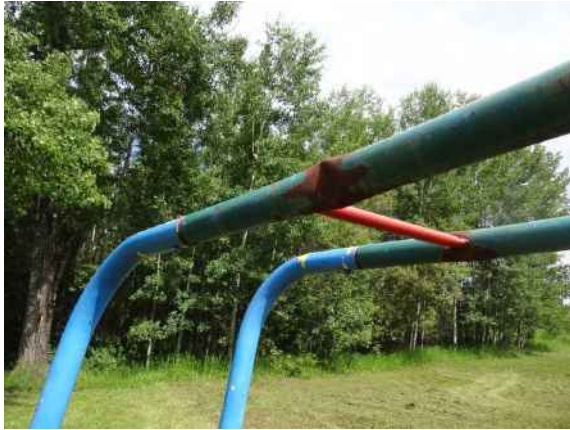
It was observed that some equipment in poor condition. Removal or replacement is recommended.

Recommendation #1 - Playground Equipment	
Type	Life Cycle Replacement
Year	2020
Cost	\$20,000.00

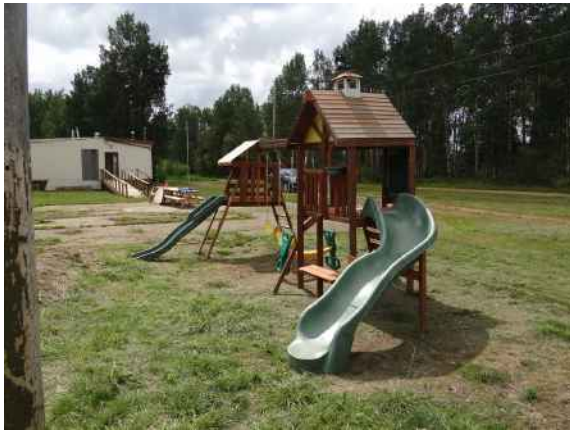
Osborn Hall - F101001

No major deficiencies were observed or reported.

Recommendation #1 - Playground Equipment	
Type	Life Cycle Replacement
Year	2030
Cost	\$10,000.00

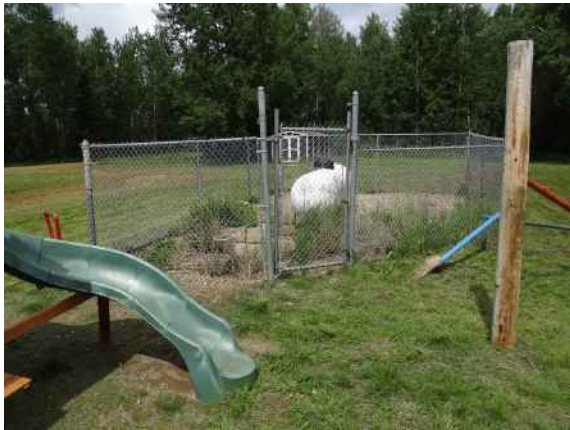
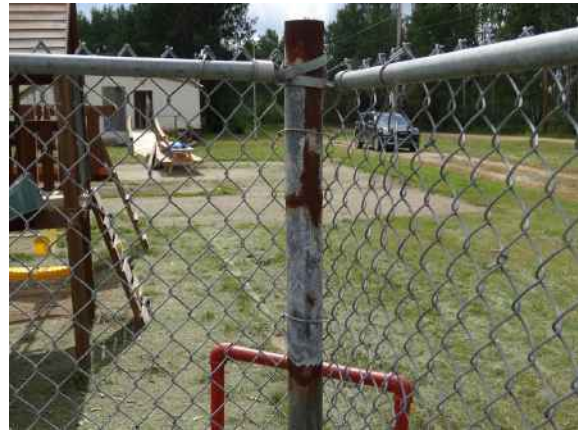
Some corrosion was observed

Recommendation #1 - Chain Link Fence Enclosure	
Type	Life Cycle Replacement
Year	2025
Cost	\$8,000.00

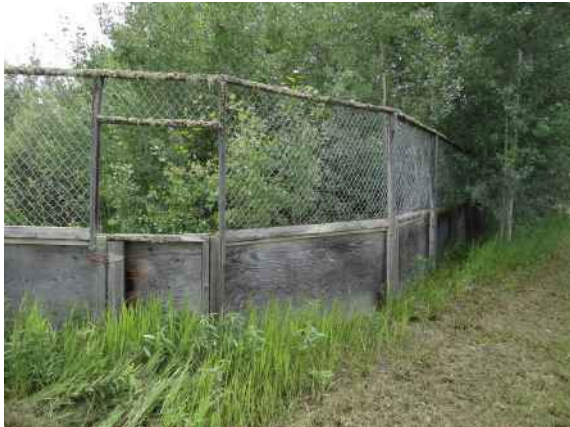
Osborn Hall - F101005

The outdoor rink appears to have been abandoned, It is heavily overgrown. Removal of remaining components is recommended.

Recommendation #1 - Arena/Race Track	
Type	Life Cycle Replacement
Year	2020
Cost	\$40,000.00

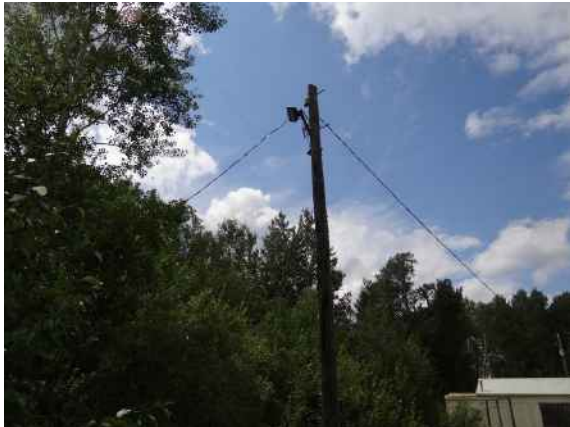
Osborn Hall - G402011

No major deficiencies were observed or reported. Performance of lights could not be confirmed.

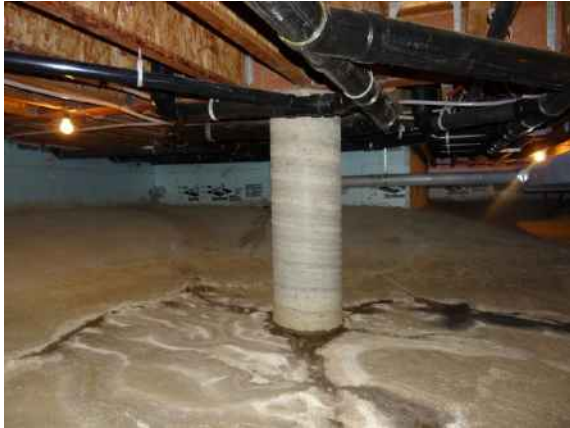
Tate Creek Community Centre - A1020

No major deficiencies were observed or reported.

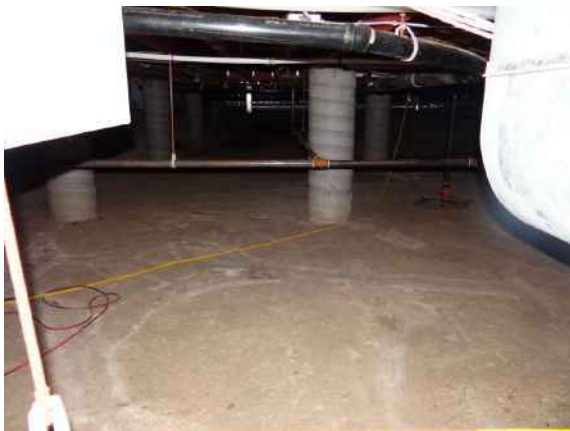
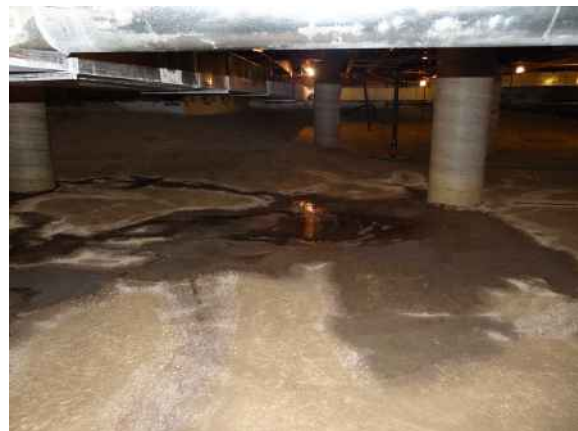
Tate Creek Community Centre - A1030

The crawlspace under the kitchen addition has a concrete slab on grade. Excess moisture as observed in the crawlspace. Source and significance of moisture should be investigated as repaired, if needed.

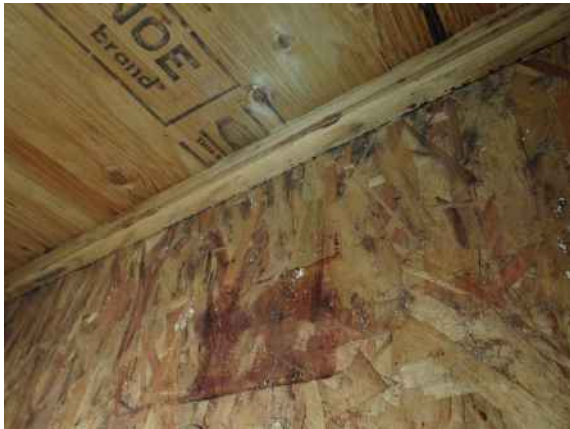
Tate Creek Community Centre - B1010

No major deficiencies were observed or reported. Excess moisture and possible related material damage was observed from the crawlspace and should be considered in conjunction with the recommended investigation.

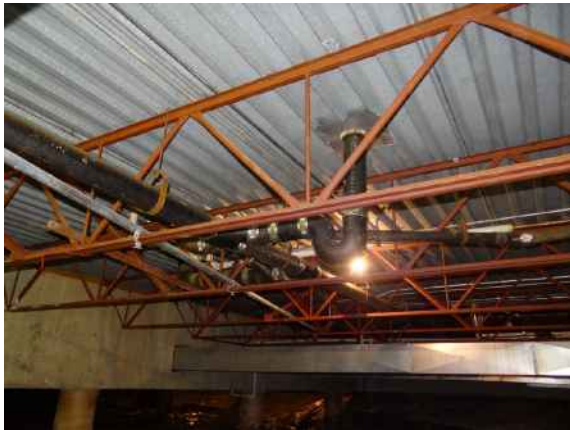
Tate Creek Community Centre - B1010

No major deficiencies were observed or reported.

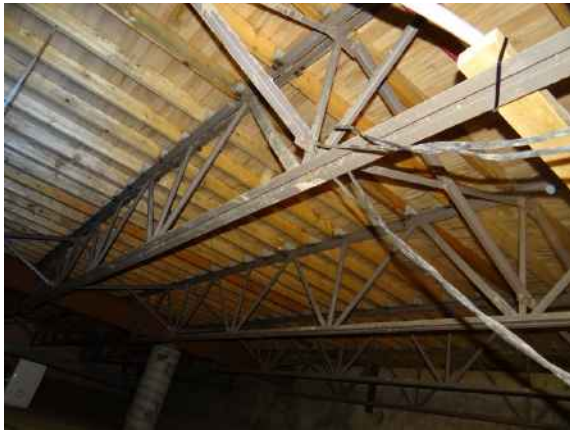
PRRD - Tate Creek Community Centre - B1010

No major deficiencies were observed or reported.

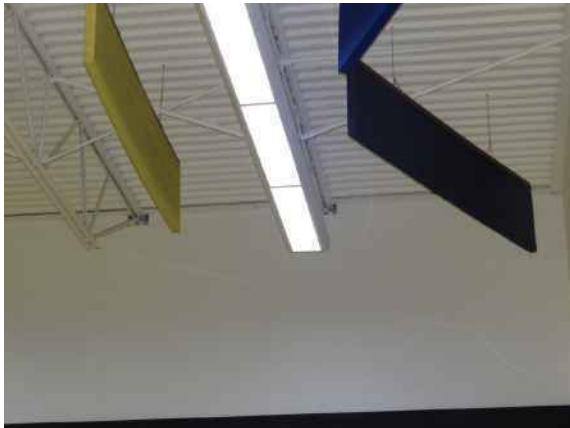
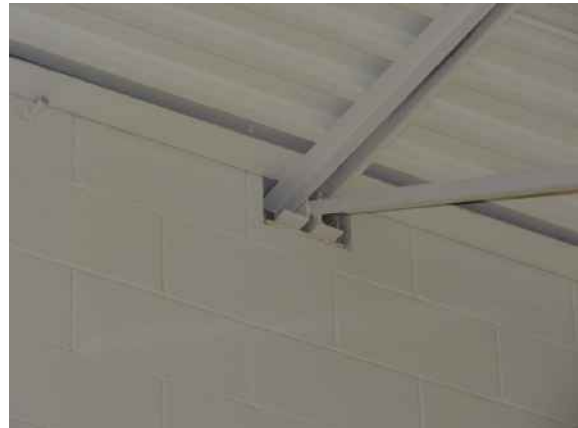
PRRD - Tate Creek Community Centre - B1020

No major deficiencies were observed or reported.

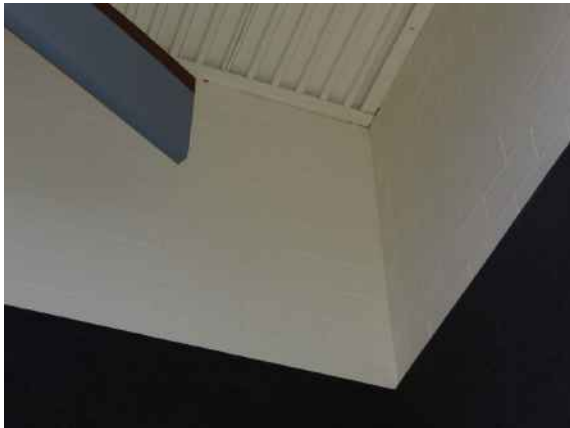
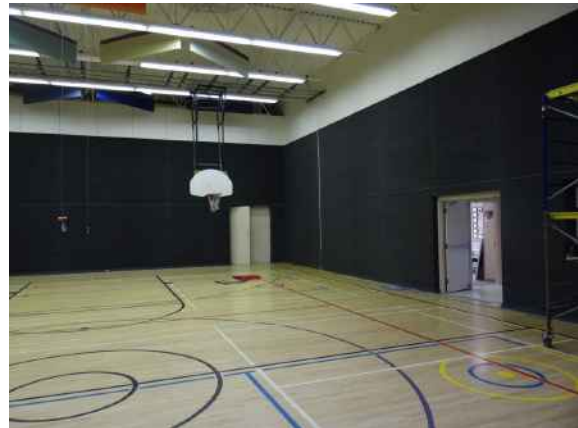
PRRD - Tate Creek Community Centre - B1030

No major deficiencies were observed or reported.

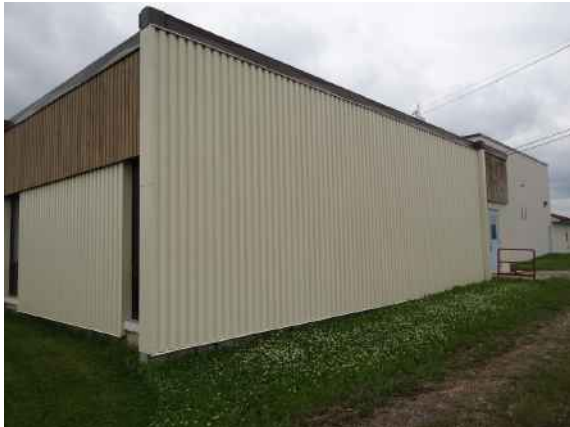
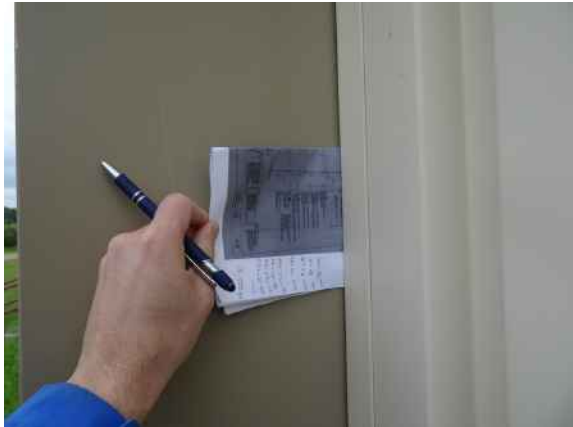
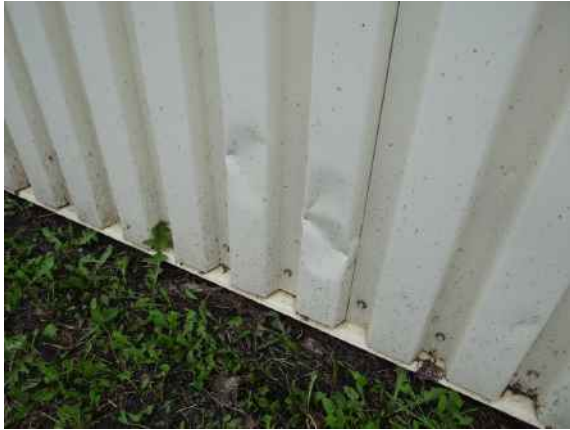
Tate Creek Community Centre - B201024

Localized damage and unsealed joints were observed and should be addressed as part of maintenance activities.

Recommendation #1 - Metal Siding	
Type	Life Cycle Replacement
Year	2025
Cost	\$48,000.00

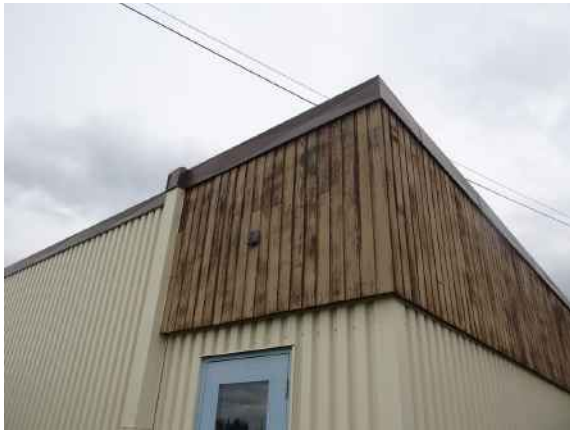
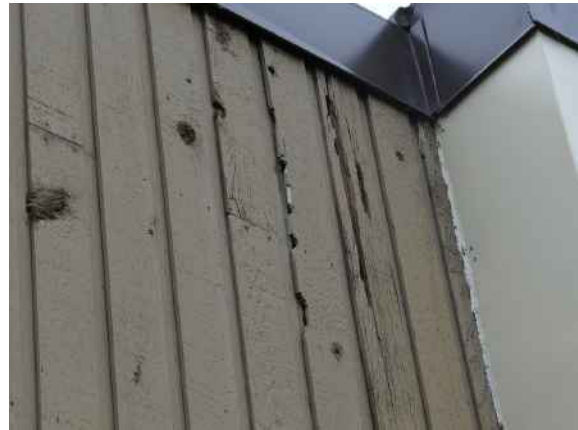
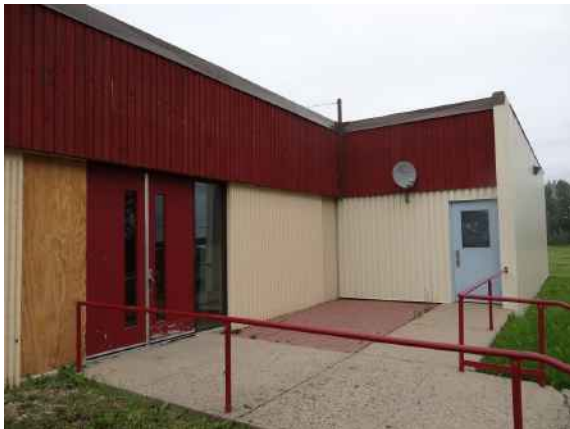
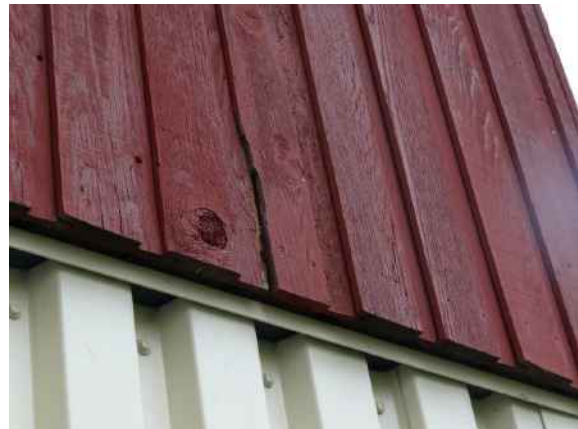
Tate Creek Community Centre - B201026

Deterioration and general weathering was observed.

Recommendation #1 - Wood Siding	
Type	Life Cycle Replacement
Year	2022
Cost	\$28,200.00

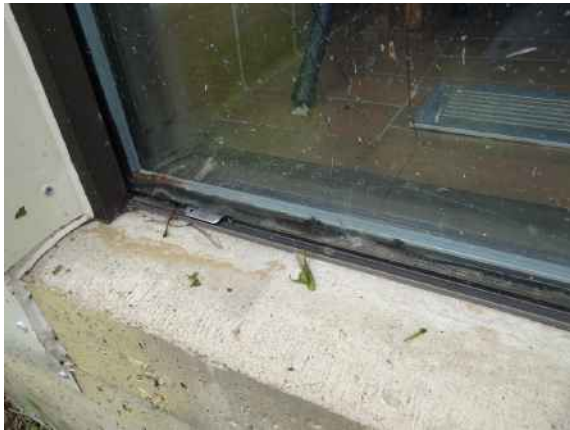
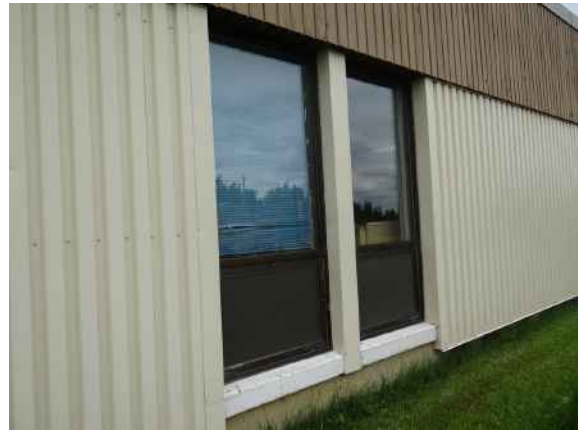
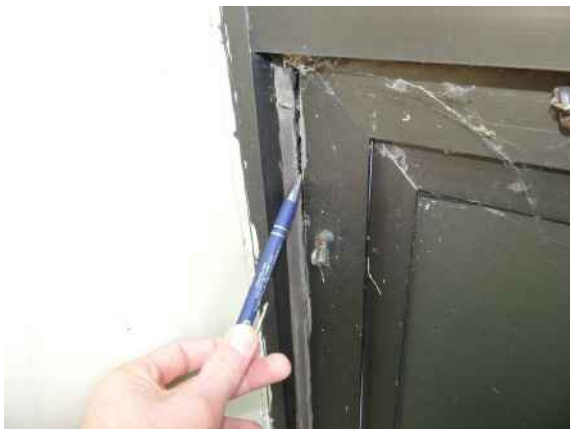
Tate Creek Community Centre - B202001

Deteriorated seals, mechanisms and caulking were observed.

Recommendation #1 - Windows	
Type	Life Cycle Replacement
Year	2022
Cost	\$29,400.00

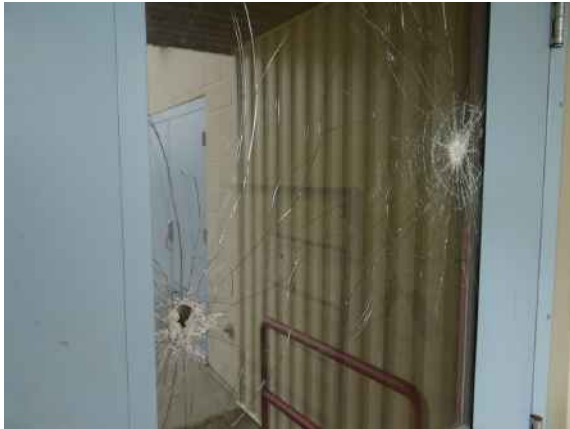
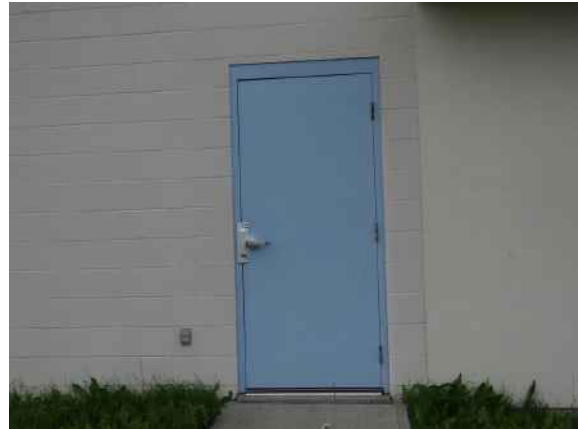
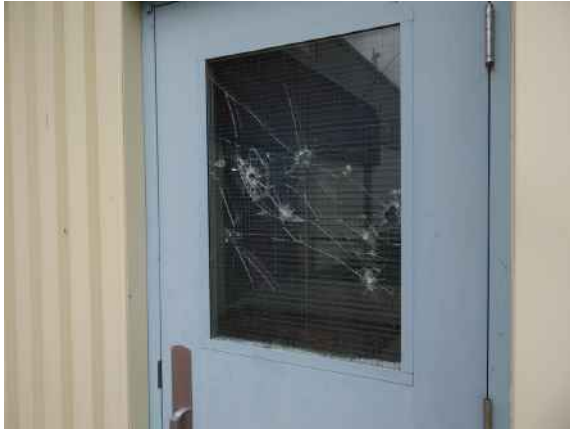
Tate Creek Community Centre - B203002

Door generally appeared weathered with faded finishes. One door had damaged glass and should be repaired/replaced.

Recommendation #1 - Repair Allowance - Damaged Door	
Type	Lifecycle Repair
Year	2020
Cost	\$3,000.00

Recommendation #2 - Solid Doors - Single	
Type	Life Cycle Replacement
Year	2022
Cost	\$12,000.00

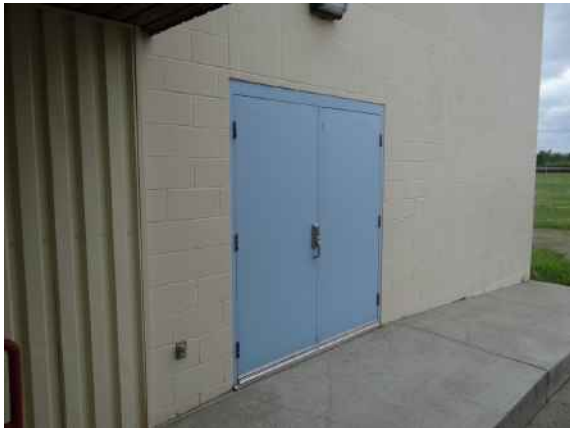
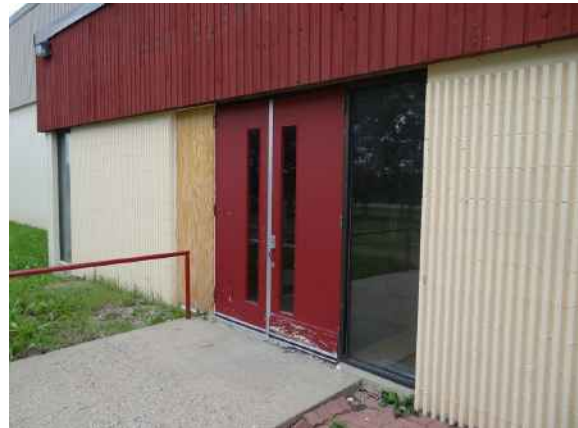
Tate Creek Community Centre - B203003

Doors generally appeared weathered with faded finishes.

Recommendation #1 - Solid Doors - Double	
Type	Life Cycle Replacement
Year	2022
Cost	\$20,000.00

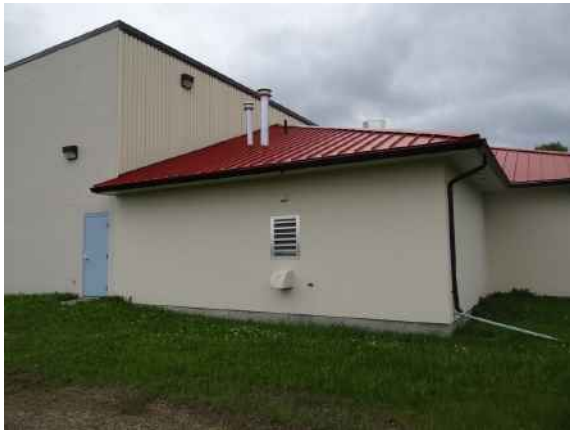
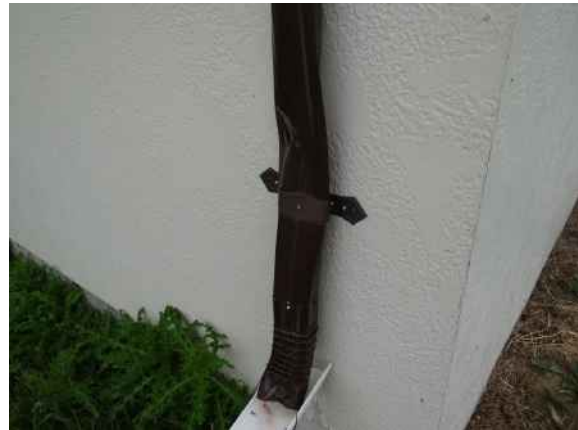
Tate Creek Community Centre - B301005

No major deficiencies were observed or reported. Some mechanical damage was observed and should be repaired as part of maintenance.

Recommendation #1 - Gutters and Downspouts	
Type	Life Cycle Replacement
Year	2036
Cost	\$1,500.00

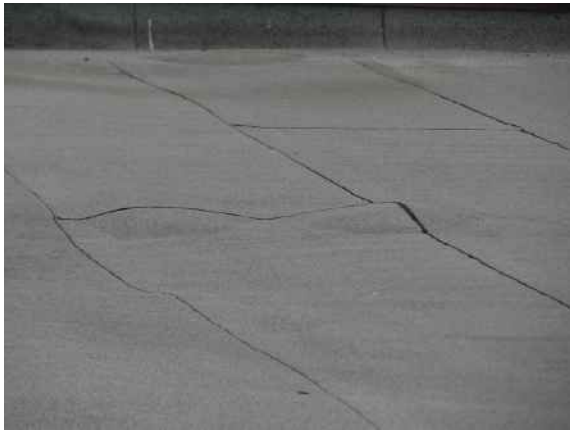
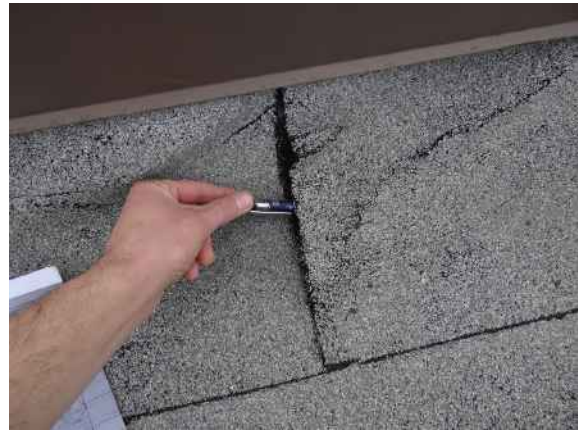
Tate Creek Community Centre - B301022

Defects such as blistering and open seams were observed.

Recommendation #1 - Conventional - Modified Bitumen	
Type	Life Cycle Replacement
Year	2020
Cost	\$140,940.00

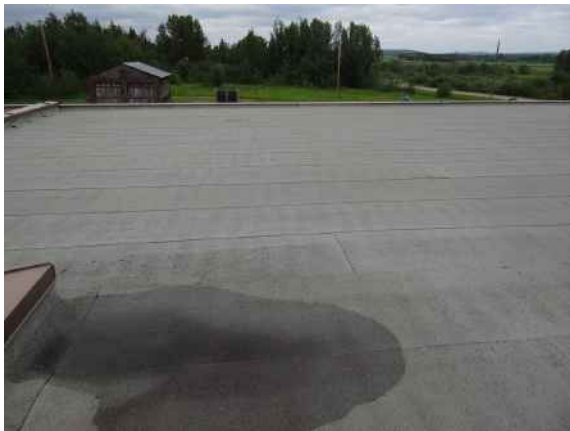
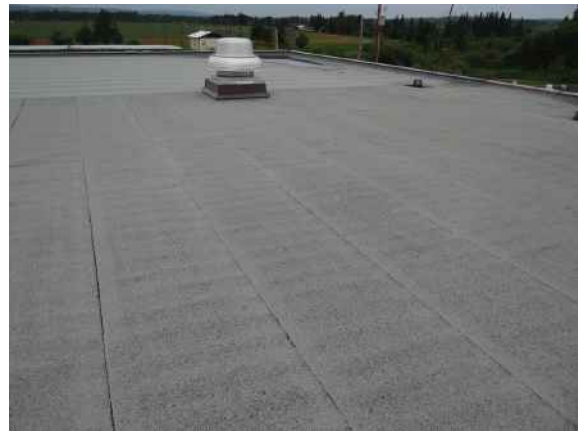
Tate Creek Community Centre - B301022

Loss of granular material was observed. Ridging commonly observed. Ponding water observed in the northwest corner.

Recommendation #1 - Conventional - Modified Bitumen	
Type	Life Cycle Replacement
Year	2022
Cost	\$108,270.00

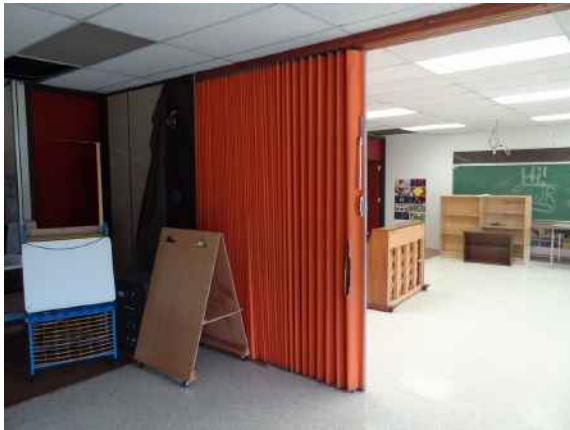
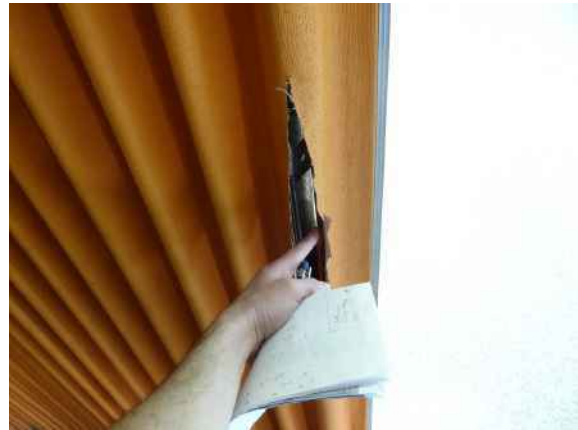
Tate Creek Community Centre - C101003

Damage and wear was observed. Partition was not serviceable.

Recommendation #1 - Retractable Partitions	
Type	Life Cycle Replacement
Year	2020
Cost	\$15,000.00

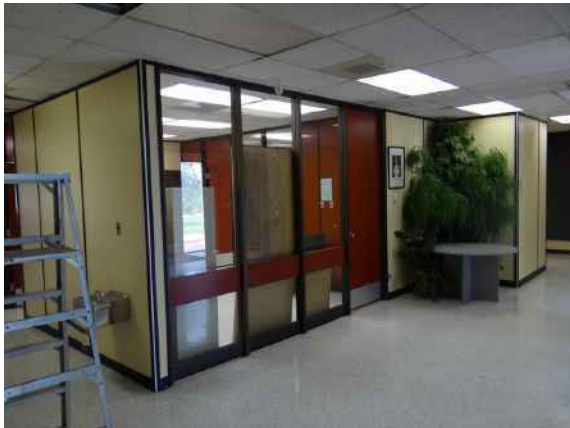
Tate Creek Community Centre - C101006

Item	Description
Uniformat Code	C101006 - Glazed Partitions and Storefronts
Installation Year	1981
Condition	1 - Good
Expected Useful Life	50 Years
Remaining Useful Life	12 Years
Quantity / Unit of Measure	10 / SM
Unit Cost	\$500.00
Difficulty / Regional / Soft Cost Factors	1.00 / 1.00 / 1.00
Element Renewal Cost	\$5,000.00

No major deficiencies were observed or reported.

Recommendation #1 - Glazed Partitions and Storefronts	
Type	Life Cycle Replacement
Year	2031
Cost	\$5,000.00

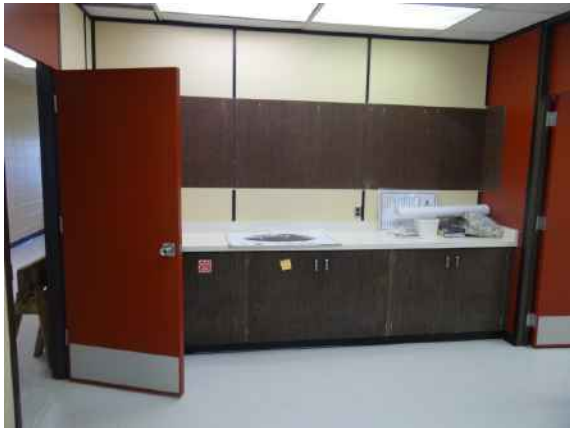
Tate Creek Community Centre - C102002

Item	Description
Uniformat Code	C102002 - Solid Interior Door - Single
Installation Year	1975
Condition	1 - Good
Expected Useful Life	40 Years
Remaining Useful Life	6 Years
Quantity / Unit of Measure	25 / Each
Unit Cost	\$2,000.00
Difficulty / Regional / Soft Cost Factors	1.00 / 1.00 / 1.00
Element Renewal Cost	\$50,000.00

No major deficiencies were observed or reported.

Recommendation #1 - Solid Interior Door - Single	
Type	Life Cycle Replacement
Year	2025
Cost	\$50,000.00

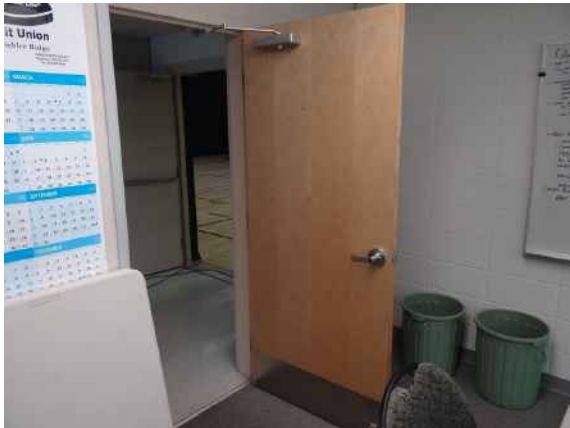
Tate Creek Community Centre - C102002

Item	Description
Uniformat Code	C102002 - Solid Interior Door - Single
Installation Year	2006
Condition	1 - Good
Expected Useful Life	40 Years
Remaining Useful Life	27 Years
Quantity / Unit of Measure	6 / Each
Unit Cost	\$2,000.00
Difficulty / Regional / Soft Cost Factors	1.00 / 1.00 / 1.00
Element Renewal Cost	\$12,000.00

No major deficiencies were observed or reported.

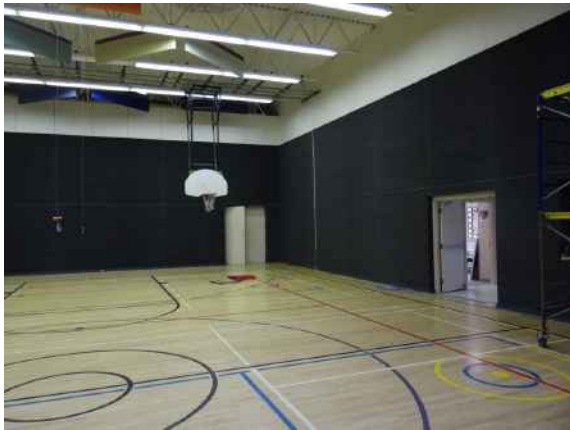
PRRD - Tate Creek Community Centre - C102003

Item	Description
Uniformat Code	C102003 - Solid Interior Door - Double
Installation Year	1981
Condition	1 - Good
Expected Useful Life	40 Years
Remaining Useful Life	6 Years
Quantity / Unit of Measure	3 / Each
Unit Cost	\$3,500.00
Difficulty / Regional / Soft Cost Factors	1.00 / 1.00 / 1.00
Element Renewal Cost	\$10,500.00

No major deficiencies were observed or reported.

Recommendation #1 - Solid Interior Door - Double	
Type	Life Cycle Replacement
Year	2025
Cost	\$10,500.00

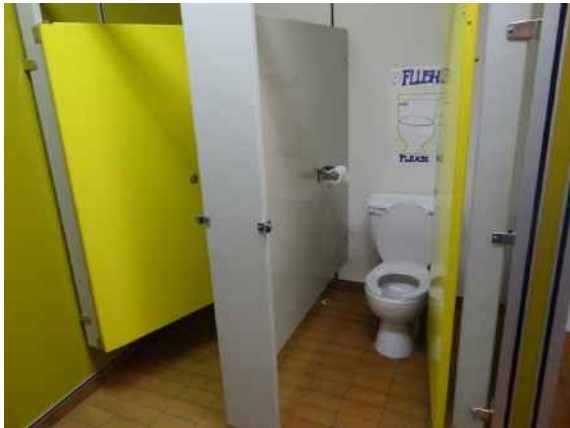
Tate Creek Community Centre - C103001

Item	Description
Uniformat Code	C103001 - Washroom Partitions
Installation Year	1981
Condition	1 - Good
Expected Useful Life	15 Years
Remaining Useful Life	6 Years
Quantity / Unit of Measure	12 / Each
Unit Cost	\$1,500.00
Difficulty / Regional / Soft Cost Factors	1.00 / 1.00 / 1.00
Element Renewal Cost	\$18,000.00

No major deficiencies were observed or reported.

Recommendation #1 - Washroom Partitions	
Type	Life Cycle Replacement
Year	2025
Cost	\$18,000.00

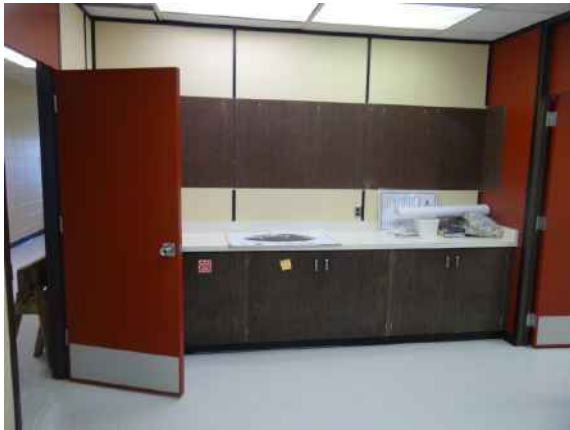
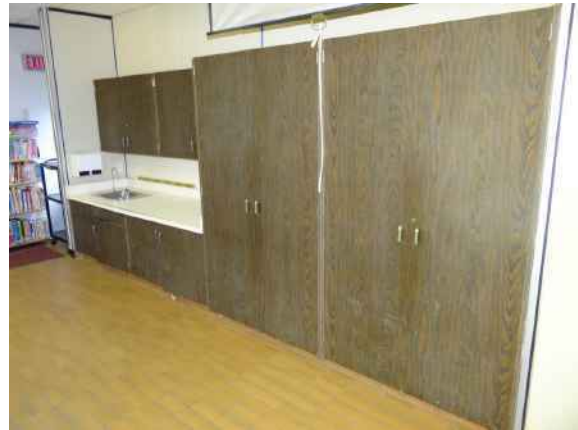
Tate Creek Community Centre - C103009

Item	Description
Uniformat Code	C103009 - Cabinets - Millwork
Installation Year	1975
Condition	2 - Fair
Expected Useful Life	30 Years
Remaining Useful Life	5 Years
Quantity / Unit of Measure	22 / LM
Unit Cost	\$500.00
Difficulty / Regional / Soft Cost Factors	1.00 / 1.00 / 1.00
Element Renewal Cost	\$11,000.00

No major deficiencies were observed or reported. Millwork appears outdated.

Recommendation #1 - Cabinets - Millwork	
Type	Life Cycle Replacement
Year	2024
Cost	\$11,000.00

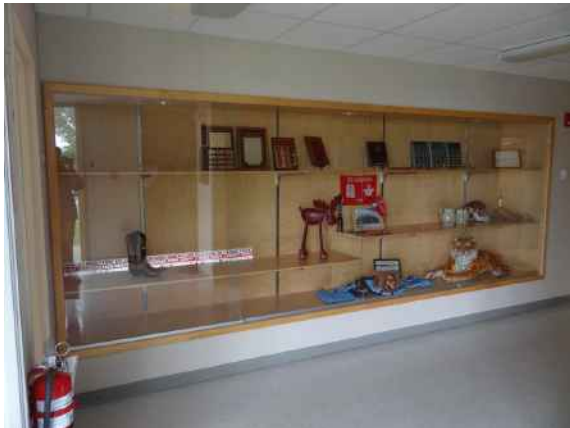
Tate Creek Community Centre - C103009

Item	Description
Uniformat Code	C103009 - Cabinets - Millwork
Installation Year	2006
Condition	1 - Good
Expected Useful Life	30 Years
Remaining Useful Life	16 Years
Quantity / Unit of Measure	8 / LM
Unit Cost	\$500.00
Difficulty / Regional / Soft Cost Factors	1.00 / 1.00 / 1.00
Element Renewal Cost	\$4,000.00

No major deficiencies were observed or reported.

Recommendation #1 - Cabinets - Millwork	
Type	Life Cycle Replacement
Year	2035
Cost	\$4,000.00

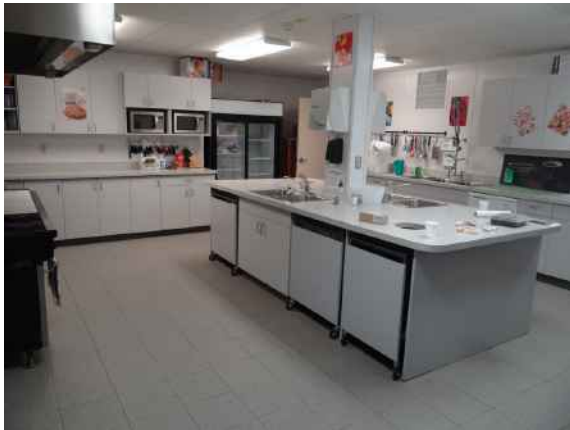
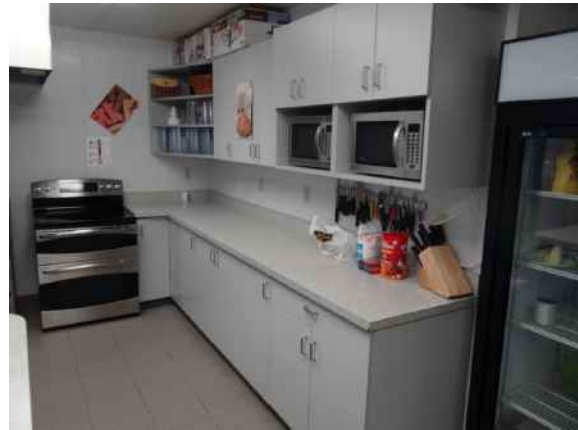
Tate Creek Community Centre - C103010

Item	Description
Uniformat Code	C103010 - Cabinets - Kitchen
Installation Year	2006
Condition	1 - Good
Expected Useful Life	30 Years
Remaining Useful Life	17 Years
Quantity / Unit of Measure	20 / LM
Unit Cost	\$1,200.00
Difficulty / Regional / Soft Cost Factors	1.00 / 1.00 / 1.00
Element Renewal Cost	\$24,000.00

No major deficiencies were observed or reported.

Recommendation #1 - Cabinets - Kitchen	
Type	Life Cycle Replacement
Year	2036
Cost	\$24,000.00

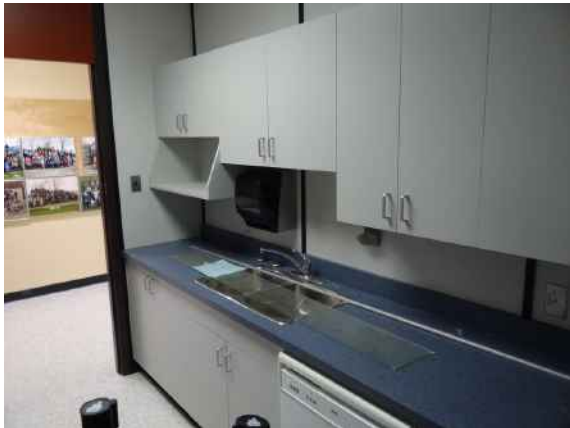
Tate Creek Community Centre - C103010

Item	Description
Uniformat Code	C103010 - Cabinets - Kitchen
Installation Year	2013
Condition	1 - Good
Expected Useful Life	30 Years
Remaining Useful Life	24 Years
Quantity / Unit of Measure	6 / LM
Unit Cost	\$1,200.00
Difficulty / Regional / Soft Cost Factors	1.00 / 1.00 / 1.00
Element Renewal Cost	\$7,200.00

No major deficiencies were observed or reported.

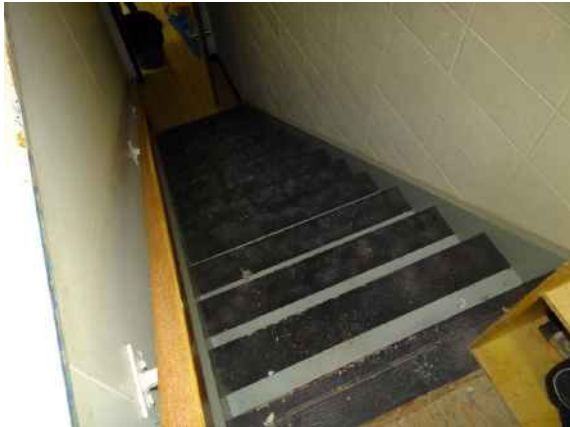
Tate Creek Community Centre - C201001

Item	Description
Uniformat Code	C201001 - Interior Stair Construction
Installation Year	1981
Condition	1 - Good
Expected Useful Life	75 Years
Remaining Useful Life	37 Years
Quantity / Unit of Measure	1 / Per Floor
Unit Cost	\$15,000.00
Difficulty / Regional / Soft Cost Factors	1.00 / 1.00 / 1.00
Element Renewal Cost	\$15,000.00

No major deficiencies were observed or reported.

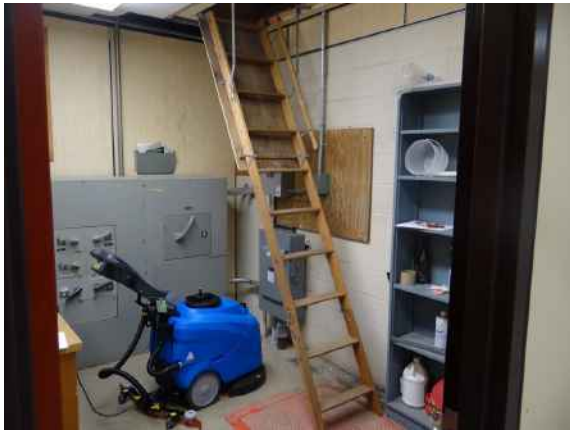
Tate Creek Community Centre - C201027

Item	Description
Uniformat Code	C201027 - Roof Access Ladders
Installation Year	1981
Condition	1 - Good
Expected Useful Life	40 Years
Remaining Useful Life	6 Years
Quantity / Unit of Measure	6 / LM
Unit Cost	\$1,000.00
Difficulty / Regional / Soft Cost Factors	1.00 / 1.00 / 1.00
Element Renewal Cost	\$6,000.00

No major deficiencies were observed or reported.

Recommendation #1 - Roof Access Ladders	
Type	Life Cycle Replacement
Year	2025
Cost	\$6,000.00

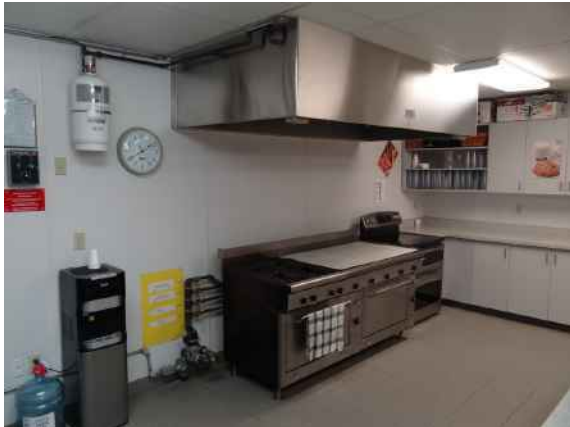
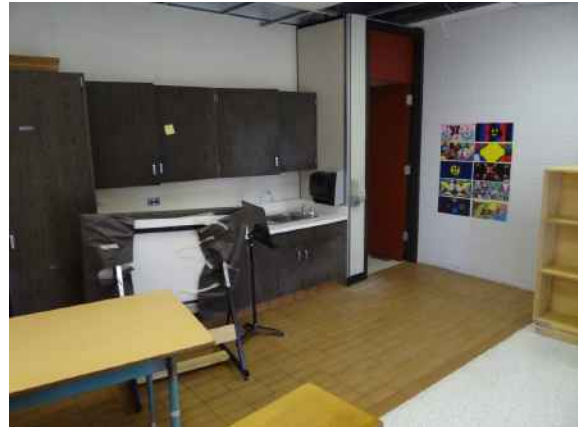
PRRD - Tate Creek Community Centre - C301005

Item	Description
Uniformat Code	C301005 - Painted Wall Covering
Installation Year	2013
Condition	2 - Fair
Expected Useful Life	10 Years
Remaining Useful Life	4 Years
Quantity / Unit of Measure	1255 / SM Building
Unit Cost	\$40.00
Difficulty / Regional / Soft Cost Factors	1.00 / 1.00 / 1.00
Element Renewal Cost	\$50,200.00

No major deficiencies were observed or reported.

Recommendation #1 - Painted Wall Covering	
Type	Life Cycle Replacement
Year	2023
Cost	\$50,200.00

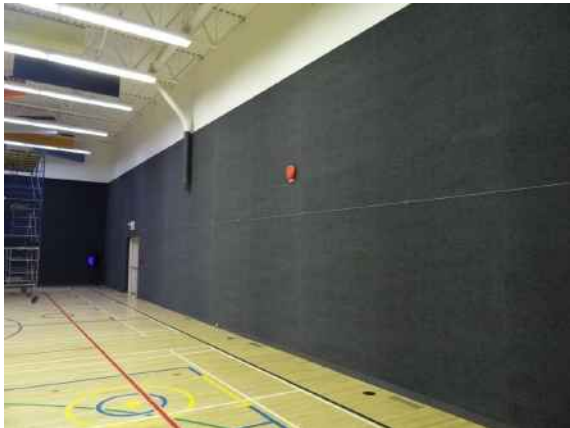
Tate Creek Community Centre - C301007

Item	Description
Uniformat Code	C301007 - Acoustic Panels
Installation Year	2019
Condition	1 - Good
Expected Useful Life	25 Years
Remaining Useful Life	25 Years
Quantity / Unit of Measure	480 / SM
Unit Cost	\$250.00
Difficulty / Regional / Soft Cost Factors	0.25 / 1.00 / 1.00
Element Renewal Cost	\$30,000.00

No major deficiencies were observed or reported.

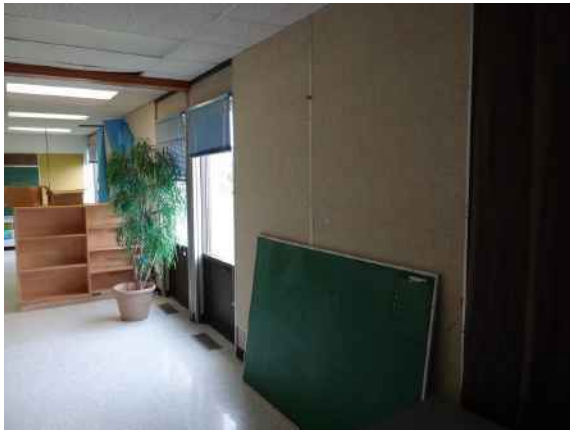
Tate Creek Community Centre - C301021

Item	Description
Uniformat Code	C301021 - Wall Paper
Installation Year	1981
Condition	2 - Fair
Expected Useful Life	15 Years
Remaining Useful Life	5 Years
Quantity / Unit of Measure	900 / SM
Unit Cost	\$60.00
Difficulty / Regional / Soft Cost Factors	1.00 / 1.00 / 1.00
Element Renewal Cost	\$54,000.00

No major deficiencies were observed or reported. The panels appear to be outdated.

Recommendation #1 - Wall Paper	
Type	Life Cycle Replacement
Year	2024
Cost	\$54,000.00

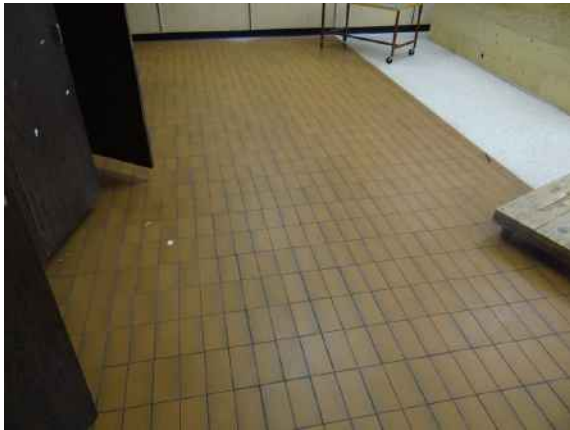
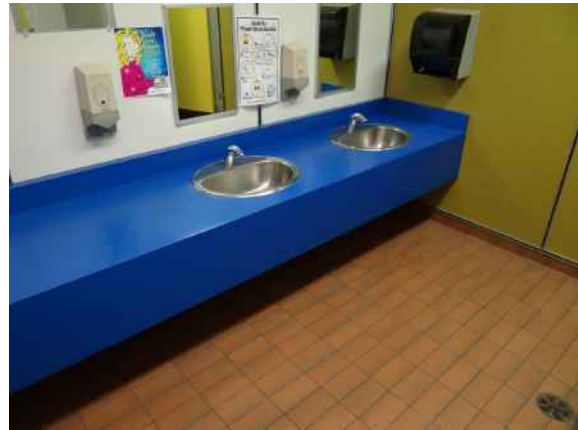
Tate Creek Community Centre - C302001

Item	Description
Uniformat Code	C302001 - Ceramic
Installation Year	1975
Condition	1 - Good
Expected Useful Life	30 Years
Remaining Useful Life	6 Years
Quantity / Unit of Measure	144 / SM
Unit Cost	\$130.00
Difficulty / Regional / Soft Cost Factors	1.00 / 1.00 / 1.00
Element Renewal Cost	\$18,720.00

No major deficiencies were observed or reported.

Recommendation #1 - Ceramic	
Type	Life Cycle Replacement
Year	2025
Cost	\$18,720.00

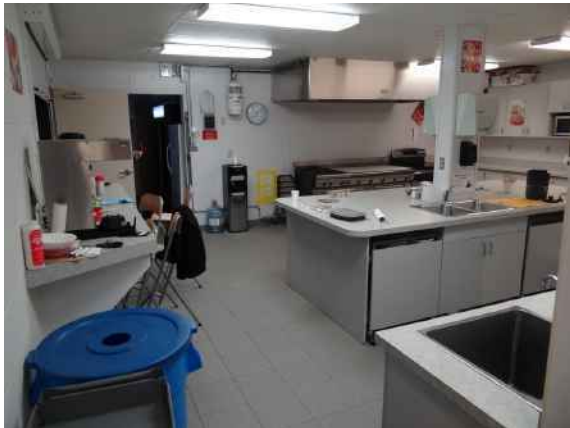
Tate Creek Community Centre - C302001

Item	Description
Uniformat Code	C302001 - Ceramic
Installation Year	2006
Condition	1 - Good
Expected Useful Life	30 Years
Remaining Useful Life	17 Years
Quantity / Unit of Measure	80 / SM
Unit Cost	\$130.00
Difficulty / Regional / Soft Cost Factors	1.00 / 1.00 / 1.00
Element Renewal Cost	\$10,400.00

No major deficiencies were observed or reported.

Recommendation #1 - Ceramic	
Type	Life Cycle Replacement
Year	2036
Cost	\$10,400.00

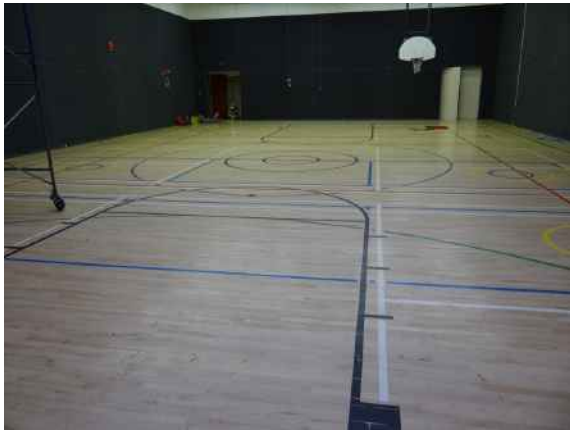
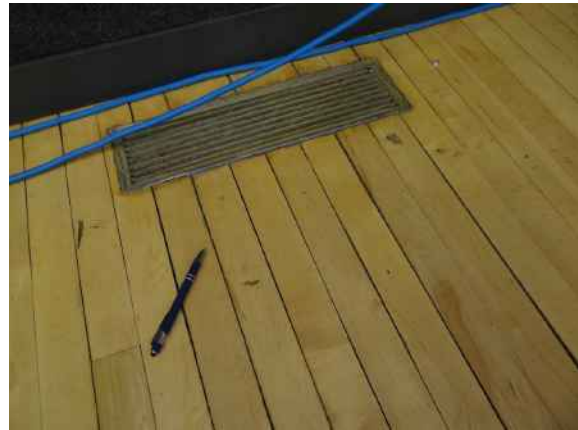
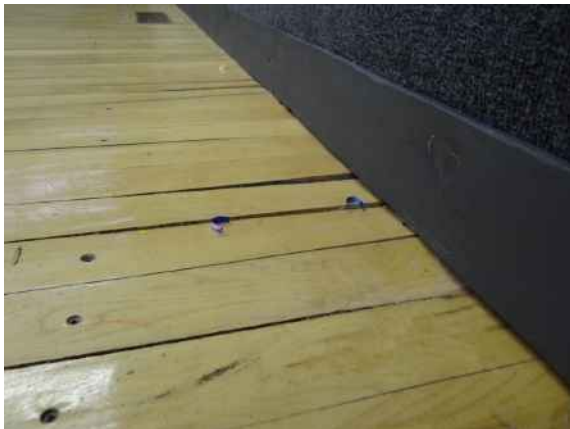
Tate Creek Community Centre - C302003

Item	Description
Unifomat Code	C302003 - Wood Flooring
Installation Year	1981
Condition	2 - Fair
Expected Useful Life	20 Years
Remaining Useful Life	4 Years
Quantity / Unit of Measure	401 / SM
Unit Cost	\$170.00
Difficulty / Regional / Soft Cost Factors	1.33 / 1.00 / 1.00
Element Renewal Cost	\$90,666.10

Numerous defects including buckling, shrinkage and wear were observed.

Recommendation #1 - Wood Flooring	
Type	Life Cycle Replacement
Year	2023
Cost	\$90,666.10

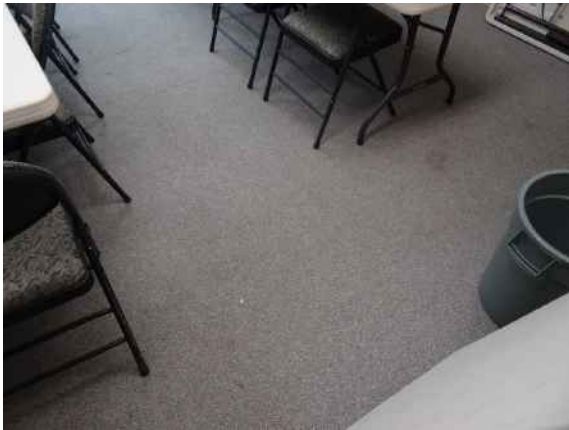
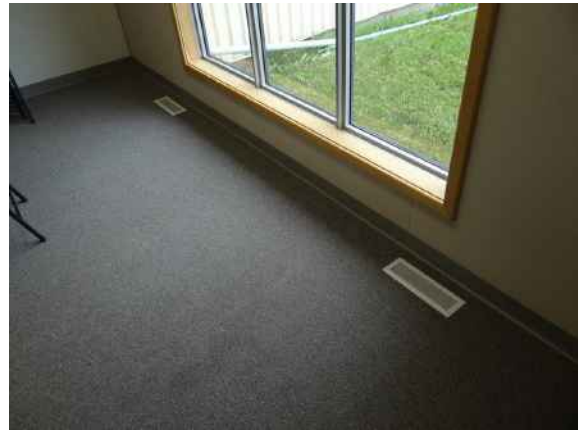
PRRD - Tate Creek Community Centre - C302005

Item	Description
Uniformat Code	C302005 - Carpet
Installation Year	2013
Condition	1 - Good
Expected Useful Life	10 Years
Remaining Useful Life	6 Years
Quantity / Unit of Measure	30 / SM
Unit Cost	\$120.00
Difficulty / Regional / Soft Cost Factors	1.00 / 1.00 / 1.00
Element Renewal Cost	\$3,600.00

No major issues observed or reported.
