## ELECTORAL AREA DIRECTORS COMMITTEE MEETING A G E N D A

### ELECTORAL AREA DIRECTORS COMMITTEE MEETING MINUTES

**Facility Condition Assessment Report  
Kelly Lake Community Centre**

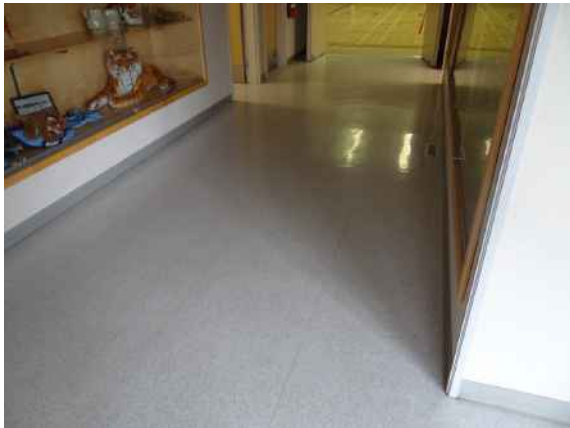
Tate Creek Community Centre - C302006

No major deficiencies were observed or reported.

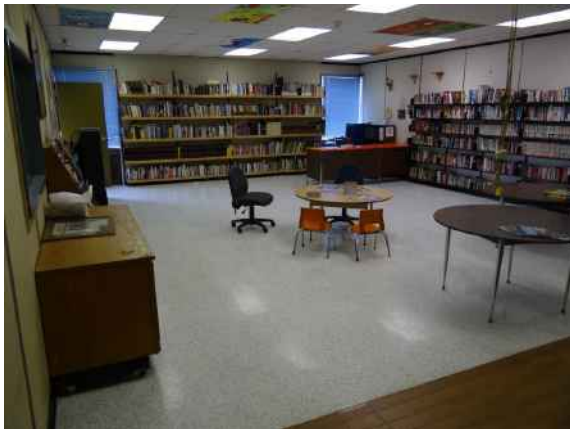
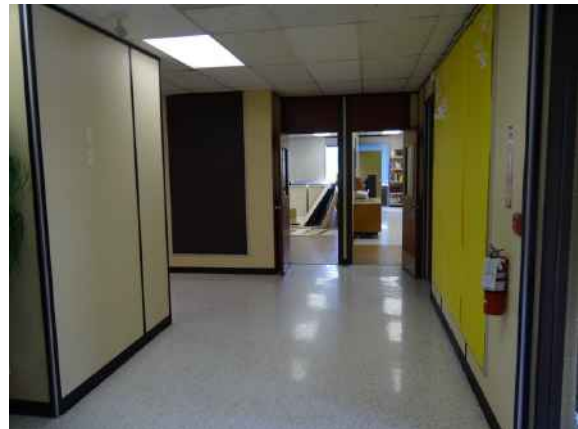
Tate Creek Community Centre - C302006

No major deficiencies were observed or reported.

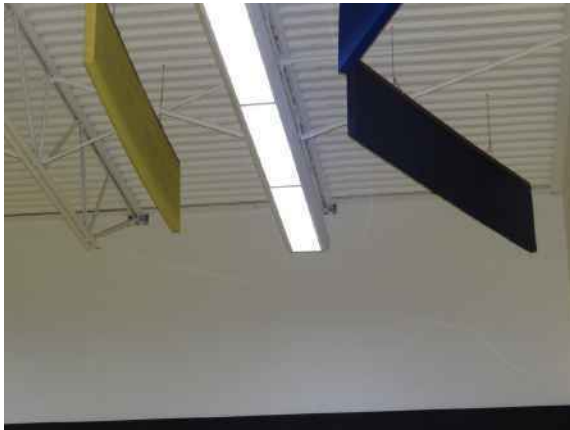
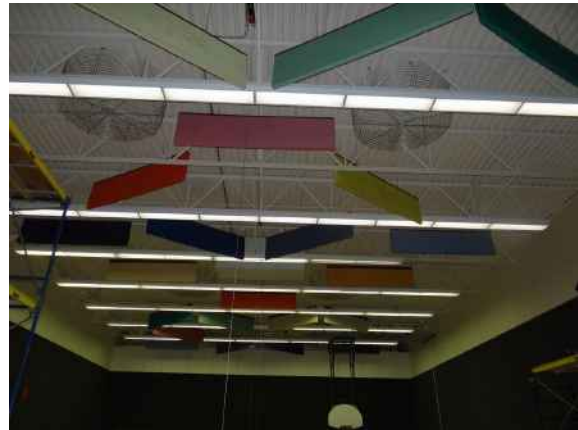
Tate Creek Community Centre - C303006

No major deficiencies were observed or reported.

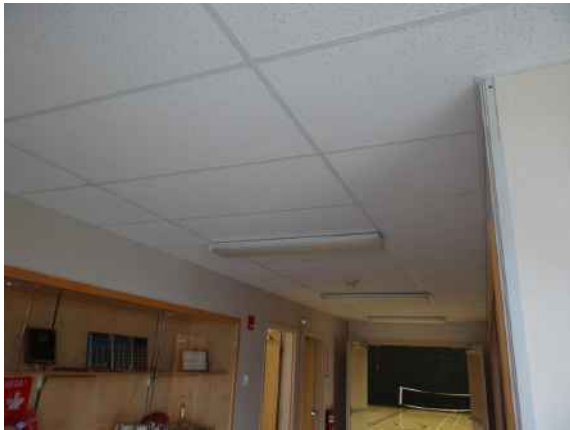
Tate Creek Community Centre - C303007

No major deficiencies were observed or reported.

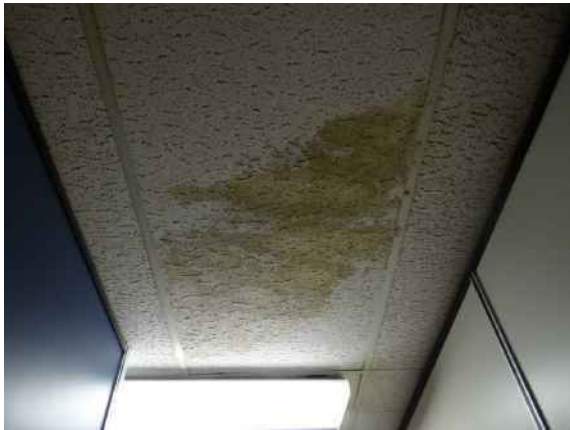
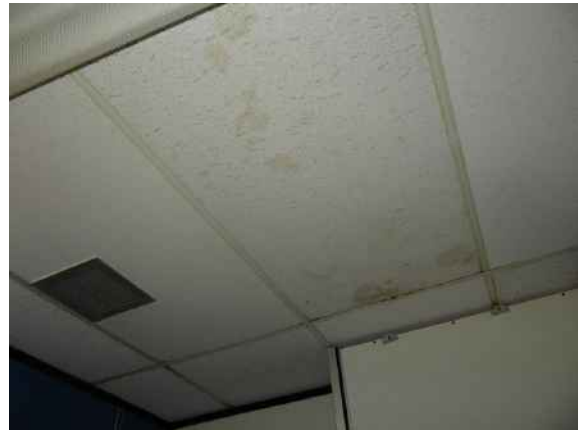
Tate Creek Community Centre - C303007

Staining was observed on some ceiling panels and should be replaced as part of maintenance.

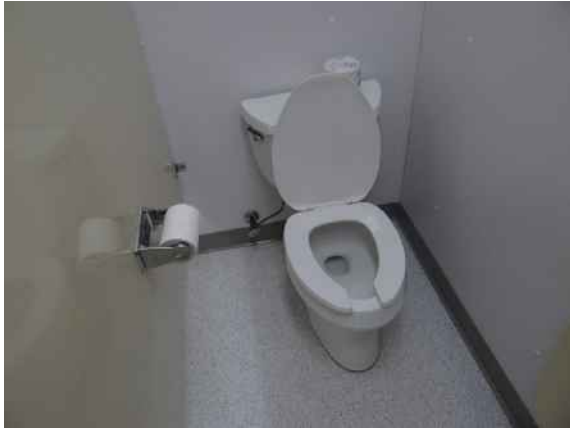
Tate Creek Community Centre - D201001

No major deficiencies were observed or reported.

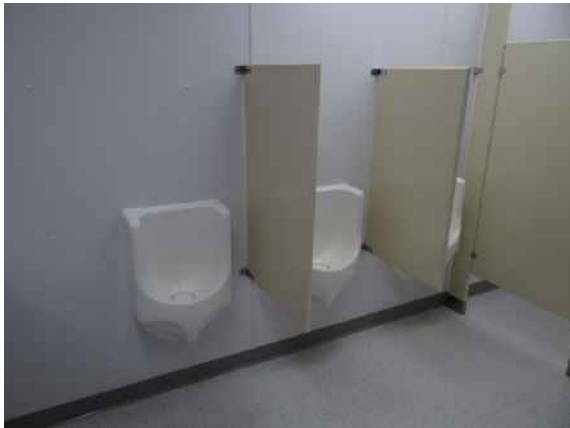
Tate Creek Community Centre - D201002

Item	Description
Unifomat Code	D201002 - Urinals
Installation Year	2006
Condition	1 - Good
Expected Useful Life	35 Years
Remaining Useful Life	22 Years
Quantity / Unit of Measure	4 / Each
Unit Cost	\$1,000.00
Difficulty / Regional / Soft Cost Factors	1.00 / 1.00 / 1.00
Element Renewal Cost	\$4,000.00

No major deficiencies were observed or reported.

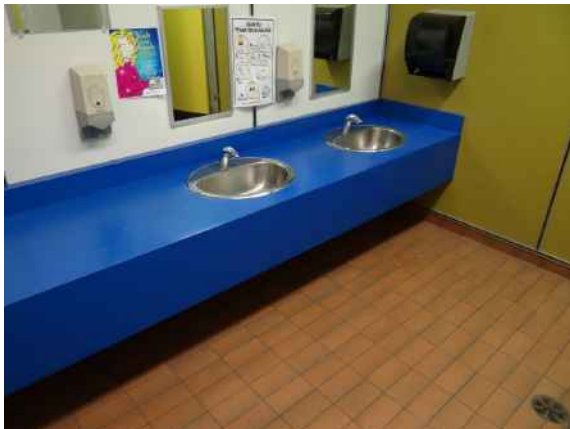
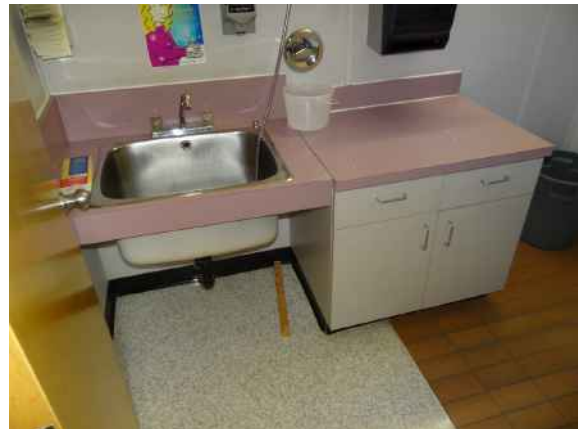
Tate Creek Community Centre - D201004

The sinks were not functional at the time of assessment due to failed water connections. Sinks are understood to be serviceable.

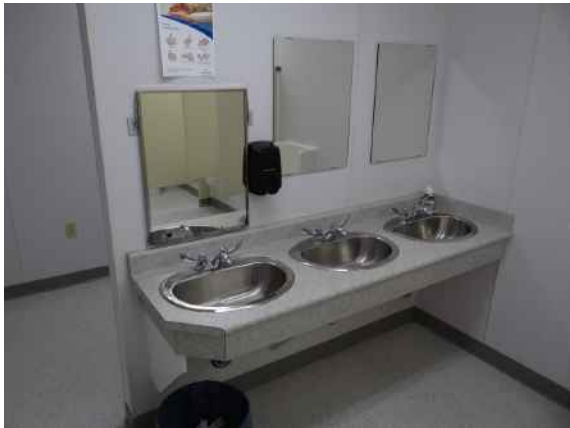
Tate Creek Community Centre - D201003

No major deficiencies were observed or reported.

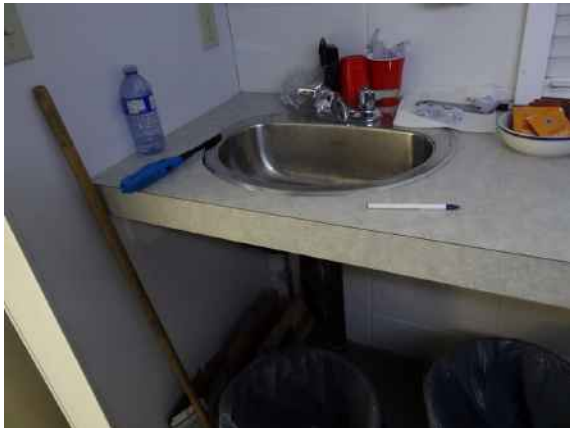
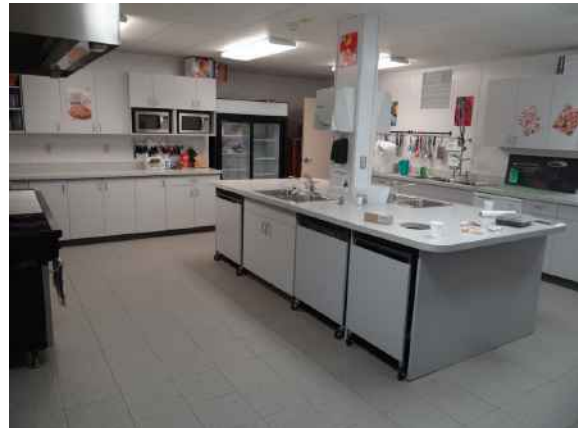
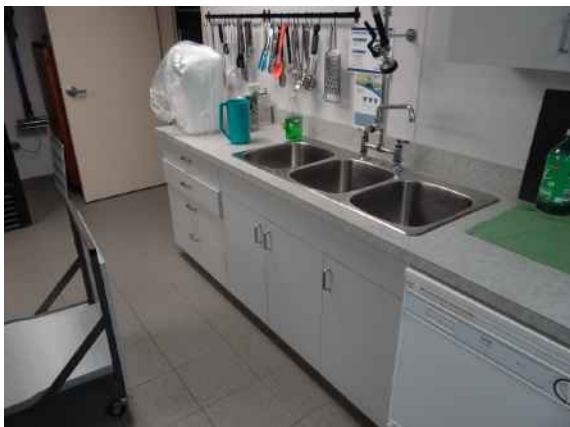
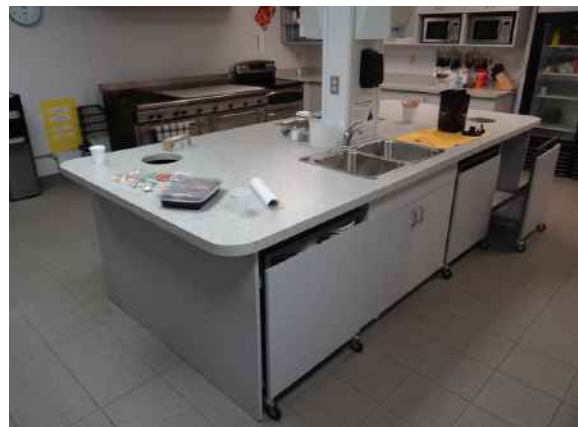
No major deficiencies were observed or reported.

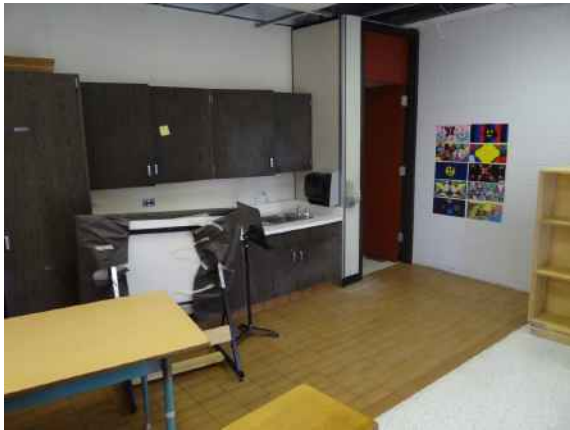
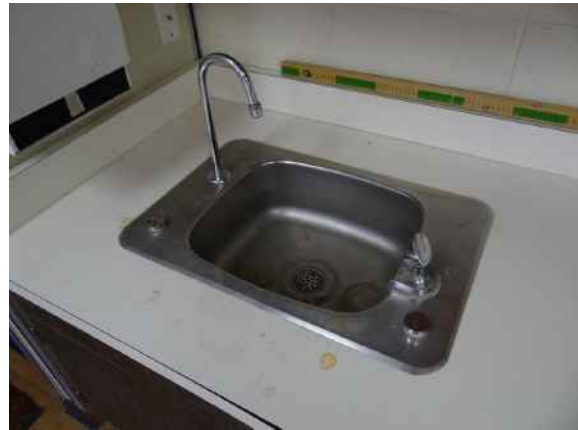
Item	Description
Uniformat Code	D201004 - Sinks
Installation Year	1975
Condition	3 - Poor
Expected Useful Life	35 Years
Remaining Useful Life	1 Year
Quantity / Unit of Measure	5 / Each
Unit Cost	\$1,000.00
Difficulty / Regional / Soft Cost Factors	1.00 / 1.00 / 1.00
Element Renewal Cost	\$5,000.00

Reportedly water connections failed. Units not anticipated to be reinstated.

Recommendation #1 - Sinks	
Type	Life Cycle Replacement
Year	2020
Cost	\$5,000.00

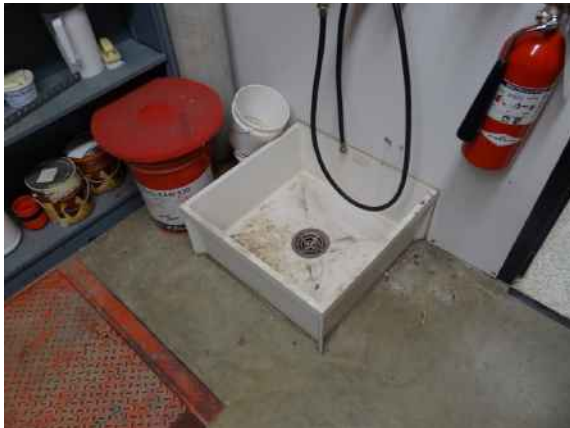
Item	Description
Unifomat Code	D201024 - Custodial Sinks
Installation Year	1975
Condition	1 - Good
Expected Useful Life	25 Years
Remaining Useful Life	6 Years
Quantity / Unit of Measure	1 / Each
Unit Cost	\$2,000.00
Difficulty / Regional / Soft Cost Factors	1.00 / 1.00 / 1.00
Element Renewal Cost	\$2,000.00

No major deficiencies were observed or reported.

Recommendation #1 - Custodial Sinks	
Type	Life Cycle Replacement
Year	2025
Cost	\$2,000.00

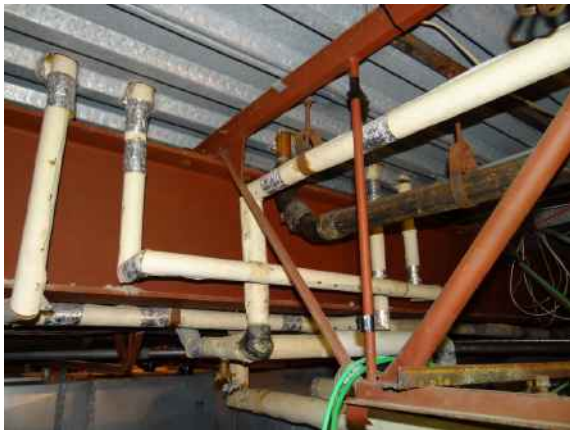
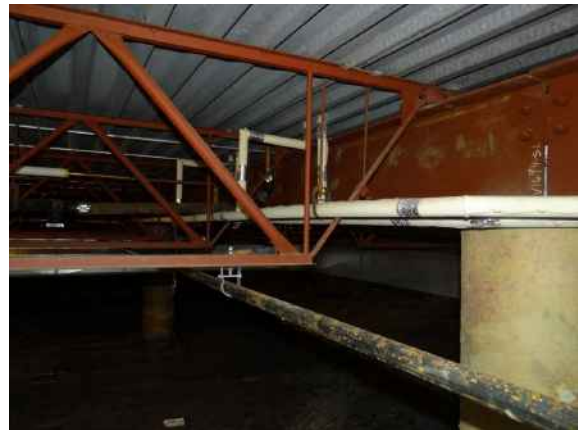
Item	Description
Unifomat Code	D202001 - Domestic Water Pipes and Fittings
Installation Year	1975
Condition	3 - Poor
Expected Useful Life	40 Years
Remaining Useful Life	2 Years
Quantity / Unit of Measure	1023 / SM Building
Unit Cost	\$40.00
Difficulty / Regional / Soft Cost Factors	1.50 / 1.00 / 1.00
Element Renewal Cost	\$61,380.00

The original plumbing system was turned off at the time due to multiple leaks and failures when last pressurized, typically at fixtures and pipes are reportedly OK. Detailed review is recommended to confirm remaining service life.

Recommendation #1 - Investigate condition of plumbing	
Type	Engineering Study
Year	2020
Cost	\$8,000.00

Recommendation #2 - Domestic Water Pipes and Fittings	
Type	Life Cycle Replacement
Year	2021
Cost	\$61,380.00

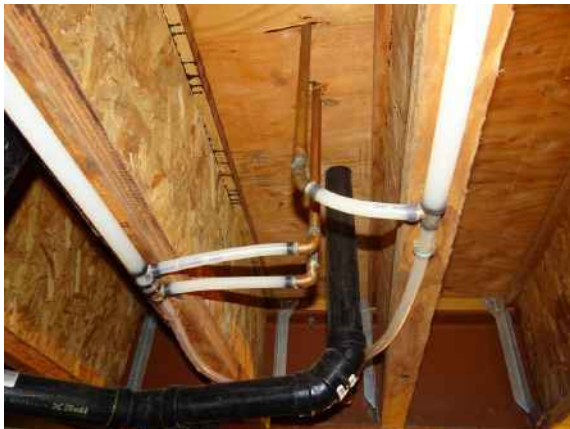
Item	Description
Uniformat Code	D202001 - Domestic Water Pipes and Fittings
Installation Year	2006
Condition	1 - Good
Expected Useful Life	40 Years
Remaining Useful Life	27 Years
Quantity / Unit of Measure	232 / SM Building
Unit Cost	\$40.00
Difficulty / Regional / Soft Cost Factors	1.00 / 1.00 / 1.00
Element Renewal Cost	\$9,280.00

No major deficiencies were observed or reported.

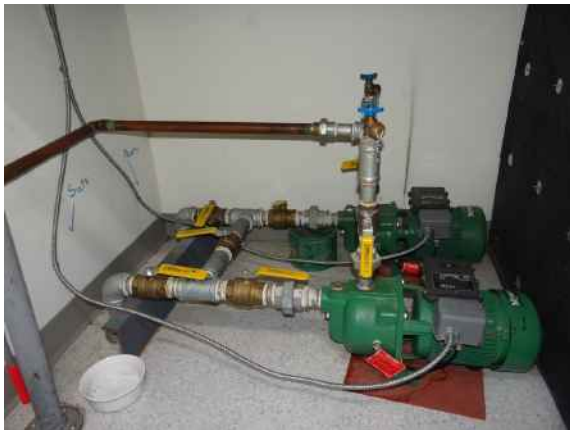
Item	Description
Unifomat Code	D202006 - Domestic Water Equipment - Booster Systems
Installation Year	2006
Condition	1 - Good
Expected Useful Life	20 Years
Remaining Useful Life	7 Years
Quantity / Unit of Measure	2 / Each
Unit Cost	\$10,000.00
Difficulty / Regional / Soft Cost Factors	1.00 / 1.00 / 1.00
Element Renewal Cost	\$20,000.00

No major deficiencies were observed or reported.

Recommendation #1 - Domestic Water Equipment - Booster Systems	
Type	Life Cycle Replacement
Year	2026
Cost	\$20,000.00

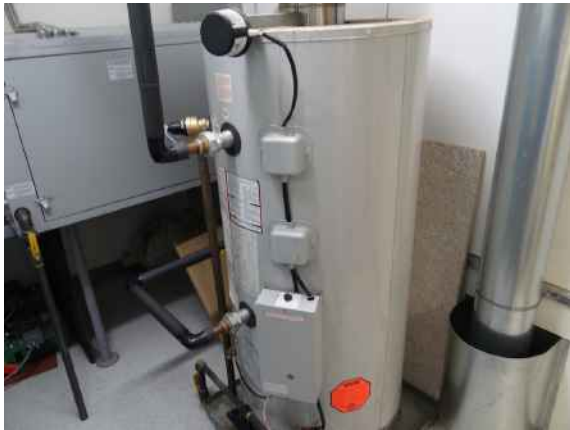
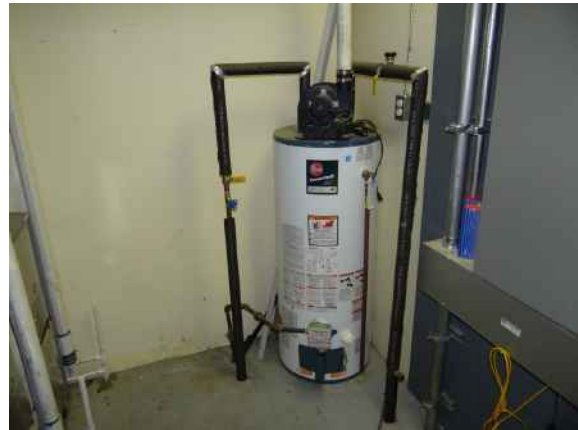
Item	Description
Uniformat Code	D202021 - Domestic Water Tank Heaters
Installation Year	2006
Condition	2 - Fair
Expected Useful Life	12 Years
Remaining Useful Life	3 Years
Quantity / Unit of Measure	283 / Liter
Unit Cost	\$45.00
Difficulty / Regional / Soft Cost Factors	1.50 / 1.00 / 1.00
Element Renewal Cost	\$19,102.50

No major deficiencies were observed or reported. Equipment has surpassed its typical useful life.

Recommendation #1 - Domestic Water Tank Heaters	
Type	Life Cycle Replacement
Year	2022
Cost	\$19,102.50

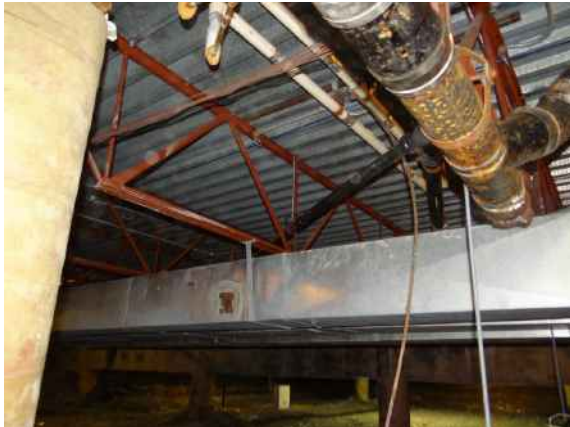
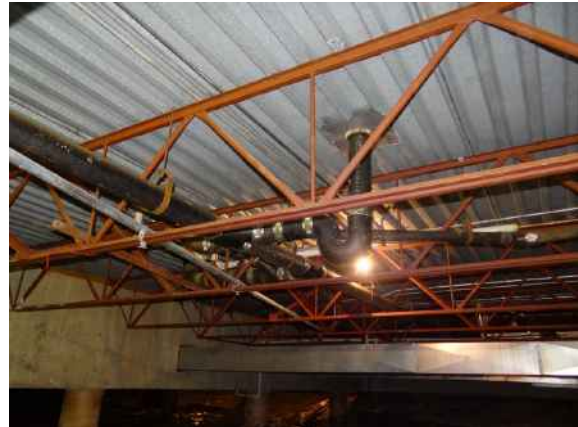
Item	Description
Uniformat Code	D203001 - Sanitary Waste and Vent Piping
Installation Year	1975
Condition	2 - Fair
Expected Useful Life	50 Years
Remaining Useful Life	5 Years
Quantity / Unit of Measure	1023 / SM Bldg
Unit Cost	\$45.00
Difficulty / Regional / Soft Cost Factors	1.00 / 1.00 / 1.00
Element Renewal Cost	\$46,035.00

Some corrosion was observed, system understood to be serviceable. System should be considered during plumbing review.

Recommendation #1 - Sanitary Waste and Vent Piping	
Type	Life Cycle Replacement
Year	2024
Cost	\$46,035.00

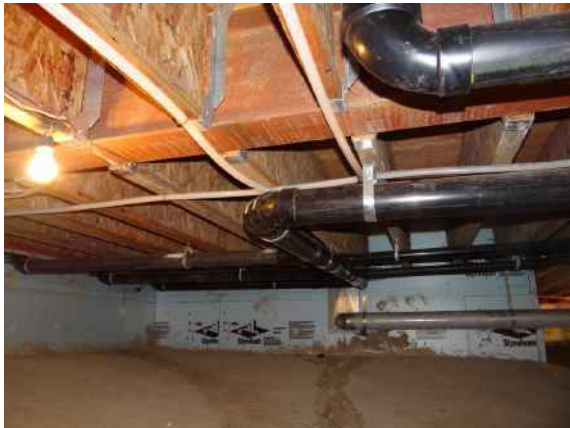
Item	Description
Uniformat Code	D203001 - Sanitary Waste and Vent Piping
Installation Year	2006
Condition	1 - Good
Expected Useful Life	50 Years
Remaining Useful Life	37 Years
Quantity / Unit of Measure	232 / SM Bldg
Unit Cost	\$45.00
Difficulty / Regional / Soft Cost Factors	1.00 / 1.00 / 1.00
Element Renewal Cost	\$10,440.00

No major deficiencies were observed or reported.

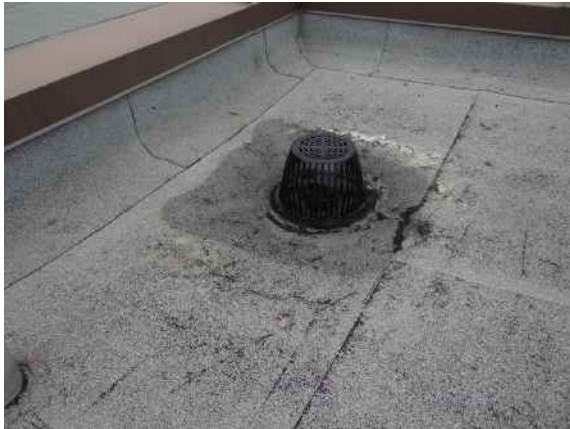
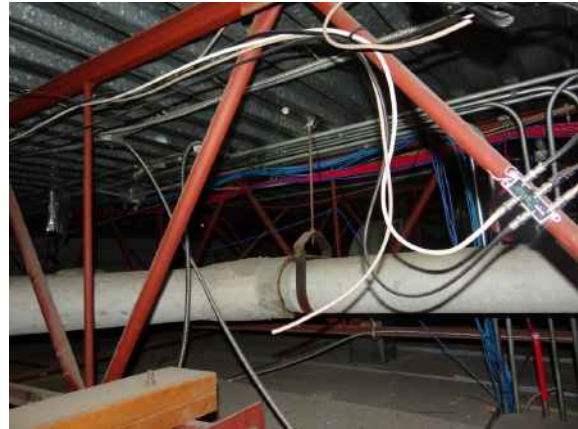
Item	Description
Uniformat Code	D204001 - Rain Water Drainage Piping and Fittings
Installation Year	1975
Condition	1 - Good
Expected Useful Life	50 Years
Remaining Useful Life	6 Years
Quantity / Unit of Measure	1023 / SM Building
Unit Cost	\$30.00
Difficulty / Regional / Soft Cost Factors	1.00 / 1.00 / 1.00
Element Renewal Cost	\$30,690.00

No major deficiencies were observed or reported.

Recommendation #1 - Rain Water Drainage Piping and Fittings	
Type	Life Cycle Replacement
Year	2025
Cost	\$30,690.00

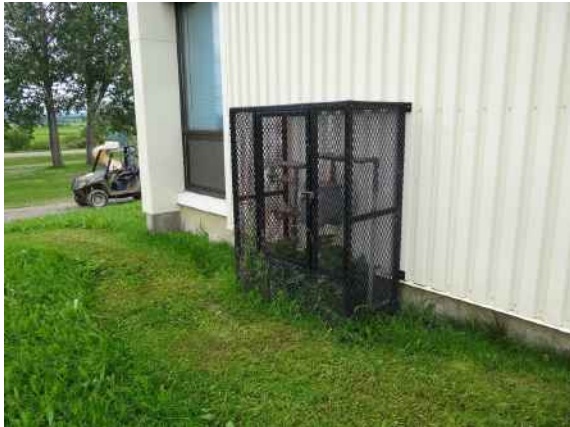
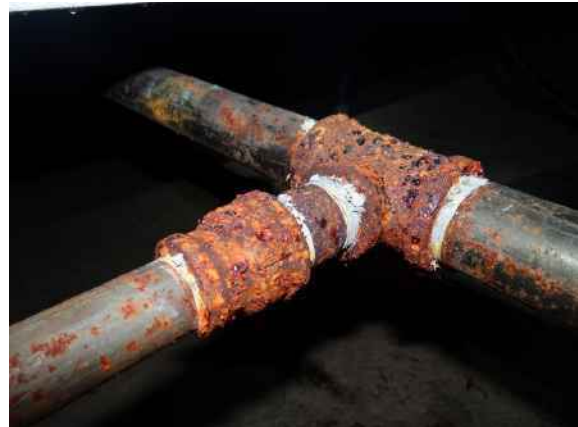
Item	Description
Uniformat Code	D301002 - Natural Gas Supply
Installation Year	2006
Condition	1 - Good
Expected Useful Life	40 Years
Remaining Useful Life	27 Years
Quantity / Unit of Measure	1255 / SM Building
Unit Cost	\$20.00
Difficulty / Regional / Soft Cost Factors	1.00 / 1.00 / 1.00
Element Renewal Cost	\$25,100.00

Corrosion was observed on the gas piping in the kitchen crawlspace. Should be reviewed and repaired.

Recommendation #1 - Repair Allowance - Natural Gas Distribution	
Type	Lifecycle Repair
Year	2020
Cost	\$5,000.00

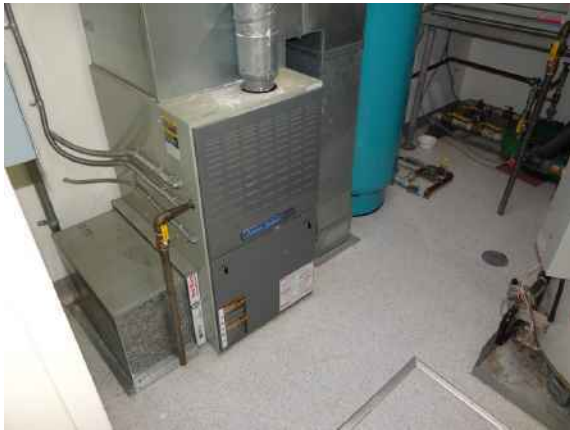
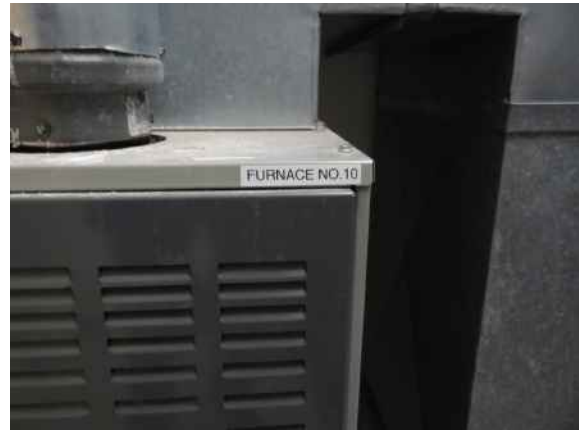
Item	Description
Uniformat Code	D302008 - Fuel Fired Forced Air Furnace
Installation Year	2006
Condition	1 - Good
Expected Useful Life	18 Years
Remaining Useful Life	6 Years
Quantity / Unit of Measure	120 / MBH
Unit Cost	\$40.00
Difficulty / Regional / Soft Cost Factors	1.00 / 1.00 / 1.00
Element Renewal Cost	\$4,800.00

No major deficiencies were observed or reported.

Recommendation #1 - Fuel Fired Forced Air Furnace	
Type	Life Cycle Replacement
Year	2025
Cost	\$4,800.00

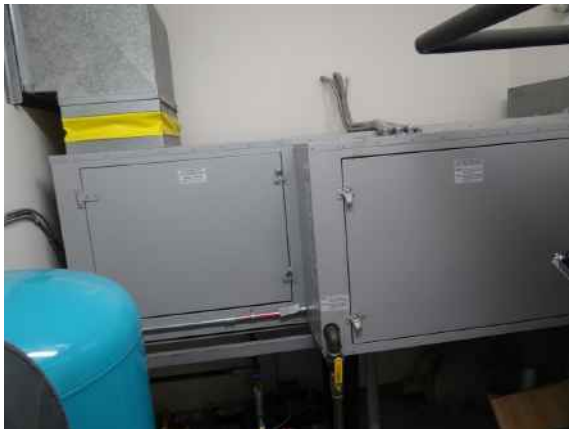
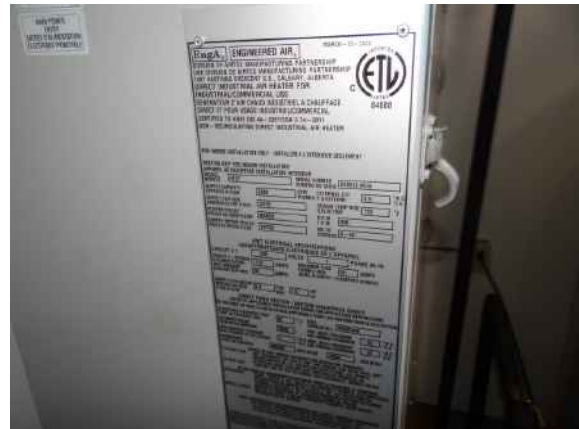
Item	Description
Uniformat Code	D302008 - Fuel Fired Forced Air Furnace
Installation Year	2006
Condition	1 - Good
Expected Useful Life	18 Years
Remaining Useful Life	6 Years
Quantity / Unit of Measure	266 / MBH
Unit Cost	\$40.00
Difficulty / Regional / Soft Cost Factors	1.00 / 1.00 / 1.00
Element Renewal Cost	\$10,640.00

No major deficiencies were observed or reported.

Recommendation #1 - Fuel Fired Forced Air Furnace	
Type	Life Cycle Replacement
Year	2025
Cost	\$10,640.00

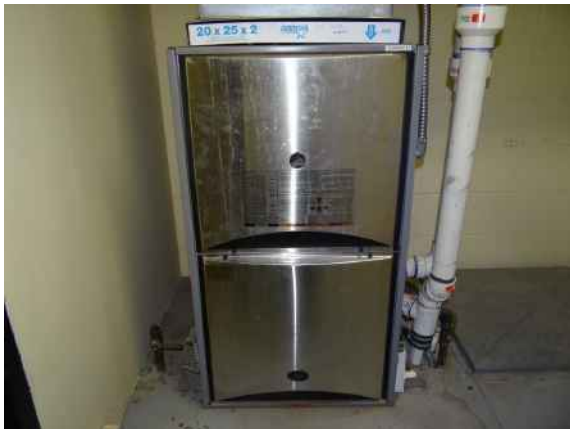
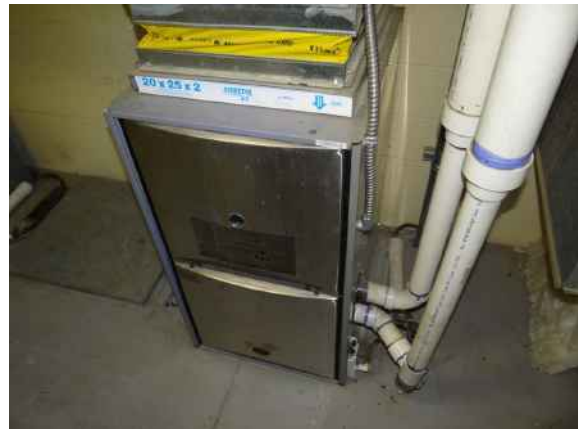
Item	Description
Uniformat Code	D302008 - Fuel Fired Forced Air Furnace
Installation Year	2010
Condition	1 - Good
Expected Useful Life	18 Years
Remaining Useful Life	9 Years
Quantity / Unit of Measure	75 / MBH
Unit Cost	\$40.00
Difficulty / Regional / Soft Cost Factors	8.00 / 1.00 / 1.00
Element Renewal Cost	\$24,000.00

No major deficiencies were observed or reported. It should be noted that the units have been installed upside down to accommodate existing ducting layout.

Recommendation #1 - Fuel Fired Forced Air Furnace	
Type	Life Cycle Replacement
Year	2028
Cost	\$3,000.00

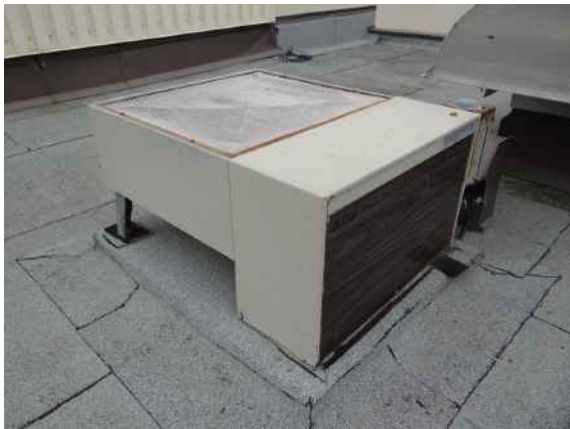
Item	Description
Uniformat Code	D303022 - Self Contained Cooling Units
Installation Year	1975
Condition	3 - Poor
Expected Useful Life	25 Years
Remaining Useful Life	1 Year
Quantity / Unit of Measure	2 / Ton
Unit Cost	\$1,500.00
Difficulty / Regional / Soft Cost Factors	1.00 / 1.00 / 1.00
Element Renewal Cost	\$3,000.00

It was reported that this unit is no longer serviceable and will is not anticipated be replaced.

Recommendation #1 - Repair Allowance - Decommissioning Equipment	
Type	Major Repair
Year	2020
Cost	\$3,000.00

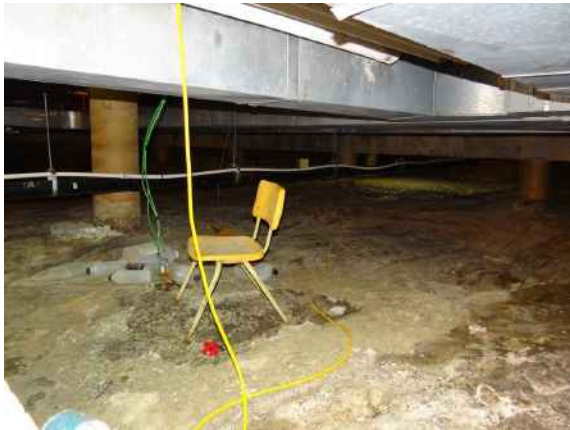
Item	Description
Uniformat Code	D304001 - Air Distribution Systems
Installation Year	1975
Condition	1 - Good
Expected Useful Life	40 Years
Remaining Useful Life	6 Years
Quantity / Unit of Measure	1023 / SM Building
Unit Cost	\$120.00
Difficulty / Regional / Soft Cost Factors	1.00 / 1.00 / 1.00
Element Renewal Cost	\$122,760.00

No major deficiencies were observed or reported.

Recommendation #1 - Air Distribution Systems	
Type	Life Cycle Replacement
Year	2025
Cost	\$122,760.00

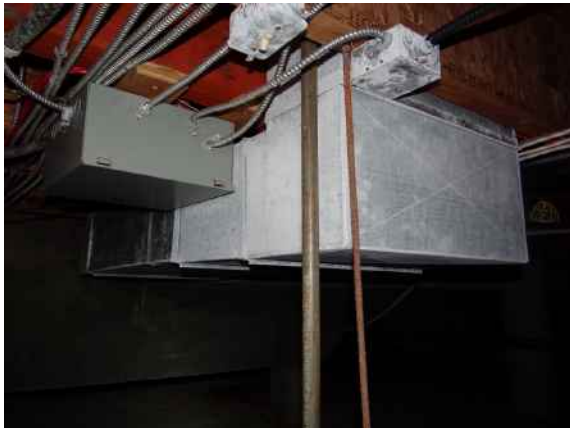
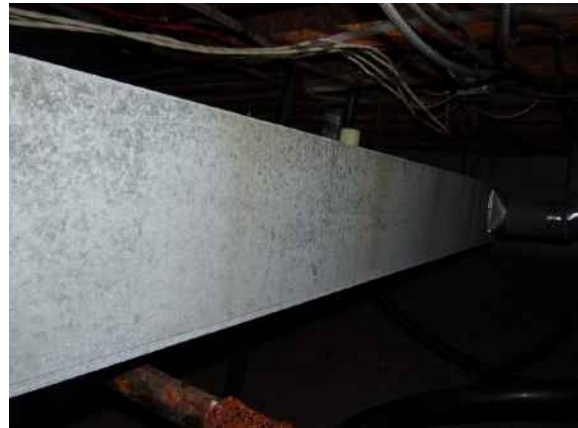
No major deficiencies were observed or reported.

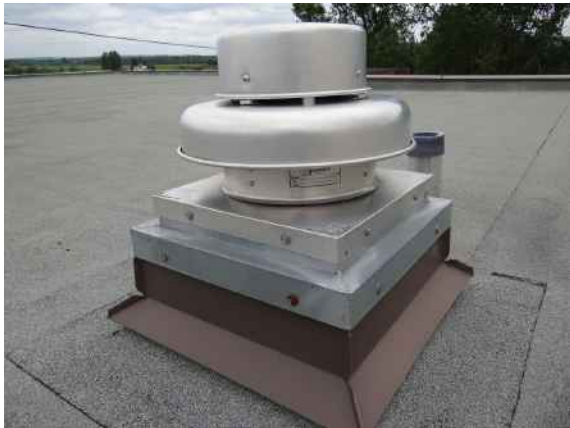
Item	Description
Uniformat Code	D304007 - Exhaust Fans
Installation Year	2006
Condition	1 - Good
Expected Useful Life	25 Years
Remaining Useful Life	12 Years
Quantity / Unit of Measure	6 / Each
Unit Cost	\$3,000.00
Difficulty / Regional / Soft Cost Factors	1.00 / 1.00 / 1.00
Element Renewal Cost	\$18,000.00

No major deficiencies were observed or reported.

Recommendation #1 - Exhaust Fans	
Type	Life Cycle Replacement
Year	2031
Cost	\$18,000.00

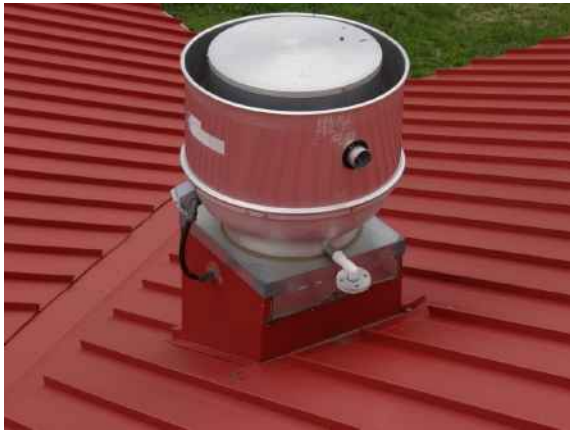
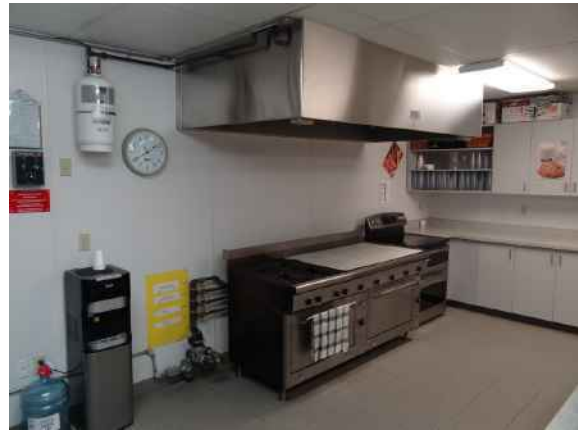
No major deficiencies were observed or reported.

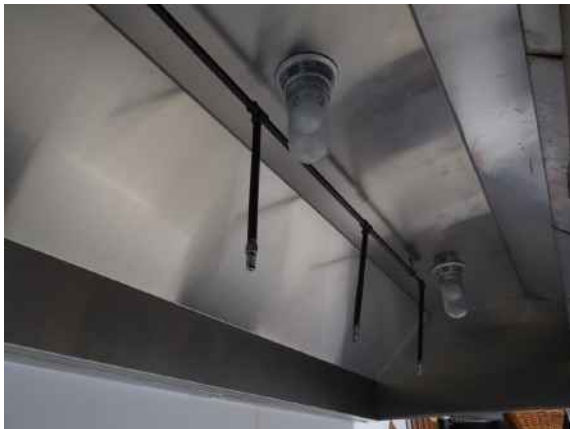
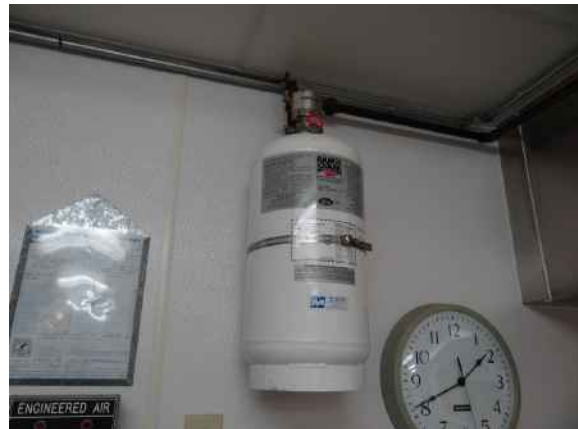
It was observed that the system has not been inspected since 2018.

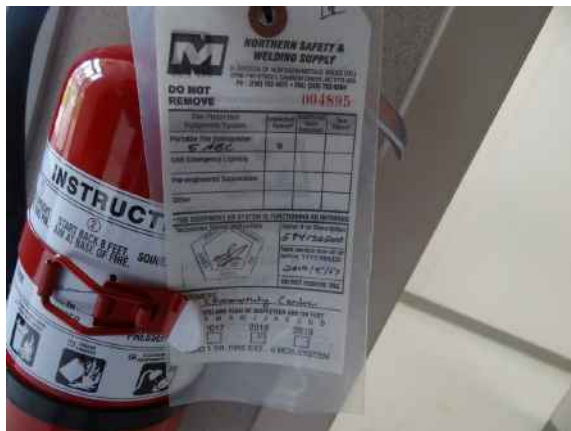
It was observed that the fire extinguishers have not been inspected since 2018. Annual inspection is recommended. Remaining service life to be confirmed by inspection.

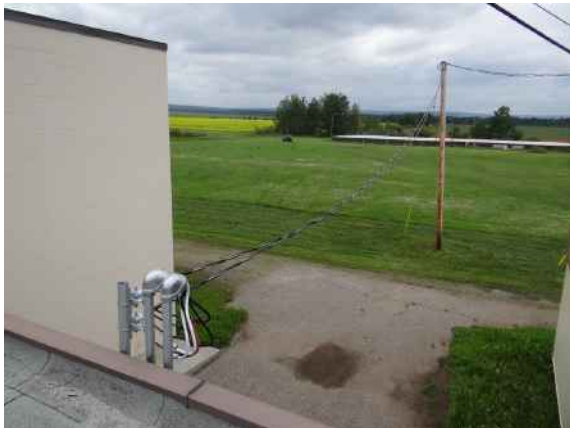
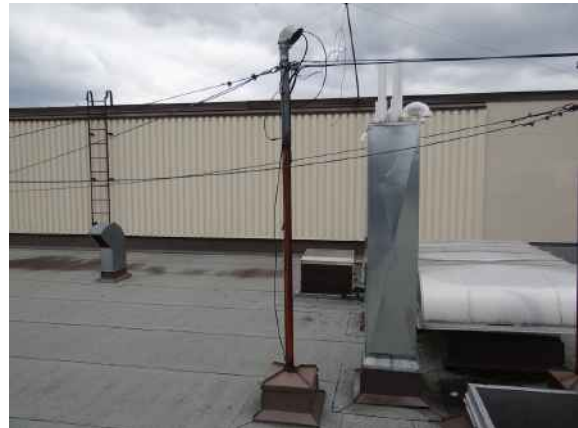
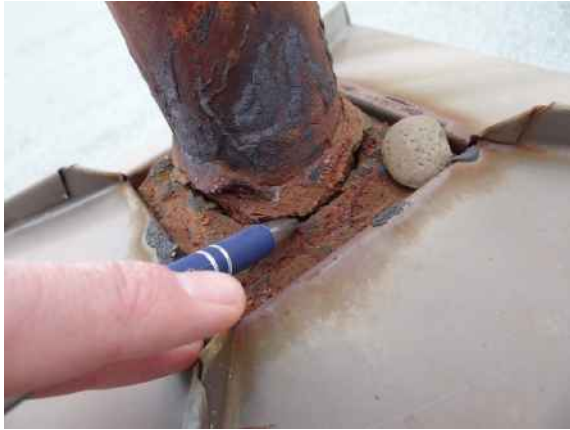
No major deficiencies were observed or reported. An old service mast on the gym roof was observed to be corroded and damaged. A repair to address the deficiencies is recommended.

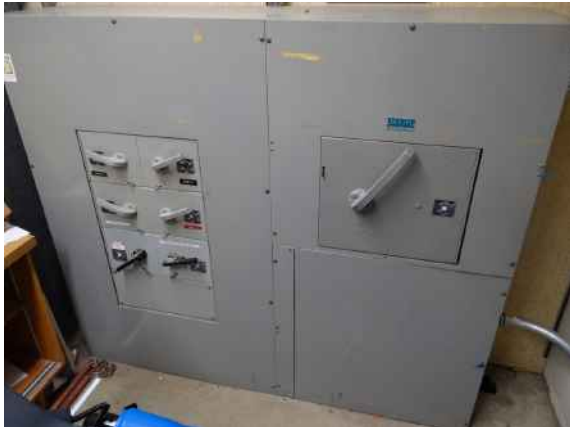
No major issues were observed or reported; however, the equipment has surpassed its typical useful life.

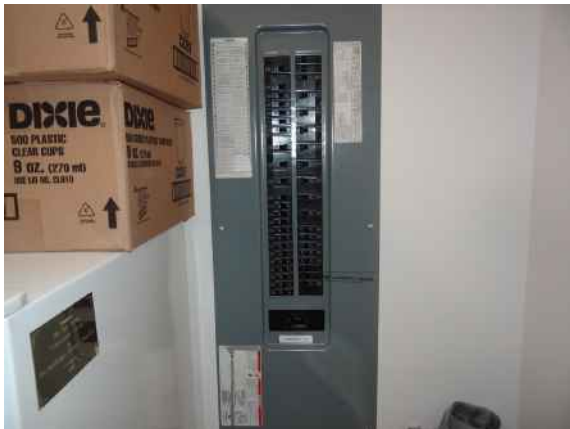
Tate Creek Community Centre - D501023

No major deficiencies were observed or reported.

Recommendation #1 - Electrical Panels	
Type	Life Cycle Replacement
Year	2025
Cost	\$28,000.00

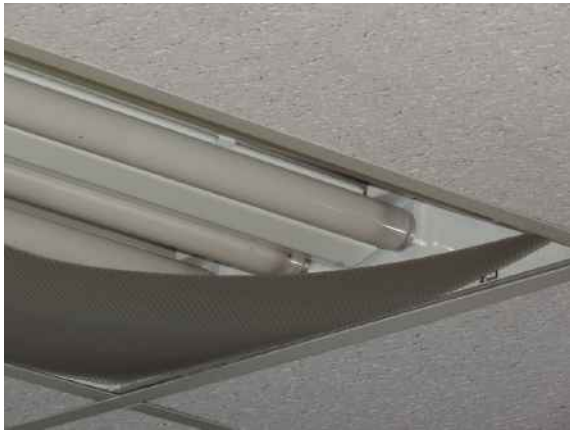
Tate Creek Community Centre - D502002

Lighting is functional but past its typical useful life with poor energy performance.

Recommendation #1 - Interior Lighting	
Type	Life Cycle Replacement
Year	2024
Cost	\$52,870.00

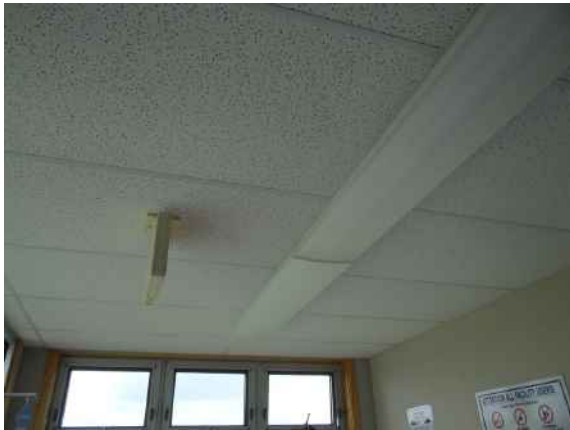
Tate Creek Community Centre - D502002

No major deficiencies were observed or reported. An upgrade to LED is recommended.

Recommendation #1 - Interior Lighting	
Type	Life Cycle Replacement
Year	2036
Cost	\$19,720.00

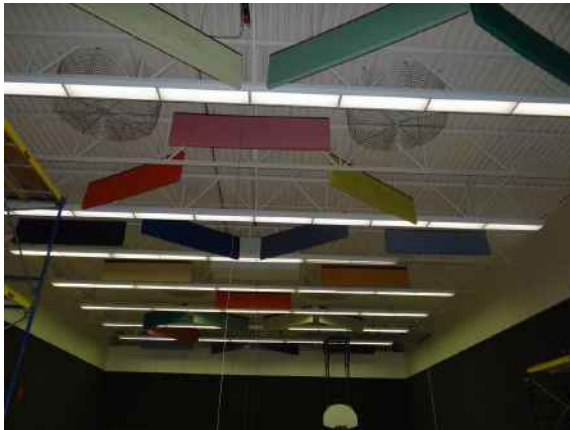
Tate Creek Community Centre - D502002

Fixtures are functional but obsolete with poor overall energy efficiency.

Recommendation #1 - Interior Lighting	
Type	Life Cycle Replacement
Year	2022
Cost	\$34,085.00

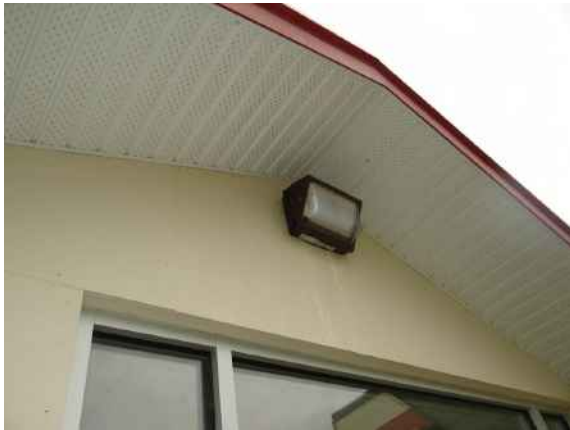
Tate Creek Community Centre - D502021

No major deficiencies were observed or reported.

Recommendation #1 - Exterior Lighting	
Type	Life Cycle Replacement
Year	2026
Cost	\$12,000.00

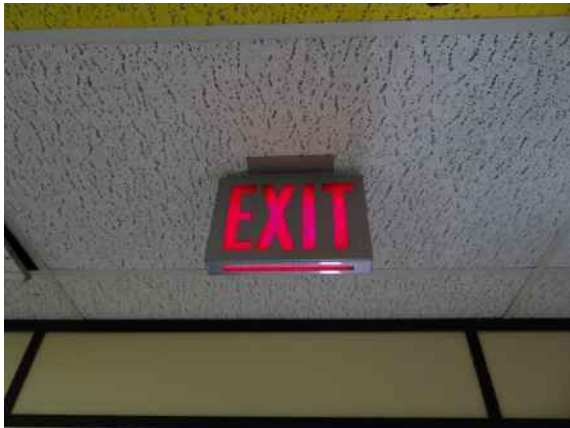
Tate Creek Community Centre - D502022

Fixtures are functional but outdated. Fixtures do not display current "running man" standard signage.

Recommendation #1 - Exit Lighting	
Type	Life Cycle Replacement
Year	2022
Cost	\$1,566.00

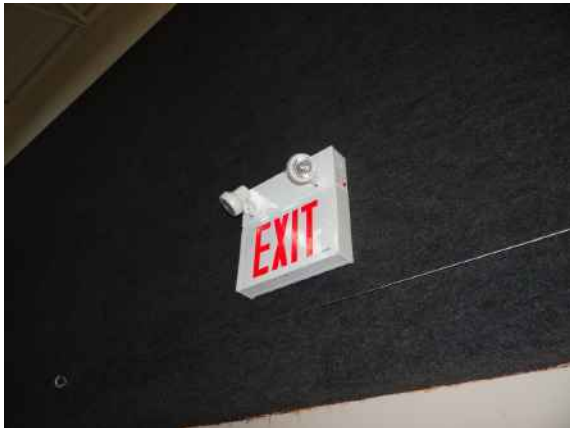
PRRD - Tate Creek Community Centre - D502022

Fixtures do not display current "running man" standard signage.

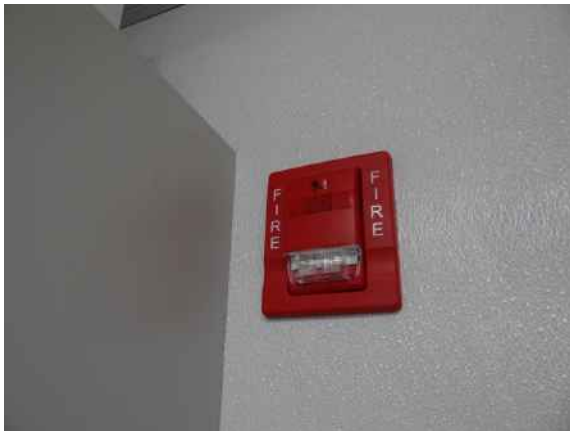
Tate Creek Community Centre - D503001

It was reported that the fire alarm system has been decommissioned in place. Replacement is recommended in the short term.

Recommendation #1 - Fire Alarm Systems	
Type	Life Cycle Replacement
Year	2019
Cost	\$62,750.00

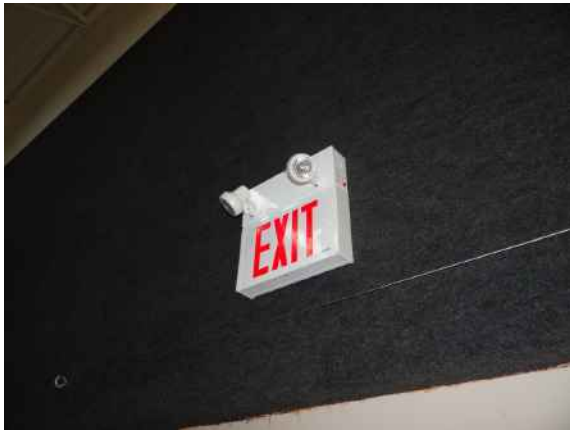
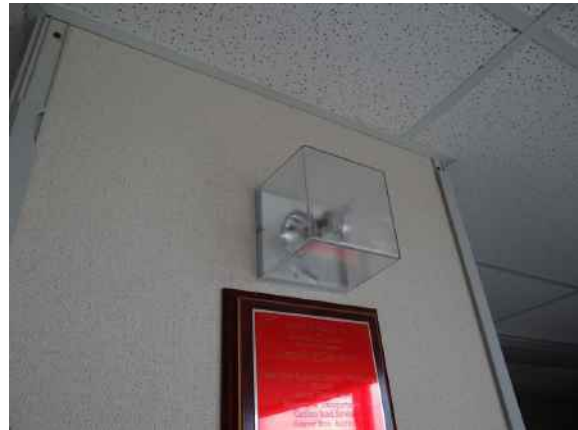
No major deficiencies were observed or reported.

Recommendation #1 - Emergency Lighting Systems	
Type	Life Cycle Replacement
Year	2026
Cost	\$6,275.00

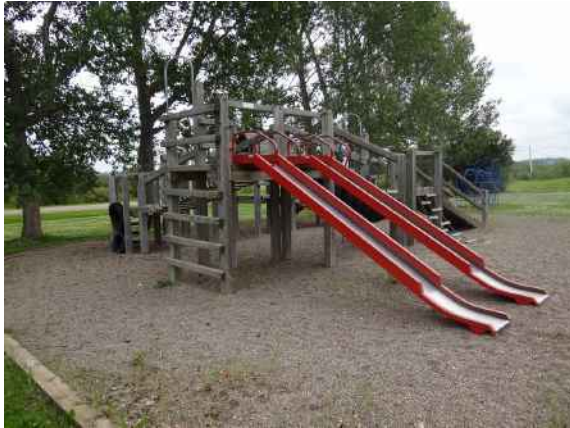
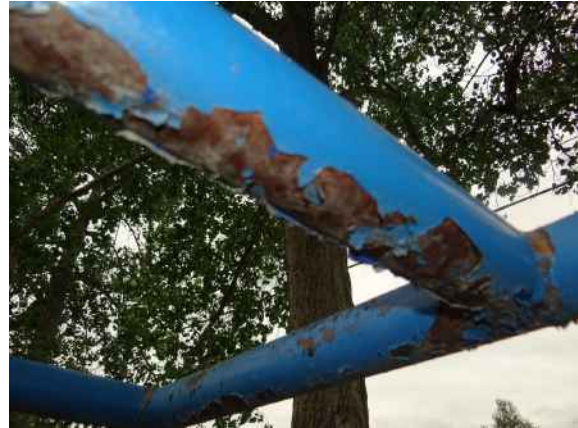
Wear and corrosion were observed.

Recommendation #1 - Playground Equipment	
Type	Life Cycle Replacement
Year	2022
Cost	\$30,000.00

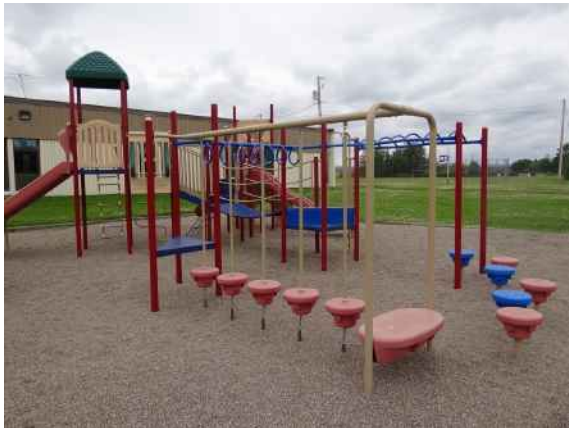
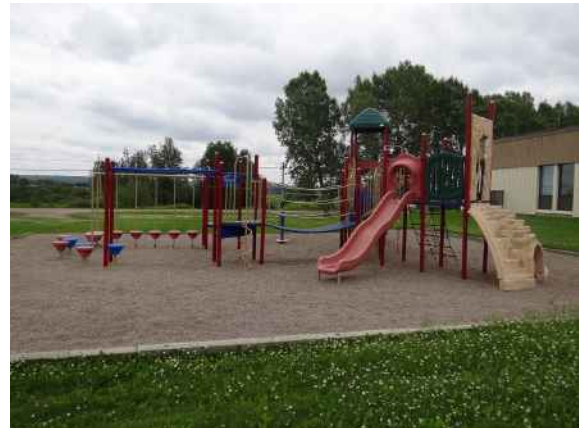
No major deficiencies were observed or reported.

Recommendation #1 - Playground Equipment	
Type	Life Cycle Replacement
Year	2031
Cost	\$40,000.00

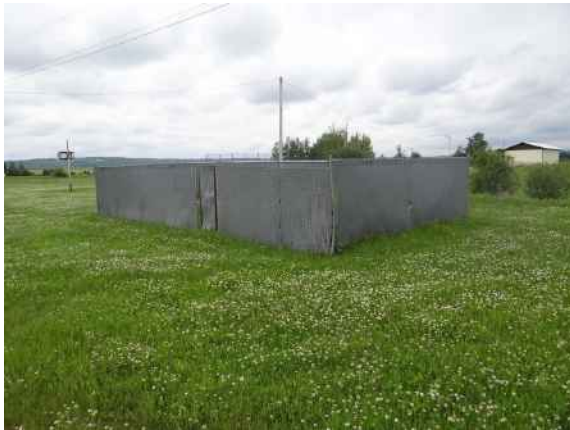
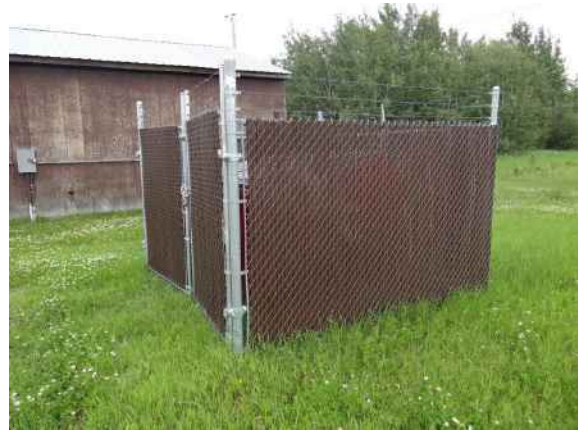
Settlement and localized damage was observed.

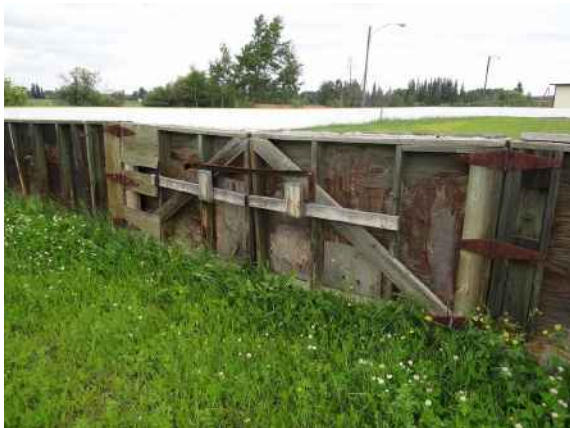
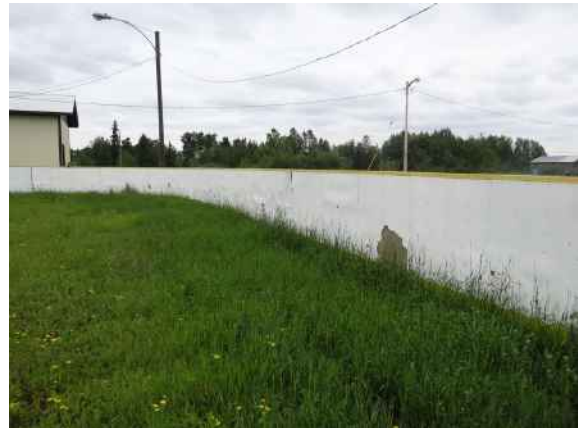
Significant deterioration of the wood guard / wall was observed.

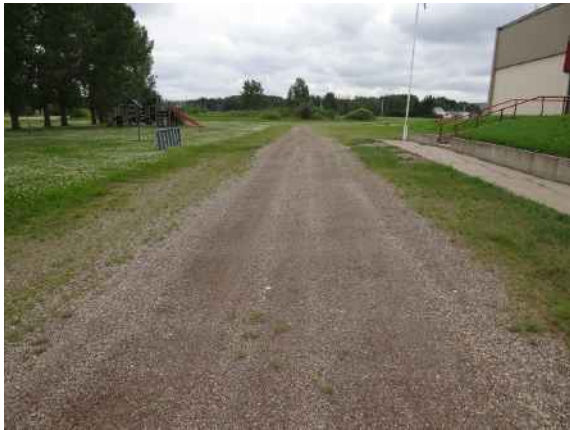
Tate Creek Community Centre - G201024

No major deficiencies were observed or reported.

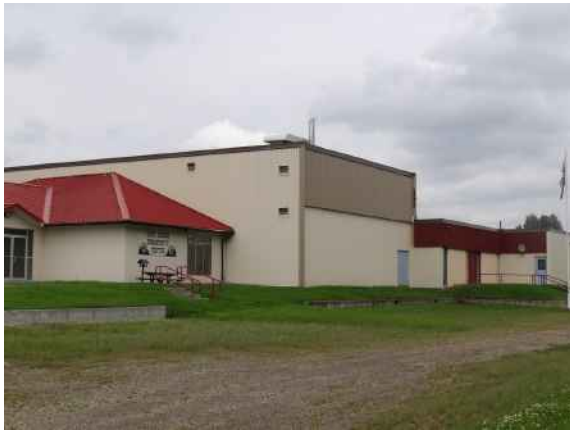
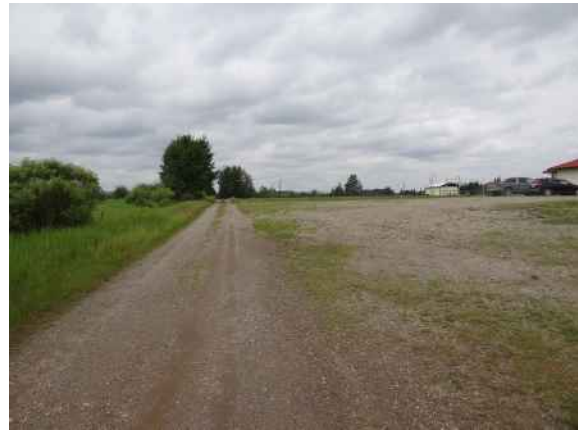
No major deficiencies were observed or reported.

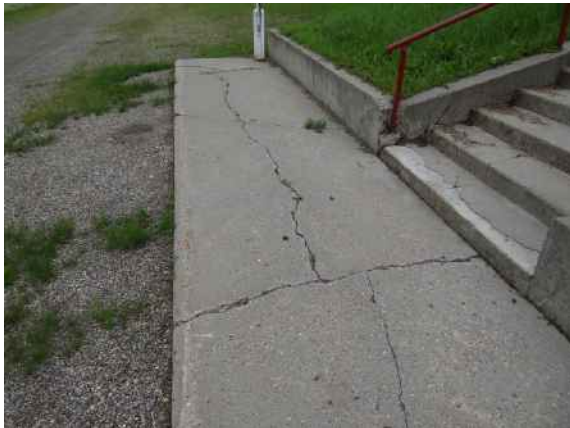
Tate Creek Community Centre - G203022

Settlement and cracked concrete was commonly observed.

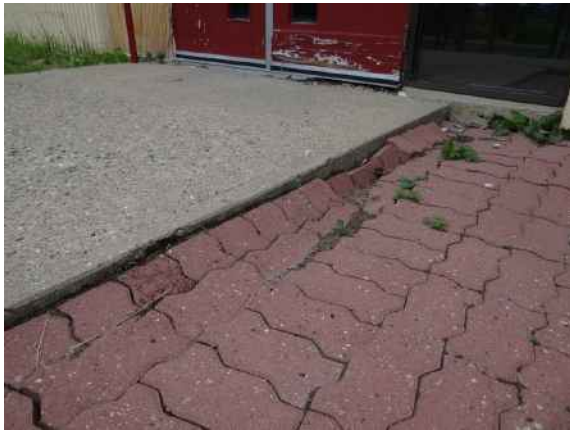
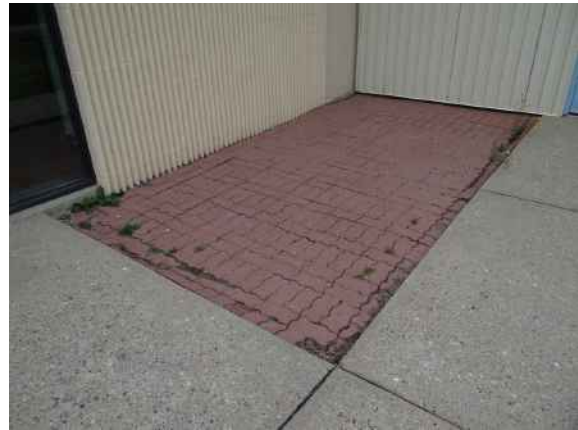
Settled creating tripping hazards was observed.

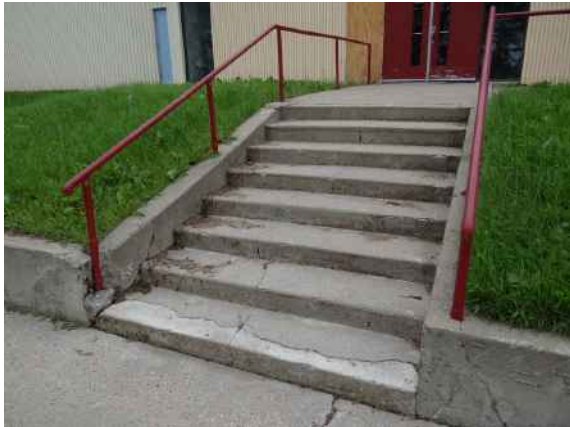
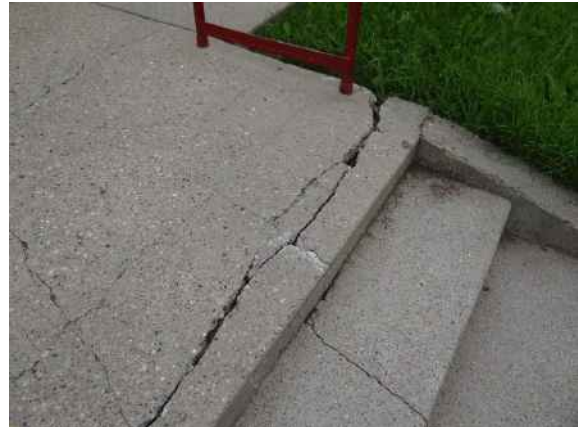
Cracking and displacement resulting in tripping hazards was observed and should be repaired in the short term to mitigate potential safety concerns.
