## ELECTORAL AREA DIRECTORS COMMITTEE MEETING A G E N D A

### ELECTORAL AREA DIRECTORS COMMITTEE MEETING MINUTES

**Facility Condition Assessment Report  
Kelly Lake Community Centre**

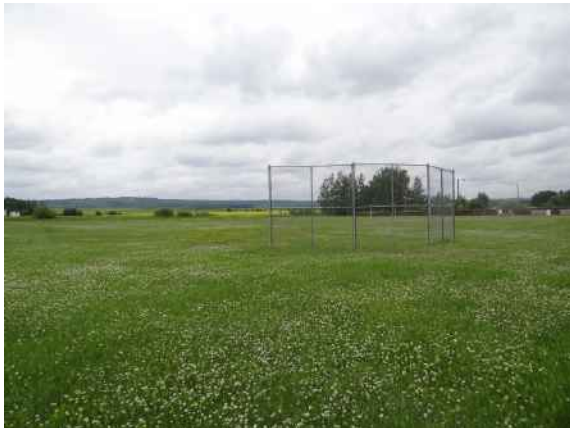
Tate Creek Community Centre - G204007

No major deficiencies were observed or reported.

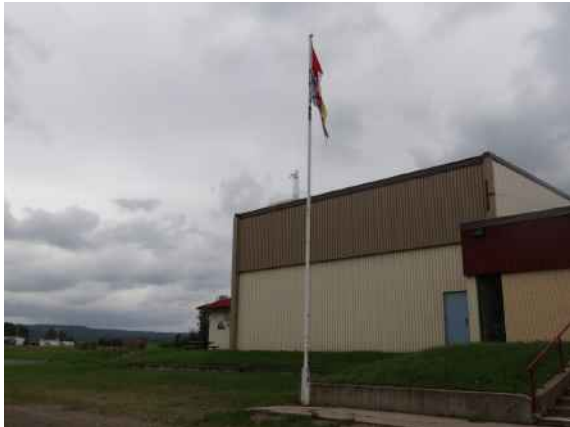
Tate Creek Community Centre - G204009

No major deficiencies were observed or reported. Surficial corrosion was observed and should be addressed as part of maintenance.

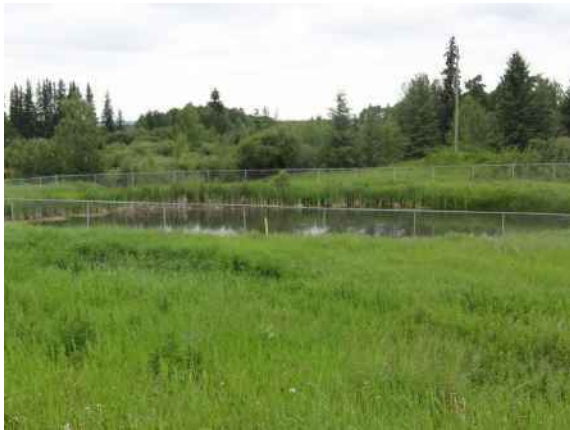
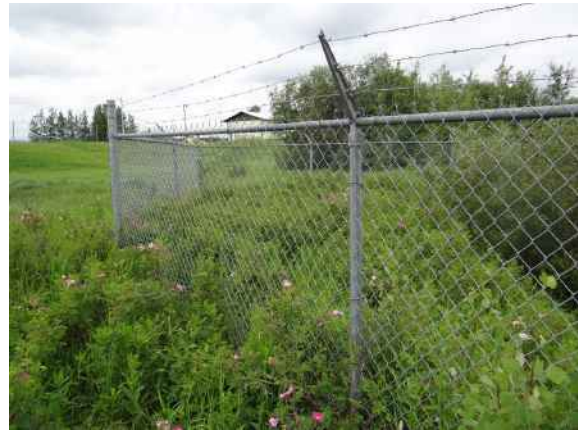
No major deficiencies were observed or reported.

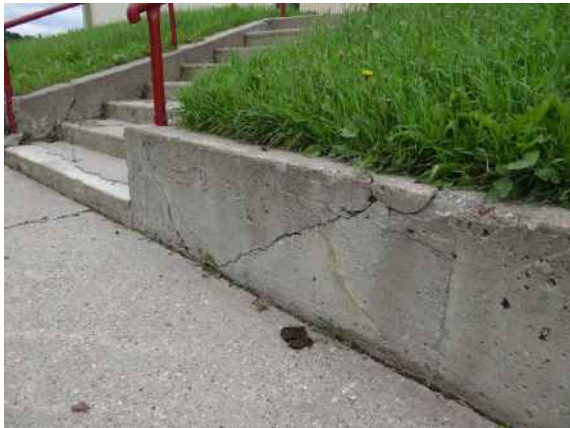
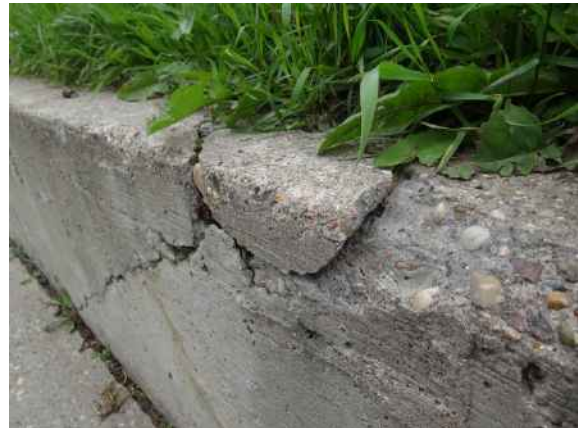
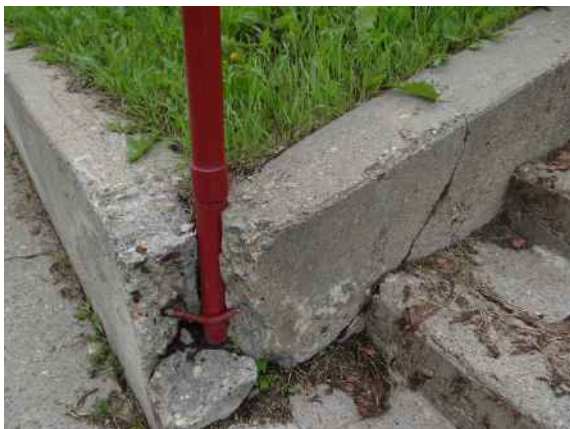
Cracks, displacement, and deterioration were observed.

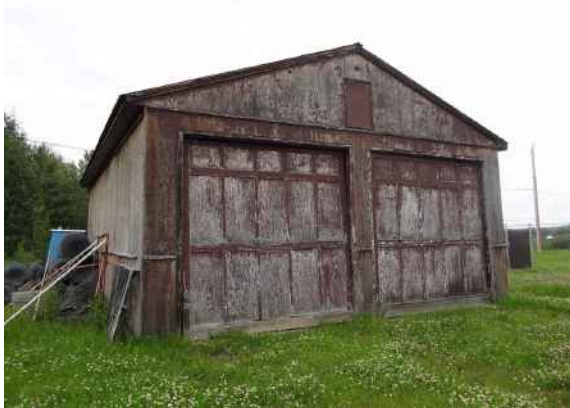
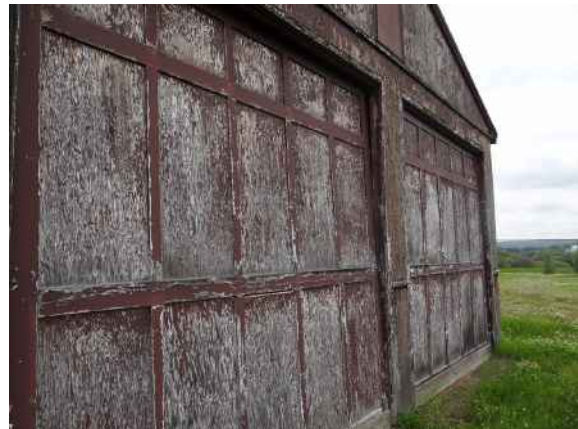
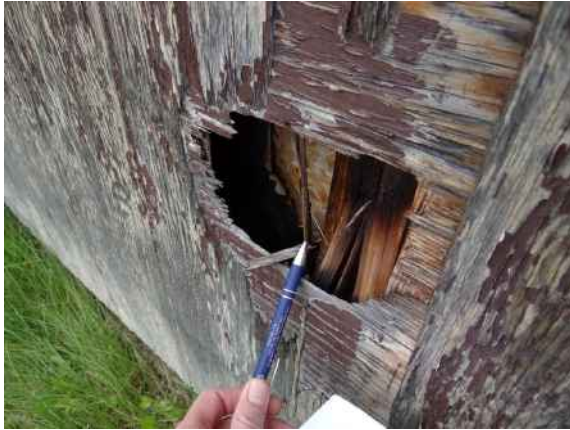
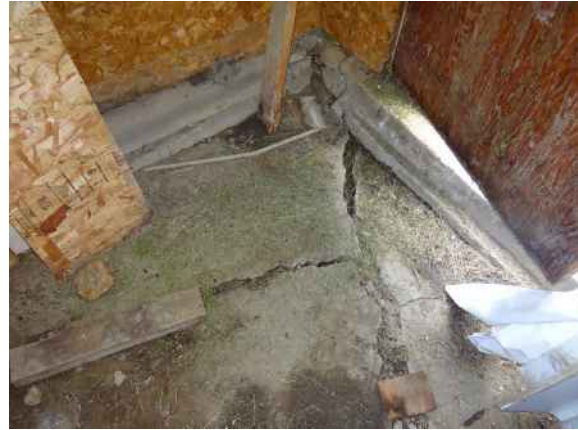
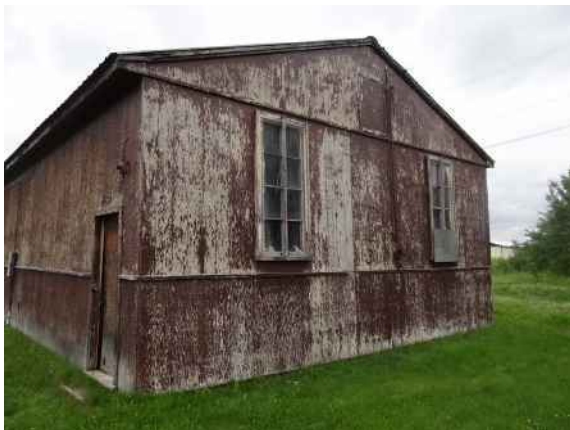
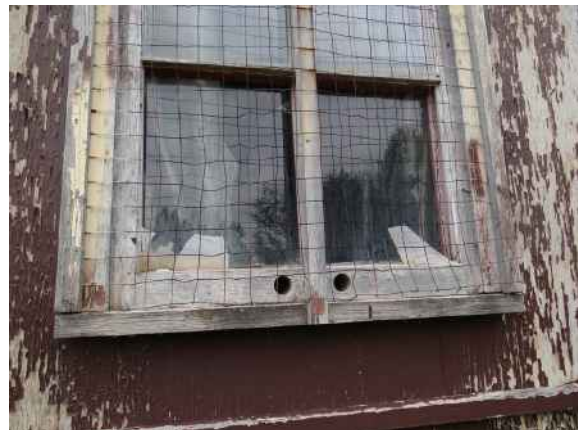
Numerous defects were observed in all building systems. The building is considered to be in poor condition overall and not reliable for long-term use.

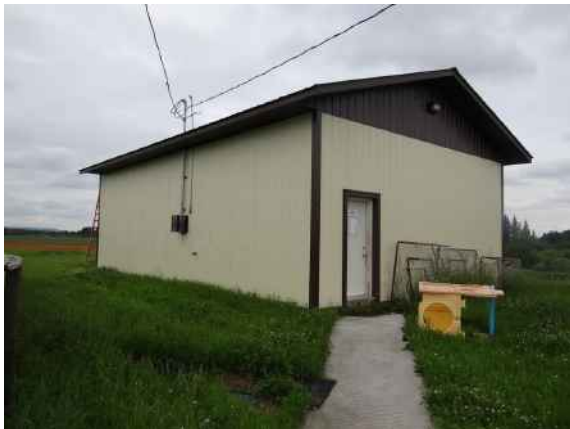
Tate Creek Community Centre - G204040

No major deficiencies were observed or reported.

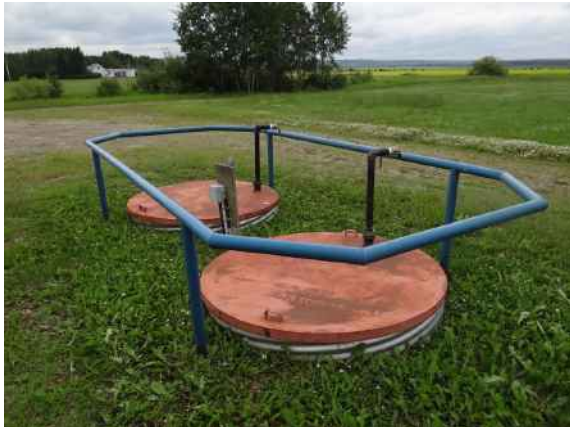
Tate Creek Community Centre - G301001

No major deficiencies were observed or reported.

Recommendation #1 - Domestic Water Storage Tank - Underground	
Type	Life Cycle Replacement
Year	2036
Cost	\$80,000.00

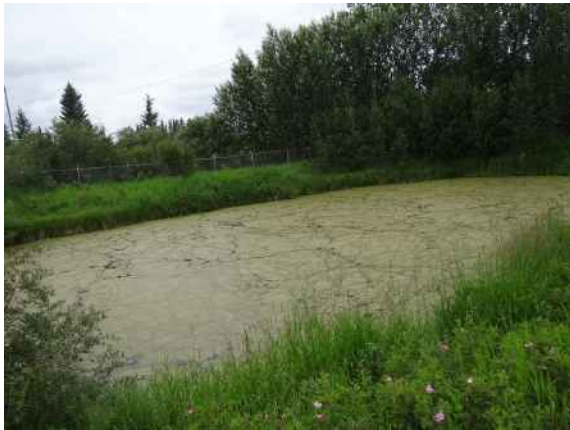
Tate Creek Community Centre - G302001

No major deficiencies were observed or reported.

Recommendation #1 - Sanitary Waste Lagoon	
Type	Life Cycle Replacement
Year	2025
Cost	\$39,000.00

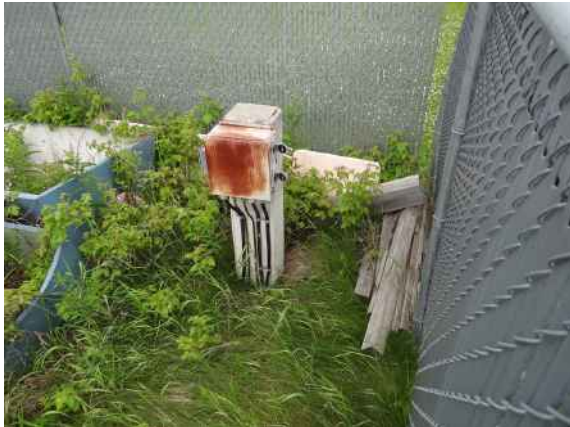
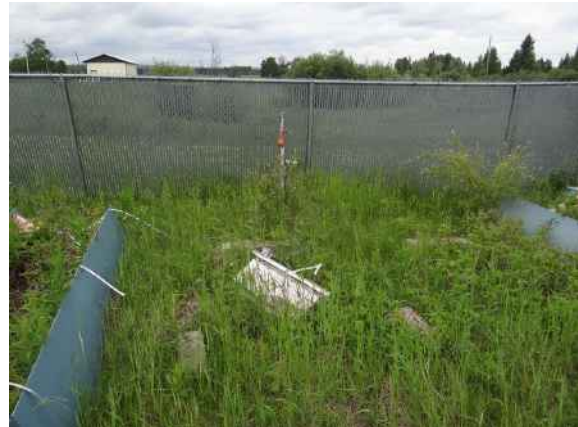
PRRD - Tate Creek Community Centre - G306099

There is an underground propane distribution system between the building and former tanks. It is assumed to be decommissioned but still in place. Removal is recommended.

The propane distribution system is no longer in use. Removal is recommended.

Recommendation #1 - Repair Allowance - System Removal	
Type	Condition-Based
Year	2020
Cost	\$20,000.00

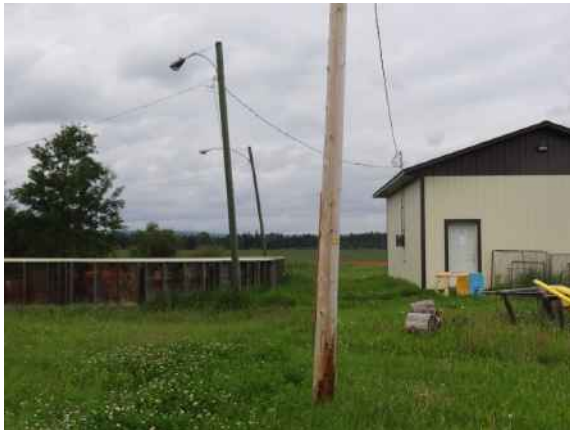
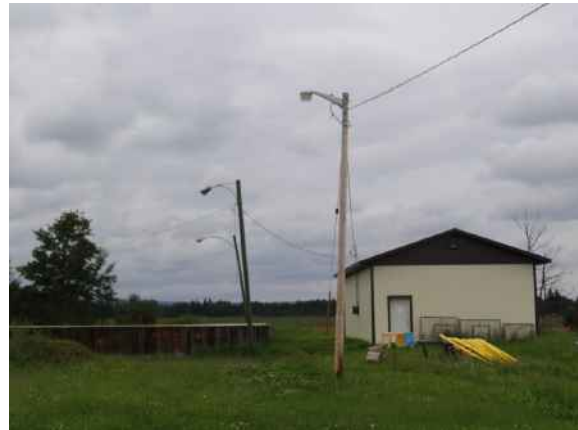
Tate Creek Community Centre - G402011

No major deficiencies were observed or reported, with the exception of 1 pole that was observed to be leaning and should be repaired.

Recommendation #1 - Repair Allowance - Leaning Standard	
Type	Lifecycle Repair
Year	2020
Cost	\$3,500.00

Recommendation #2 - Light poles - 20' high	
Type	Life Cycle Replacement
Year	2023
Cost	\$12,600.00
